Advanced Air Bag Investigation / Vehicle to Vehicle
Dynamic Science, Inc. / Case Number: DS03004
2003 Chevrolet Venture LS Minivan
California
November, 2002

1. Report No. DS03004	2. Government Accession No.	3. Recipient Catalog No.	
4. Title and Subtitle Advanced Air Bag Investigation		5. Report Date August 25, 2005

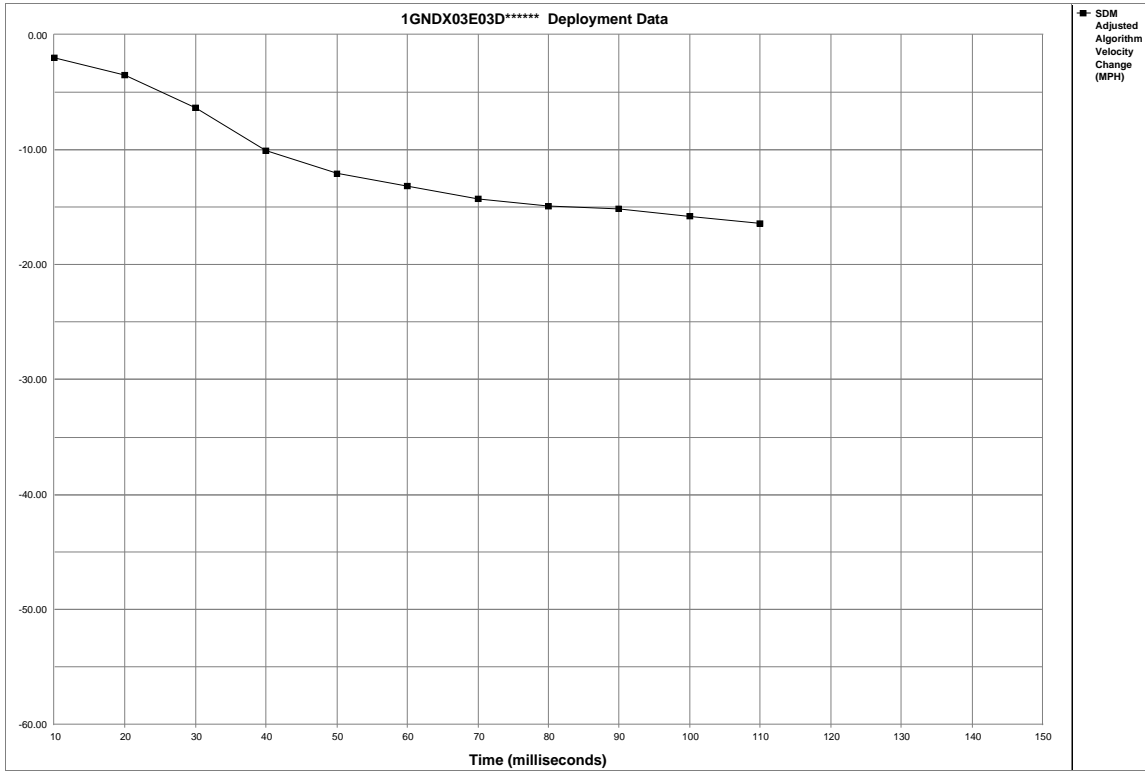
Time (milliseconds)	10	20	30	40	50	60	70	80	90	100	110	120	130	140	150
Adjusted Algorithm Velocity Change	-1.95	-3.49	-6.34	-10.07	-12.05	-13.15	-14.24	-14.90	-15.12	-15.78	-16.44	N/A	N/A	N/A	N/A
