Advanced Occupant Protection System Investigation / Vehicle to Vehicle
Dynamic Science, Inc. / Case Number: DS03007
2003 Toyota Matrix XR sport utility
Texas
January, 2003

Dynamic Science, Inc.
Accident Investigation
Case Number: DS03007

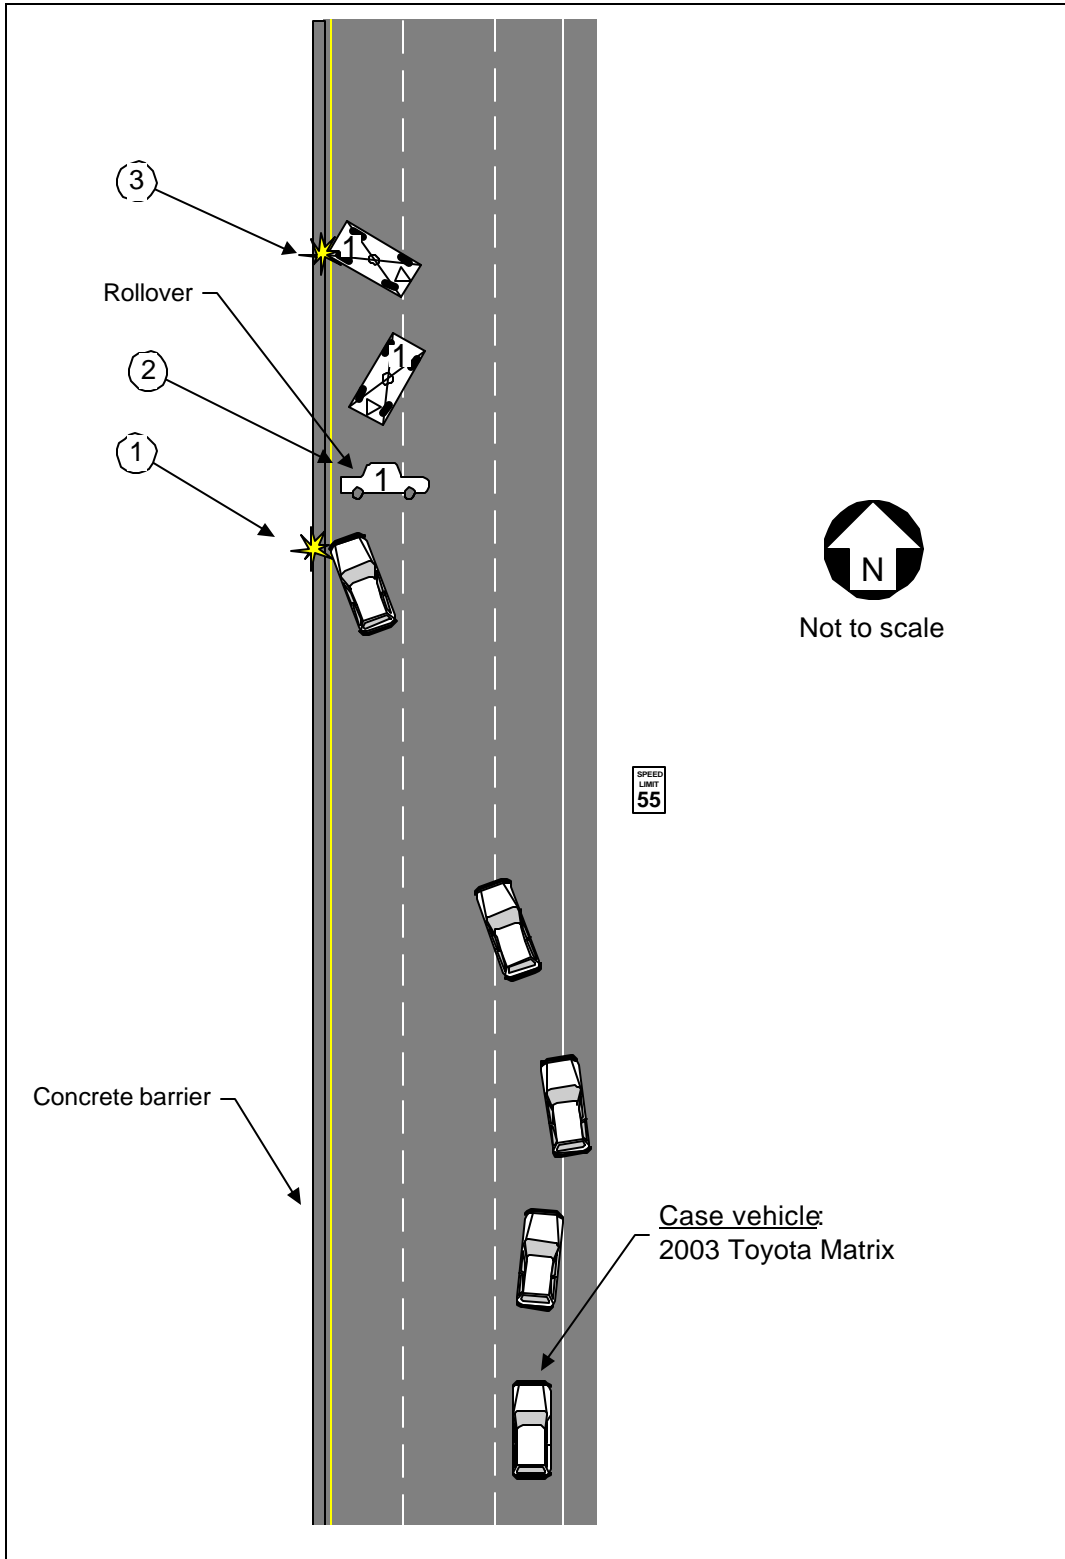
Figure 5. Scene diagram

This single vehicle crash occurred in January, 2003 at 2327 hours in Texas. The crash occurred on three-lane toll road. The concrete roadway was dry and free of reported defects. The northbound lanes are separated from the southbound lanes by a concrete median barrier. The speed limit is 89 km/h (55 mph).
