Advanced Air Bag Investigation / Vehicle to Vehicle
Dynamic Science, Inc. / Case Number: DS03008
2003 Chevrolet Avalanche
Texas
February, 2003

1. Report No. DS03008		2. Government Accession No.		3. Recipient Catalog No.	
4. Title and Subtitle Advanced Air Bag Investigation				5. Report Date November 3, 2003

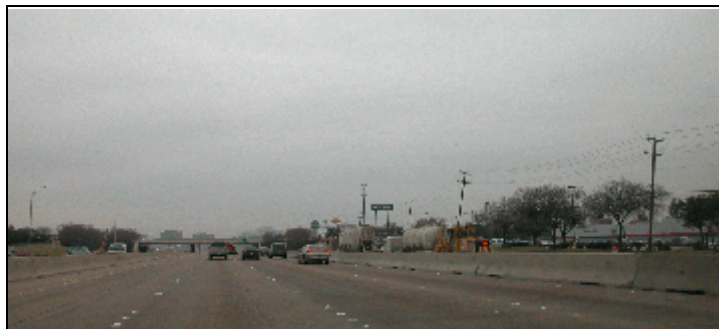
Figure 1. Overview of crash scene (south).

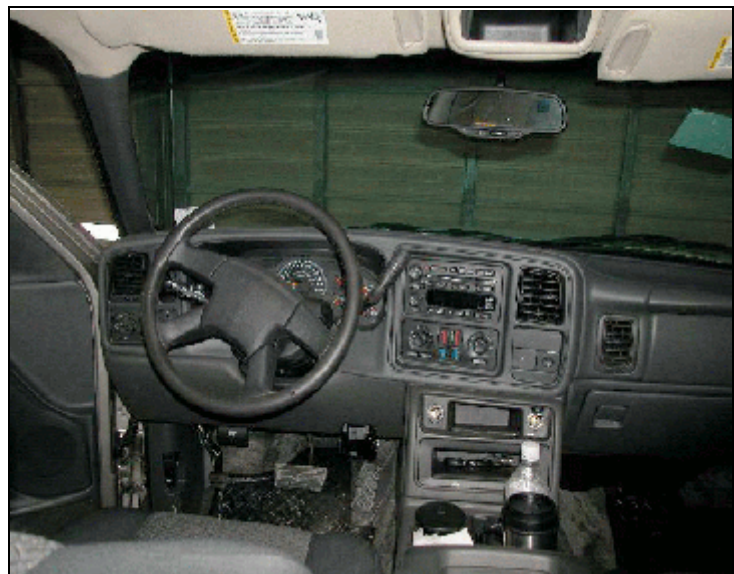
Figure 4. Driver's seated position

The 44-year-old male driver of the case vehicle was seated in a normal, upright fashion in the cloth covered split bench seat. The seat was adjusted to the rear most track position. The seat back was slightly reclined. The adjustable head rest was in the full down position. The driver was wearing the integral lap and shoulder belt. Prior to impact, the case vehicle was slowing and the driver had his foot on the brake. The case vehicle was then struck in the rear by the Chevrolet 2500 series pickup. The driver moved rearward in response to the 6 o'clock direction of force. The vehicle was pushed forward. The driver reacted to this motion by braking once again. The vehicle then decelerated to 10 km/h (6 mph) before striking the rear of the Toyota Camry. He moved slightly forward in response to the 12 o'clock direction of force. His left knee contacted the left lower instrument panel. There was no injury related to this contact.

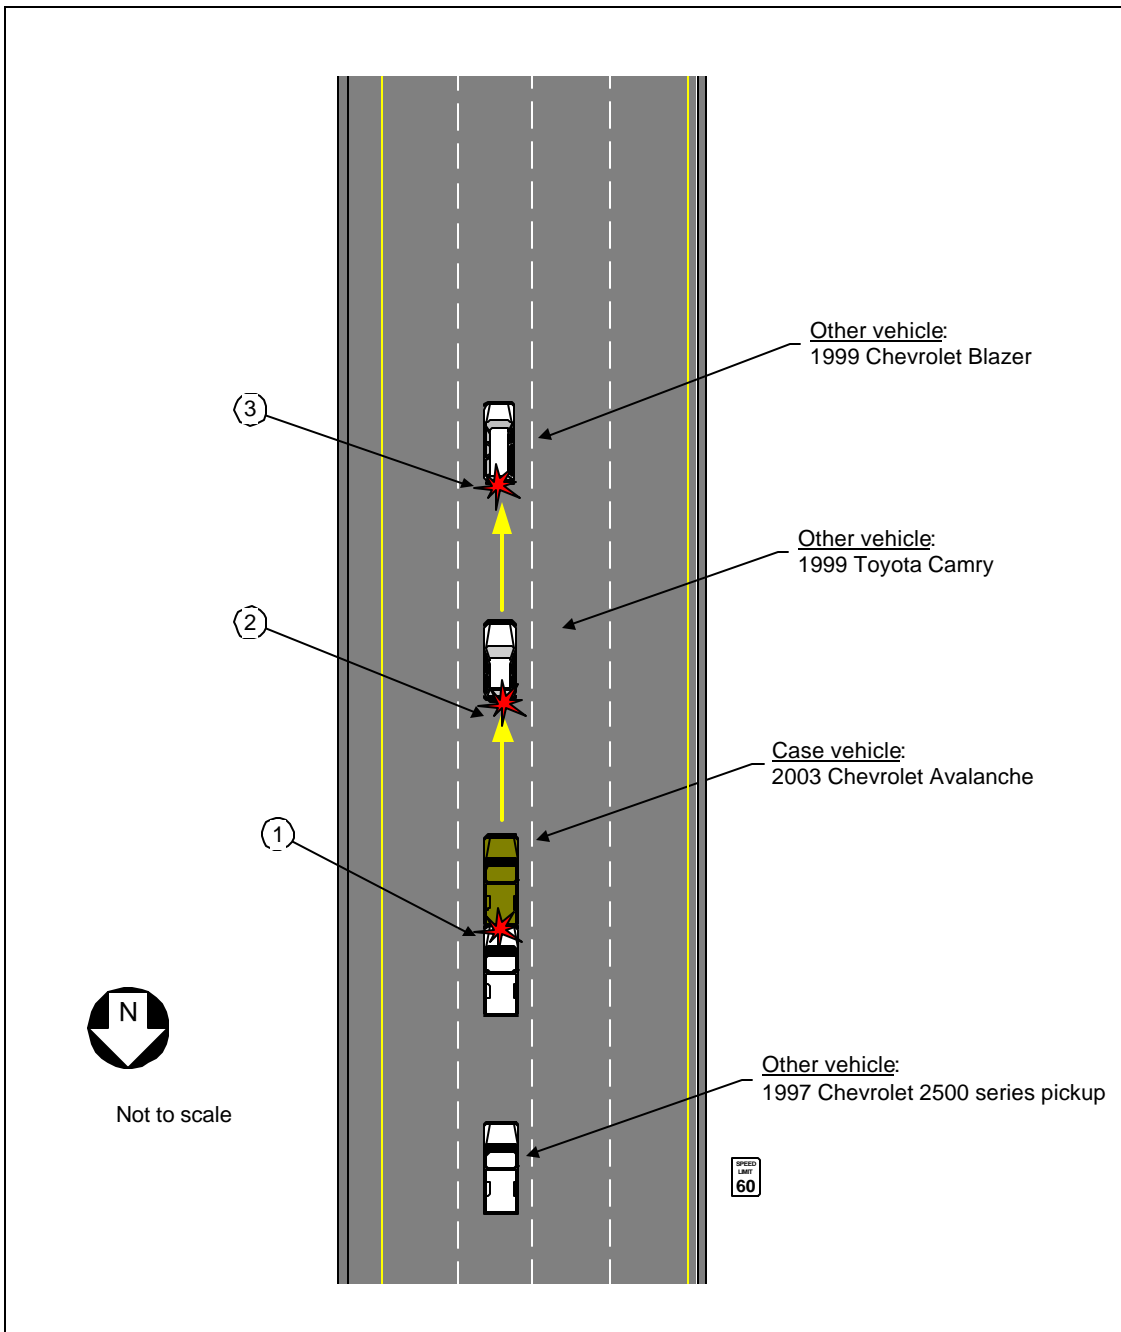
The Blazer was stopped in the third lane from the right facing south. The Toyota Camry was behind the Blazer and was slowing. The case vehicle was behind the Camry and was slowing. The Chevrolet 2500 series pickup was traveling behind the case vehicle. The driver of the pickup failed to stop in time and rear-ended the case vehicle (06BDEW1). The case vehicle was pushed forward and struck the rear of the Camry with its front end (12FYLW1). The Camry was then pushed forward into the rear of the Blazer just as it was beginning to pull forward with traffic.

Figure 5. Scene diagram

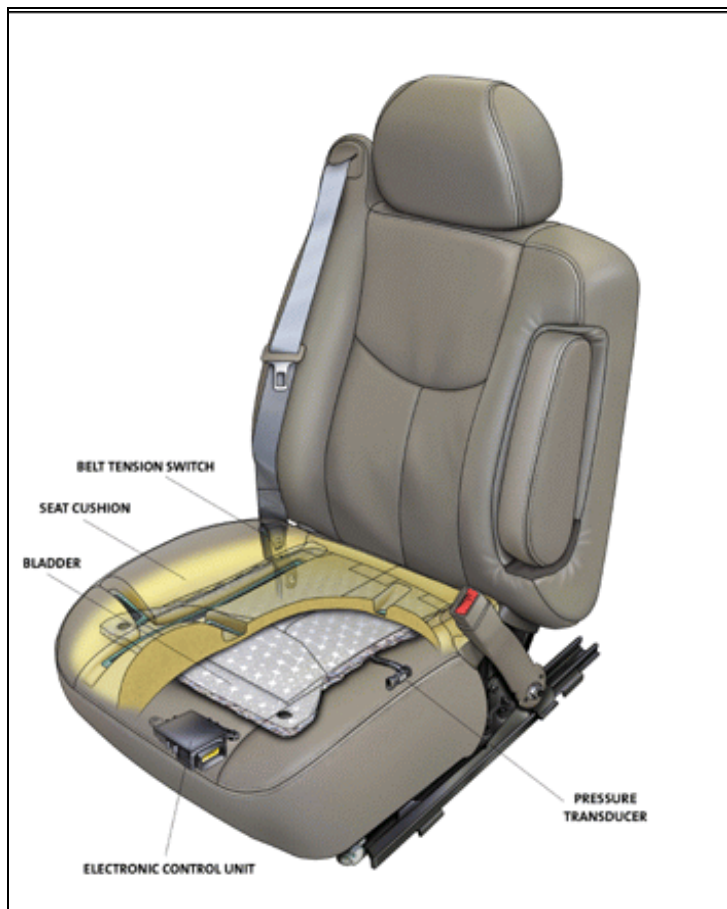
There is an indicator on the center rear-view mirror that alerts vehicle occupants to the status of the system at all times. If the light reads "Passenger Air Bag ON," the air bag is programmed to deploy in a frontal crash of sufficient severity. If it reads "Passenger Air Bag OFF," the system has turned off the air bag because it determined either that there is no occupant on the front passenger seat, or that a rear-facing infant seat, a forward-facing child restraint, a booster seat or a smaller person, such as a child who has outgrown child restraints, is present. The sensing system is standard on most 2003 full-size pickups and sport-utility vehicles. There were no air bag deployments. The vehicle was equipped with seat integrated seat belts. There were no indications of seat belt loading.

Figure 7. Passenger sensing system (photo from GM web site www.gm.com/company/gmability/safety/images/pss.jpg)

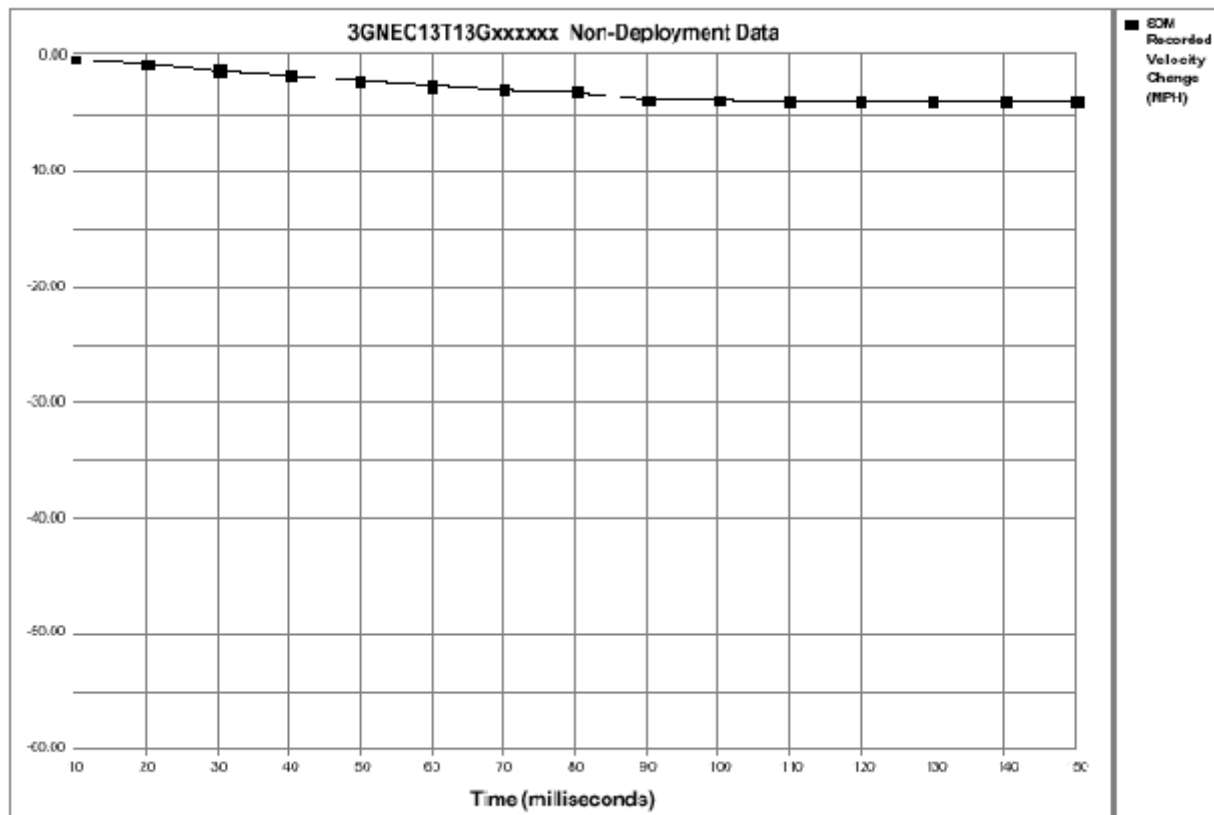
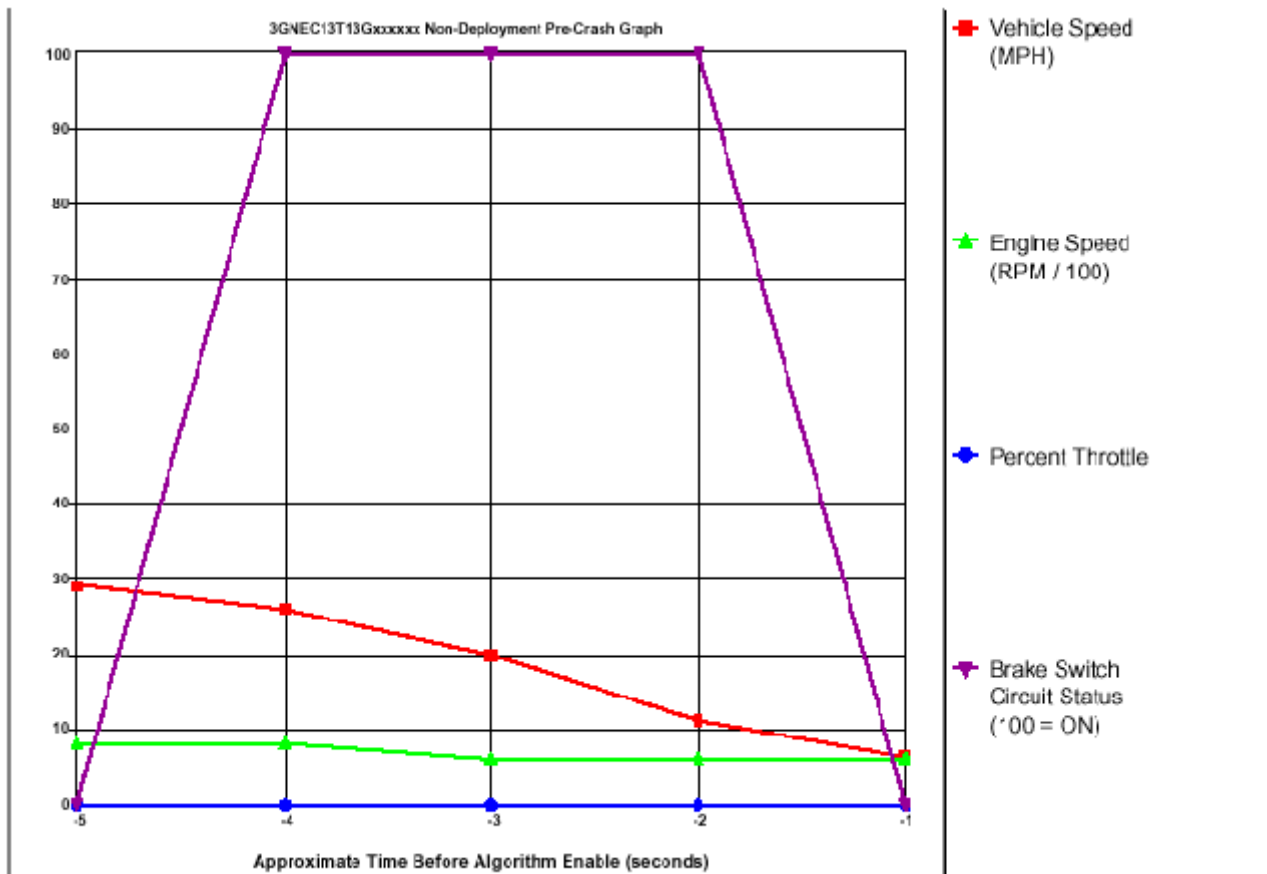
The downloaded data indicated that the case vehicle had a maximum recorded velocity change of -6.4 km/h (-4.04 mph) at the 100 ms mark as a result of the forward impact. The result appears slightly low given that there was residual damage to the bumper mounting bracket.

SIR Warning Lamp Status	OFF
Driver's Belt Switch Circuit Status	BUCKLED
Ignition Cycles At Non-Deployment	484
Ignition Cycles At Investigation	509
Maximum SDM Recorded Velocity Change (MPH)	-4.04
Algorithm Enable to Maximum SDM Recorded Velocity Change (msec)	100
Event Recording Complete	Yes
Multiple Events Associated With This Record	Yes
One Or More Associated Events Not Recorded	Yes
