### ON-SITE CHILD SAFETY SEAT INVESTIGATION

CASE NUMBER - IN-03-008  
LOCATION - ILLINOIS  
VEHICLE - 2003 CHEVROLET K1500 TAHOE  
CRASH DATE - January 2003

August 10, 2007

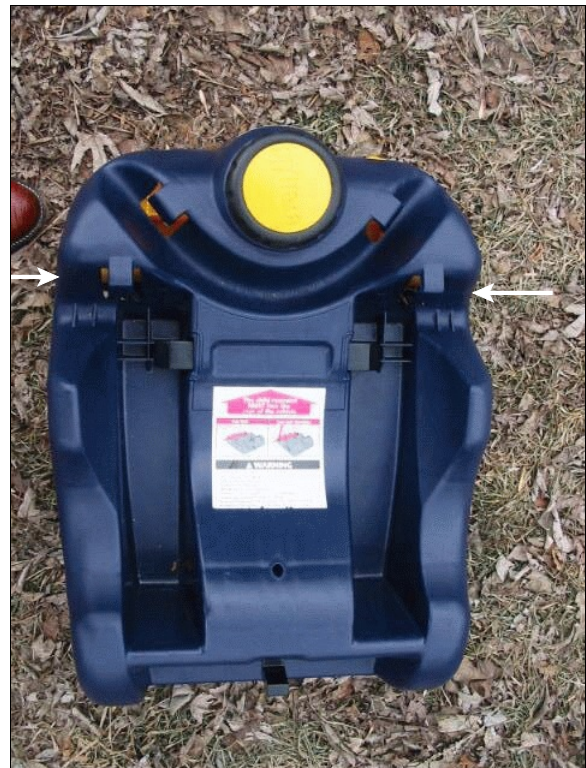
**Figure 15:** Overhead view of infant child safety seat's detachable base; arrows indicate where case vehicle's safety belts attach through slots in base (case photo #101)

The second seat center passenger was seated in a rear facing infant child safety seat with a separable base (**Figure 15**). The child safety seat was manufactured by Evenflo, on April 18, 2002, and was identified by Model name "Cozy Carry" and Model number 4771273P1. The infant seat was designed with a five-point harness. There were three slots in the seat's back for positioning

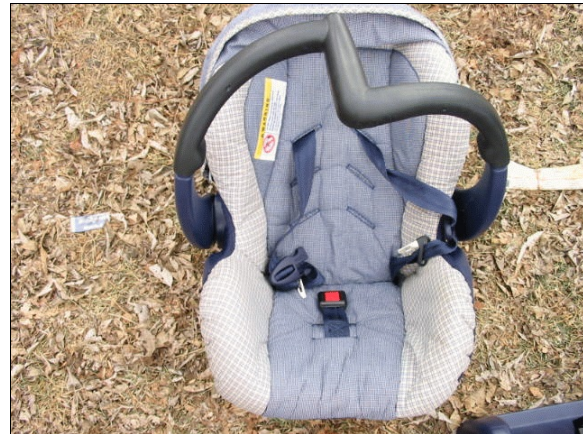
the harness straps; the harness was positioned in the top slots (**Figure 16**). The child seat was in the reclined position.

**Figure 16:** Overhead view of infant child safety seat used by case vehicle’s back center passenger; Note: harness straps positioned through top of three provided slots (case photo #103)

The position of the child seat's carrying handle (Figures 16 and 18 above) at the time of the crash is unknown. This contractor has no indication that the handle was other than in its down position.

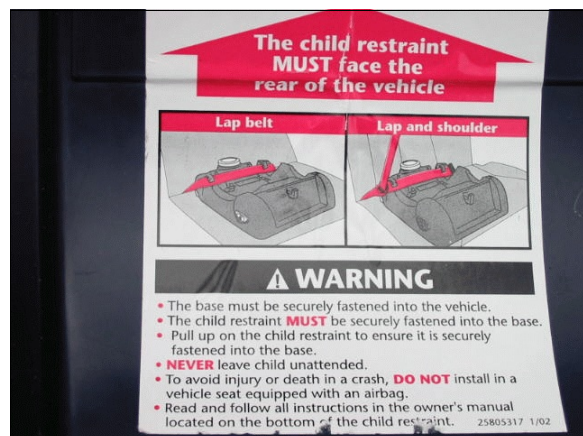
**Figure 17:** Warning label mounted on top of detachable base of infant child safety seat used in case vehicle (case photo #107)

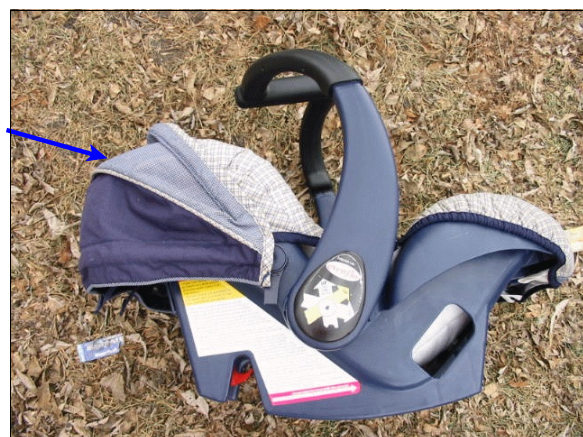
**Figure 18:** Overhead view of left side of infant child seat used by case vehicle’s back center passenger showing warning label and red and white leveling arrow at bottom of label; Note: child’s head is positioned toward arrow (case photo #104)

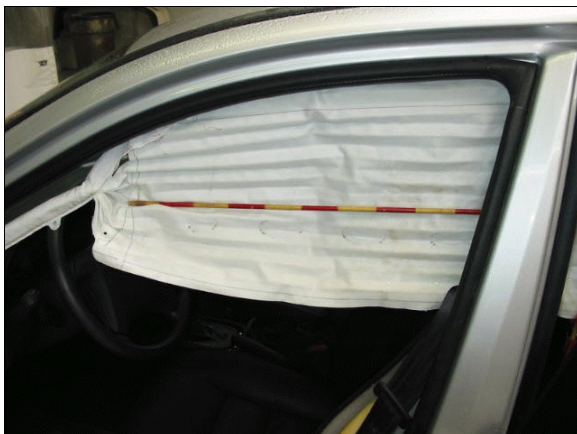
Neither frontal air bag deployed (**Figure 25**) as a result of the Volvo's left side impact (**Figure 4** above) with the case vehicle nor was either driver or front right passenger knee bolsters damaged or deformed. On the other hand, the driver's seat back-mounted side air bag (**Figures 26 and 27** below) and the left side inflatable curtain (**Figures 28 through 31** below) did deploy as a result of the Volvo's left side impact with the case vehicle.

**Figure 28:** Outboard surface of Volvo's left side inflatable curtain protecting driver's seating area (case photo #78)

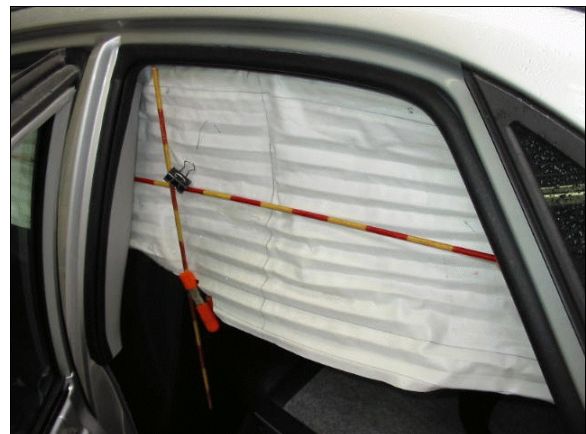
**Figure 29:** Outboard surface of Volvo's left side inflatable curtain protecting back left seating area (case photo #91)

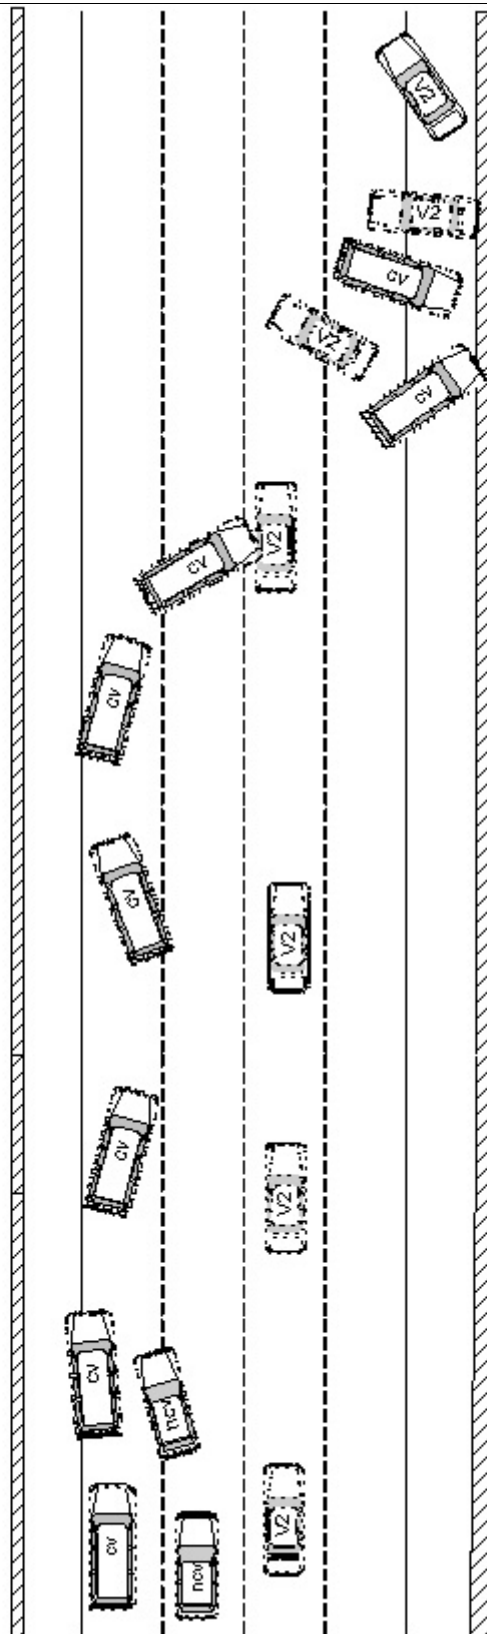
**IN-03-008**

Impact and final rest positions of both vehicles are estimated based on police schematic and interview with case vehicle's owner/occupant

1 cm = 2.5 m  
Straight, Level (i.e., very slight slope, negative to south--downgrade)  
Dark but lighted, Snowing, Snowy/slushy concrete roadway; Coefficient of friction = .40
