ON-SITE ADVANCED OCCUPANT PROTECTION SYSTEM INVESTIGATION

CASE NUMBER - IN-03-013
LOCATION - TEXAS
VEHICLE - 2003 LINCOLN NAVIGATOR
CRASH DATE - March 2003

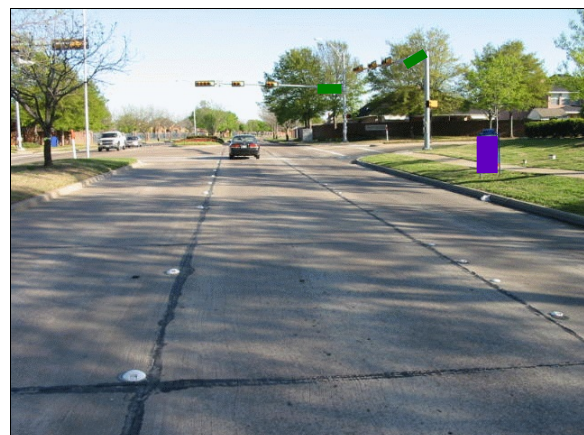
Crash Environment: The trafficway on which both vehicles were traveling was a five-lane, divided, city street, traversing in a north-northwesterly and south-southeasterly direction, and the case vehicle was approaching a four-leg intersection (**Figure 1**). On both the northern and southern legs of the intersection, both the northern and southern roadways had two through lanes. On the northern leg, the southern roadway had a left-hand turn lane and, similarly, on the southern leg, the northern roadway also had a left-hand turn lane. The city roadway was straight and level [i.e., actual slope was 1.6%, positive (an upgrade) in the case vehicle's southern direction of travel, or 0.8%, negative (a downgrade) in the Pontiac's northern direction of travel] just prior to the area of impact. The pavement was new-to-traveled concrete and, for the case vehicle, the width of the inside southern roadway's through lane was 3.4 meters (11.2 feet) and, for the Pontiac, the width of the northern roadway's left-hand turn lane was 3.8 meters (12.5 feet). Both the southern and northern roadways were bordered by barrier curbs

Figure 1: Case vehicle's south-southeastward travel path in inside southern through lane approaching four-leg intersection (case photo #01)

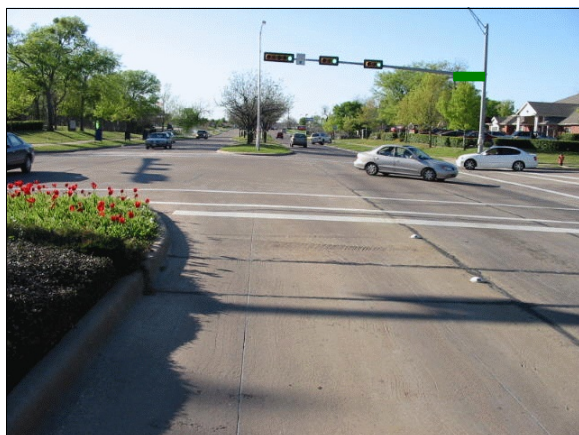
Figure 2: Pontiac's north-northwestward travel path in northern left-hand turn lane prior to turning left at four-leg intersection (case photo #04)

Pre-Crash: The case vehicle was traveling south-southeast in the inside through lane of the southern roadway intended to proceed straight ahead. The Pontiac had been traveling north-northwest in the left-hand turn lane (Figure 2) of the northern roadway and was making a left-hand turn, intending to travel west-southwestward on an intersecting eastern-western trafficway. The case vehicle's driver braked, attempting to avoid the crash. The crash occurred in the inside southern lane, within the four-leg intersection of the two trafficways (Figure 3).

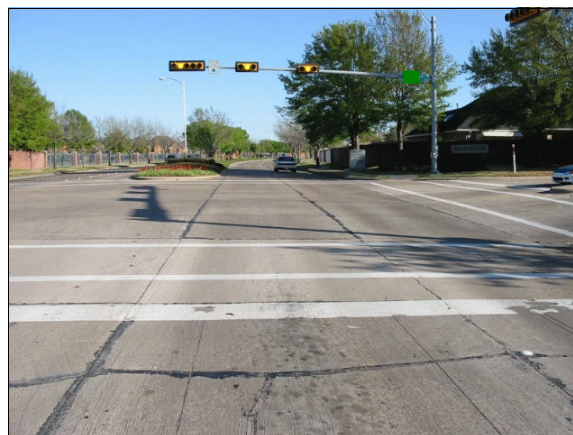
Figure 3: Case vehicle's south-southeastward travel path into intersection in inside southern through lane and area of impact (case photo #01a)

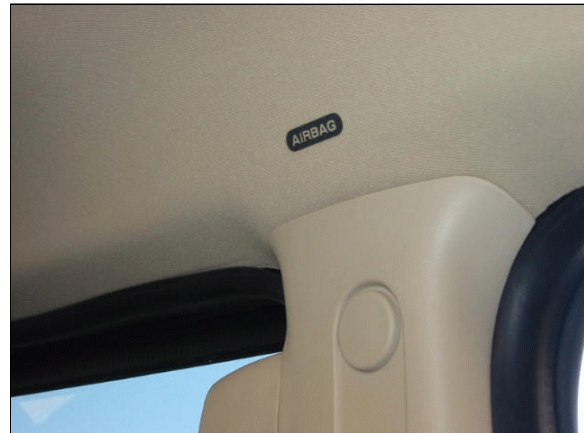
The case vehicle was equipped with a Supplemental Restraint System (SRS) that contained dual stage frontal air bags at the driver and front right passenger positions. In addition, the vehicle was equipped with side curtain inflatable air bags which extend from each of the roof side rails (**Figure 9**). Both frontal air bags deployed as a result of the frontal impact with the Pontiac (**Figures 7 and 8** above). It is unknown if the second stage of either frontal air bag was activated, but based on the calculated Delta Vs it is unlikely that the second stage was used. The case vehicle's side inflatable curtain did not deploy as a result of the case vehicle's frontal impact with the Pontiac. The case vehicle's driver air bag was located in the steering wheel hub. The module cover consisted of asymmetrical "H"-configuration cover flaps made of medium, pliable vinyl with overall dimensions of 12.5 centimeters (4.9 inches) at the horizontal seam and 8 centimeters (3.1 inches) vertically for the upper flap and 10 centimeters (3.9 inches) vertically for the lower flap. An inspection of the air bag module's cover flaps and the air bag's fabric revealed that the cover flaps opened at the designated tear points, and there was no evidence of damage during the deployment to the air bag or the cover flaps. The driver's air bag was designed with two tethers, each approximately 13.5 centimeters (5.3 inches) in width. The driver's air bag had two vent ports, approximately 3 centimeters (1.2 inches) in diameter, located at the 11 and 1 o'clock positions. The deployed driver's air bag was round with a diameter of 52 centimeters (20.5 inches). An inspection of the driver's air bag fabric revealed no contact evidence readily apparent on the air bag's fabric (**Figure 10**). The distance between the mid-center of the driver's seat back, as positioned at the time of the vehicle inspection, and the front surface of the air bag's fabric at full excursion was 34 centimeters (13.4 inches).

Figure 9: Air bag label on case vehicle's left roof side rail indicating present of vehicle's safety canopy system (case photo #23)
