On Site Advanced Occupant Protection Investigation / Vehicle to Vehicle  
Dynamic Science, Inc. / Case Number: DS03014  
2001 Ford Crown Victoria  
Arizona  
March, 2003

1. Report No. DS03014	2. Government Accession No.	3. Recipient Catalog No.	
4. Title and Subtitle  Advanced Occupant Protection Investigation		5. Report Date October 11, 2004

**Dynamic Science, Inc.  
Crash Investigation  
Case Number: DS03014**

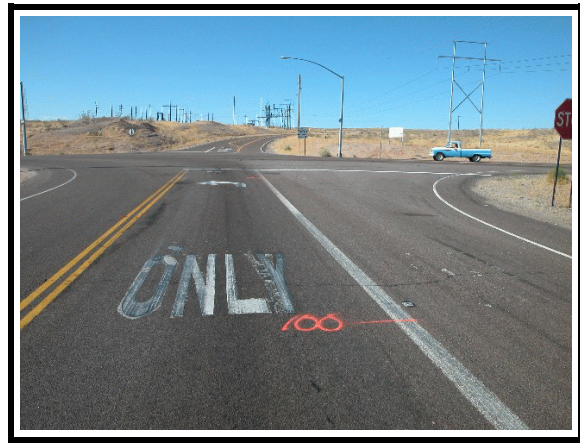
Figure 1. Case vehicle approach (north)

This two vehicle crash occurred in March, 2003 at 2030 hours. The crash took place within the confines of a four leg intersection. The northbound leg of the intersection was comprised of one through/right hand turn lane, one left turn lane, and one southbound lane. A stop sign is present. The speed limit is 89 km/h (55 mph). The eastbound leg of the intersection was comprised of a right hand turn lane, an eastbound through lane, a left hand turn lane, and two westbound through lanes. The road has a slight left hand curve. There is +2.1% grade. The speed limit is 89 km/h (55 mph). All roadways were of asphalt construction and were dry. It was dark at the time of the crash and the street lights were on.

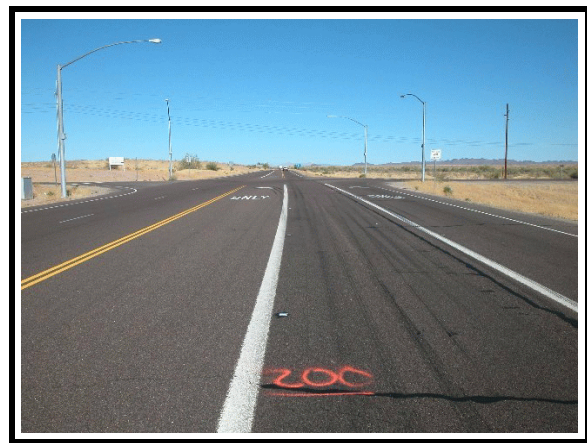
Figure 2. Other vehicle approach (east)

The case vehicle was a 2001 Ford Crown Victoria Police Interceptor driven by a properly restrained 29-year-old male (180 cm/71 in, 108 kg/240 lbs). The driver was wearing his protective vest. The other vehicle was a 1992 Freightliner conventional cab behind engine (CBE) tractor that was being driven by a 31-year-old male. This vehicle was pulling a 16 m (53 ft) Merritt livestock trailer that was fully loaded with cattle.

The case vehicle was traveling northbound and was in the left hand turn lane. The other vehicle was traveling eastbound. The case vehicle attempted a left hand turn (to go west) in front of the other vehicle. The driver of the other vehicle braked and steered left.

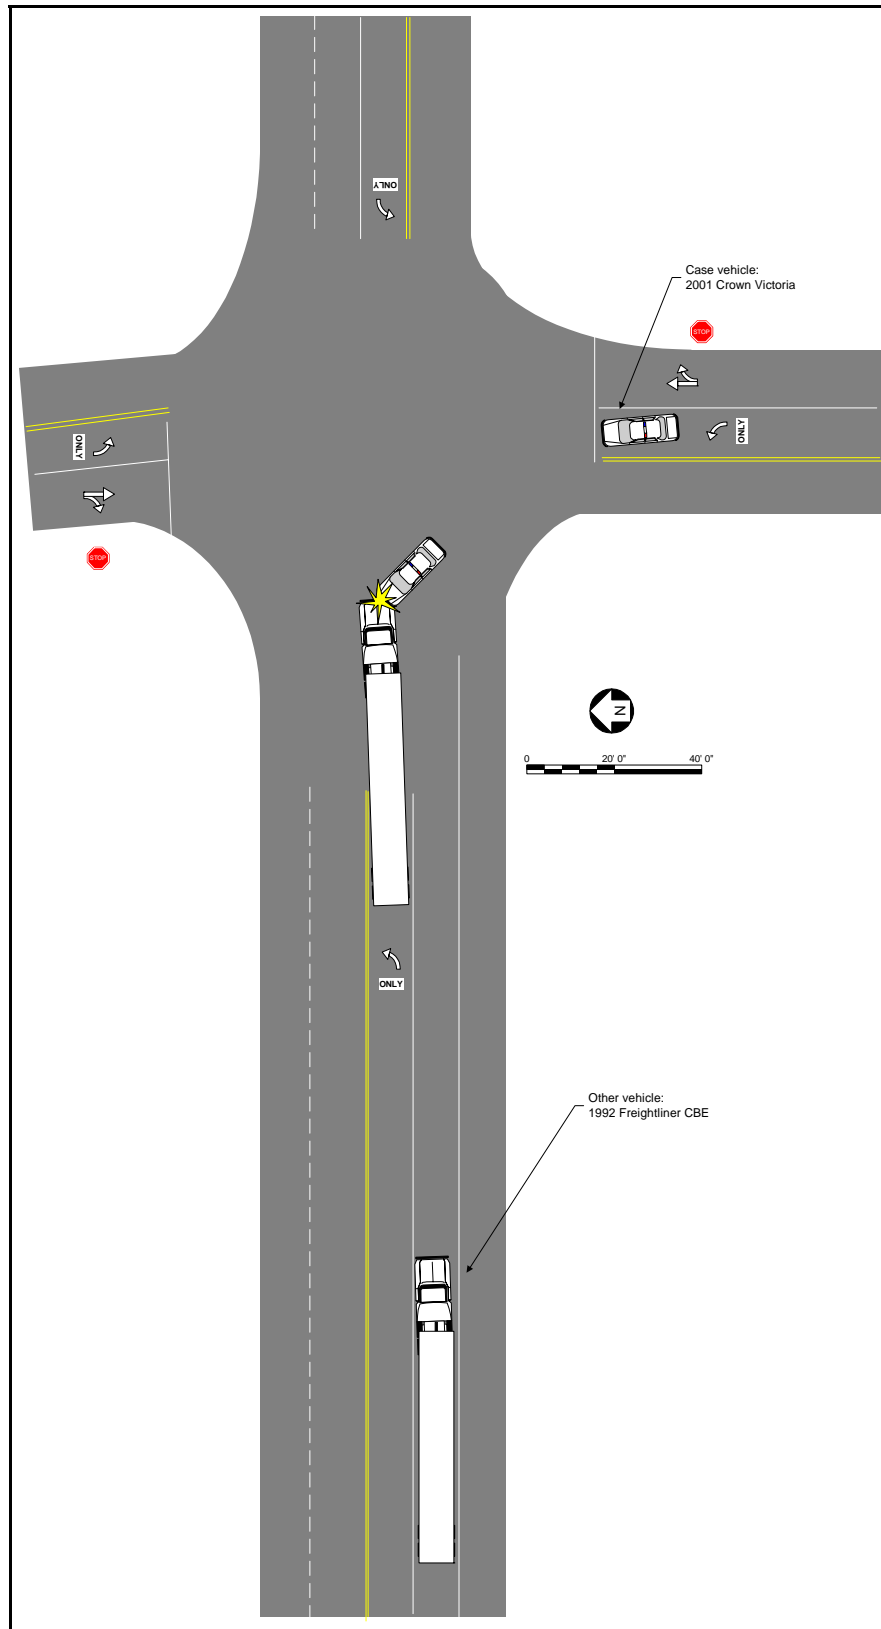
Figure 5. Scene diagram (impact)

The front of the case vehicle (11FDEW2) struck the front of the other vehicle. The case vehicle sustained a total delta V of 42.0 km/h (26.1 mph)<sup>1</sup> as calculated using the barrier option of the WinSmash collision model. The longitudinal and lateral delta V components were -36.4 km/h (-22.6 mph) and 21.0 km/h (13.0 mph), respectively. This was a borderline reconstruction because the crash is beyond the scope of WinSmash. Both front air bags deployed in the case vehicle. The case vehicle rotated clockwise and came to rest in the intersection. The other vehicle veered to the left and departed the roadway on the left side. The front left tire struck a metal pole—causing minor contact damage. The vehicle continued on and struck an embankment with its front end before coming to rest.

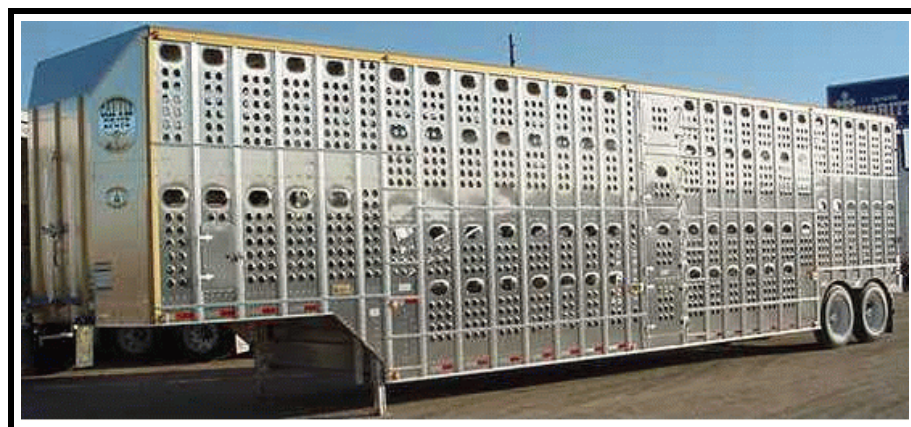
**Figure 14.** Exemplar view of Merritt livestock trailer

Damage Description: Towed, due to damage. Police indicate vehicle disabled. Right front axle wheel and left springs torn off frame. Left front wheel slid back onto leaf springs. Passenger side fuel tank torn off vehicle.

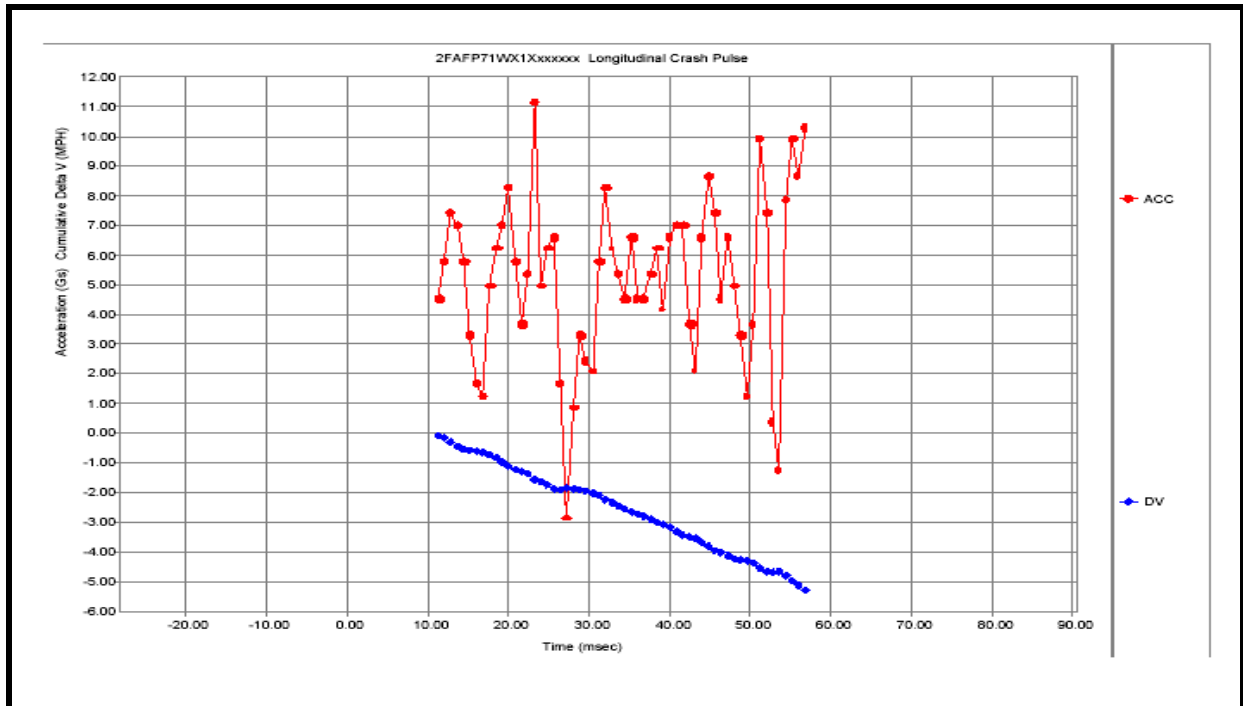
Crash Pulse Data

Ford Part Number Prefix	1W7A
Number Of Active Faults	0
Driver Seat Belt Buckle	Buckled
Passenger Seat Belt Buckle	Unbuckled
Driver Seat Track In Forward Position	No
Occupant Classification Status Value	Dual Stage
Unbelted Stage 1	Fire
Unbelted Stage 2	No Fire
Belted Stage 1	Fire
Belted Stage 2	No Fire
Driver Pretensioner	Fire
Passenger Pretensioner	Fire
