Side Air Bag Investigation / Vehicle to Vehicle
Dynamic Science, Inc. / Case Number: DS03027
1999 BMW 328i
Colorado
June, 2003

Technical Report Documentation Page

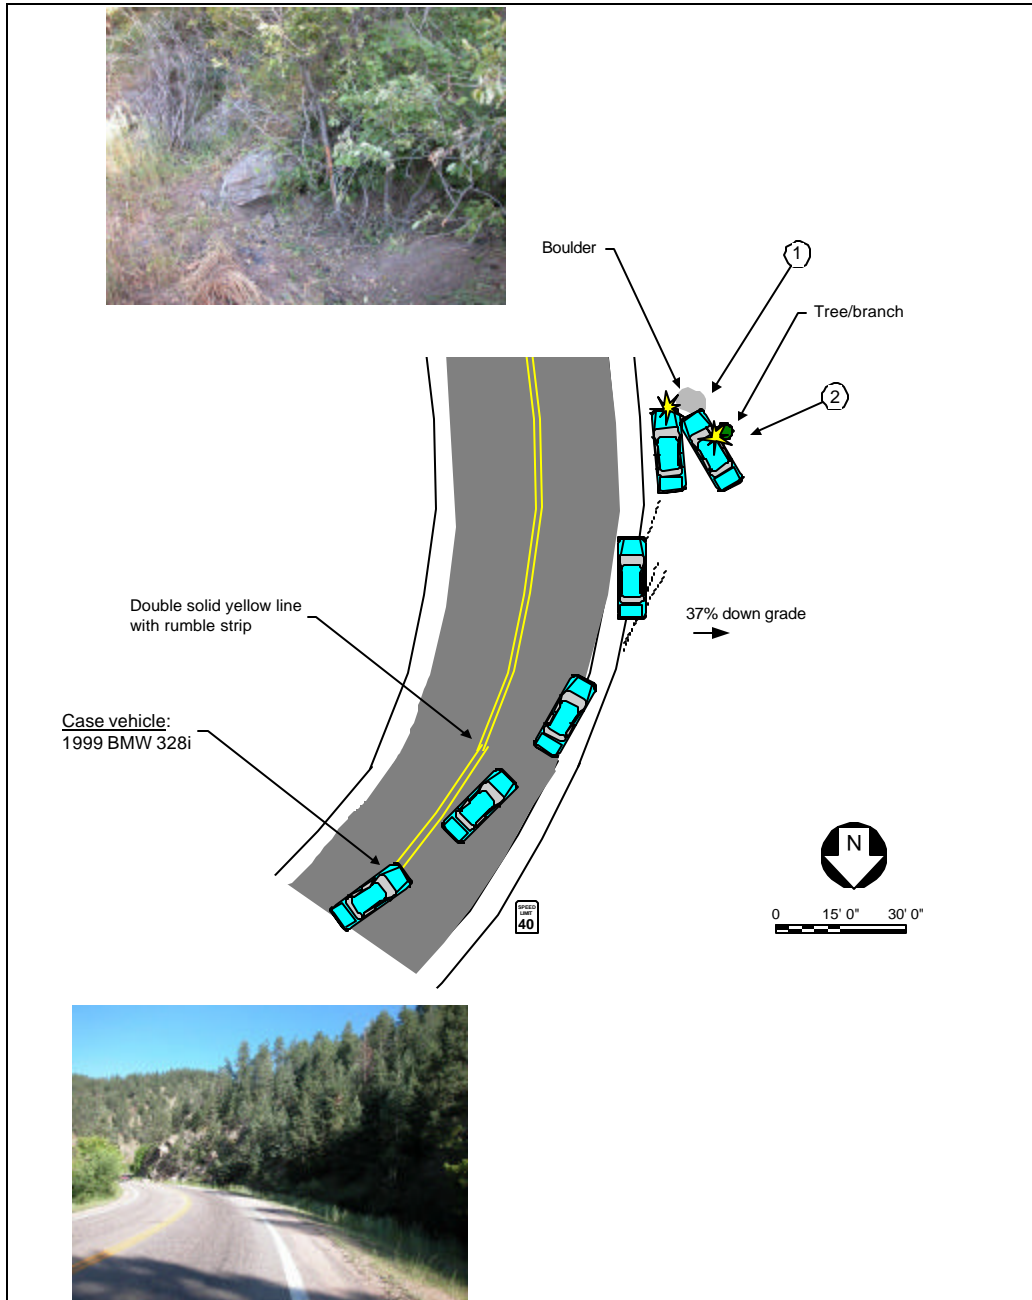
Figure 4. Scene diagram

COLLISION MEASUREMENT TABLE						
Crash Data	Vehicle #1					
Surface Type	Asphalt - Roadway					
Surface Condition	Dry					
Grade (pre-impact)	+2.5%					
Grade (impact)	-37%					
Speed Limit	64 km/h (40mph)					
Reference Point: paddle marker north of curve			Reference Line: artificial line set along north/south axis			
Data Point	Distance and Direction from RL			Distance and Direction from RP		
	ft	m	d	ft	m	d
ERF	0.7	0.2	W	38.0	11.6	S
BRF	0	0	W	59.0	18	S
ELR	6.5	2	W	52.0	15.8	S
ERR	9.3	2.8	W	35.0	10.7	S
BLR	1.0	0.3	E	71.0	21.6	S
BRR	1.0	0.3	E	71.0	21.6	S
Rock	16.0	4.9	W	19.0	5.8	S
Impacted tree/bushes	20	6.1	W	21.0	6.4	S
Chord - 30.4m (100.0 ft)						
Middle ordinate - 2.1 m (7.0 ft)

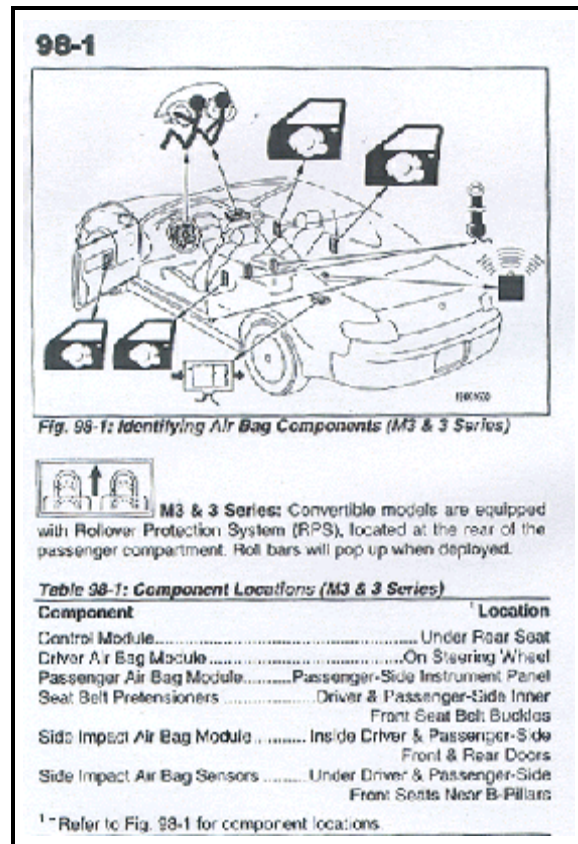
Figure 7. Air bag component locations

The case vehicle was equipped with a dual stage driver’s air bag, a dual stage front right passenger air bag, a driver’s door mounted side air bag, a front right passenger side air bag, and the Inflatable Tubular Structure (ITS) head protection for both front seats. Both front seat manual restraints were also configured with buckle pretensioners. The front air bags include a “smart” dual-threshold deployment system. The system will automatically assess the severity of an impact and choose between two inflation rates for the front air bags. The front right seat cushion contains a sensor mat that detects seat occupancy. The sensor recognizes if the seat is occupied or not. If the seat is not occupied, the air bag won't go off in the event of a collision. The ITS is entirely concealed above the front doors and within the A-pillar and roof cladding or upholstery. The ITS is a hollow, flexible, essentially airtight tube. At one end, this tube is anchored inside the vehicle’s A-pillar, near the bottom of the pillar. At the other end, it is anchored in the roof just above the rear door. Upon side impact, the inflator, mounted on one end of the tube, inflates the tube with an inert gas. A relatively airtight inner tube of silicon material manages the inflation; a woven nylon outertube manages the tube’s shape. The diameter increase forced by inflation causes the length to decrease. In turn, the tube no longer fits inside the area where it is stored; it pulls out of the headliner and forms a soft, straight tube and stretched in a straight line from the lower windshield pillar to the roof. According to BMW literature on the ITS, the tube is designed to stay inflated for approximately six seconds after deploying. The ITS is described in BMW’s literature as the Head Protection System (HPS).

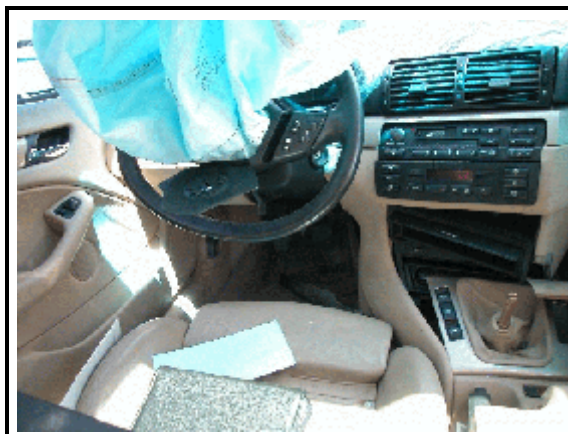
Figure 11. Driver's seated position

The 22-year-old male driver of the case vehicle was seated in a forward facing fashion. He was seated in a leather covered bucket seat; the seat had been adjusted to the mid track position. He was using the available type 2 lap and shoulder belt with an emergency locking retractor (ELR). Loading evidence was found on the seat belt. The shoulder belt upper anchorage was adjusted to the mid position. His right foot was on the brake, the left was on the floor board. He was actively steering the vehicle to the left. His right hand was likely above the left. The vehicle was in a counterclockwise yaw and both occupants were pitched somewhat to the right due to rotation and the 37% embankment down grade. At impact, the driver's air bag deployed and the seat belt pretensioner fired. The driver pitched forward and to the right in response to the 40 degree direction of force—loading the locked lap and shoulder belt and causing an abrasion to the upper left chest. His left knee engaged the lower instrument panel—causing a minor abrasion. The driver engaged the deployed air bag with his face and torso but did not sustain any injuries. The air bag did, however, contact his left forearm—causing an abrasion. His left foot was initially on the floor but moved sharply to the right at impact and struck the clutch pedal. He sustained minor ankle abrasion from this contact. The vehicle rotated counterclockwise after the initial impact and engaged a bush/tree. This contact did not have a significant effect on this occupant. He was able to exit the vehicle on his own. He was transported to a local hospital. He arrived shortly after the crash and initially refused any treatment, but was later treated and released.
