On Site Child Safety Seat Investigation / Vehicle to Vehicle
Dynamic Science, Inc. / Case Number: DS03031
1995 Ford Windstar
Arizona
August, 2003

1. Report No. DS03031	2. Government Accession No.		3. Recipient Catalog No.	
4. Title and Subtitle On Site Child Safety Seat Investigation			5. Report Date June 15, 2004

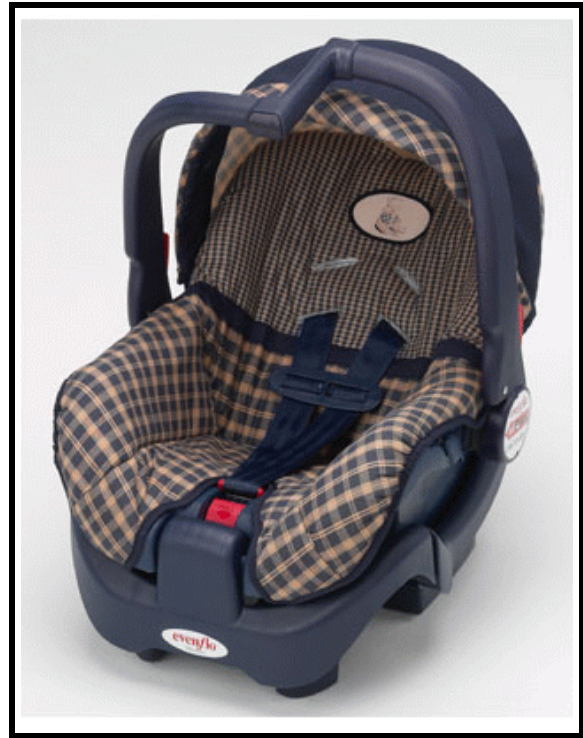
Figure 13. Exemplar view of Evenflo infant safety seat

The second row left seat was occupied by a 4-month-old male (03) who was seated in an Evenflo Discovery rear facing infant safety seat (ISS), model #33161356P1 with a manufacture date of 04/04/03. The seat was designed to be used in a rear facing fashion for infants weighing between 2-9 kg (5-20 lbs). Police photos show that the child was restrained using the 3-point harness. The investigating officer indicated that the seat was properly anchored to the case vehicle using the available lap and shoulder belt. This does not appear to be the case. The left rear seat position was equipped with an emergency locking retractor, which would have necessitated the use of a locking clip. There are no indications that a locking clip was used.

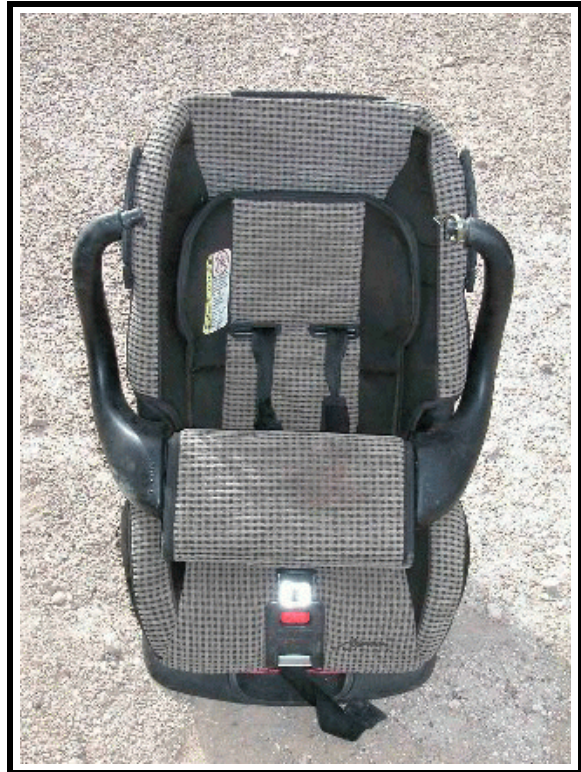
Figure 16. Cosco Alpha Omega child safety seat

The harness and shield are to be removed when being used as a belt positioning booster. In this crash, the seat was being used as a forward facing toddler seat. The seat was anchored to the vehicle using the available lap and shoulder belt. The child seat harness was routed through the top slots. The third row left rear seat position was equipped with an emergency locking retractor, which would have necessitated the use of a locking clip. There are no indications that a locking clip was used.

There were indications of loading to the child seat harness, the lap and shoulder belt routing guide on the right side of the child seat, to the lap and shoulder belt itself, and to the D pillar lap and shoulder attachment. Both sides of the tray shield mounting fractured and came free during the crash.

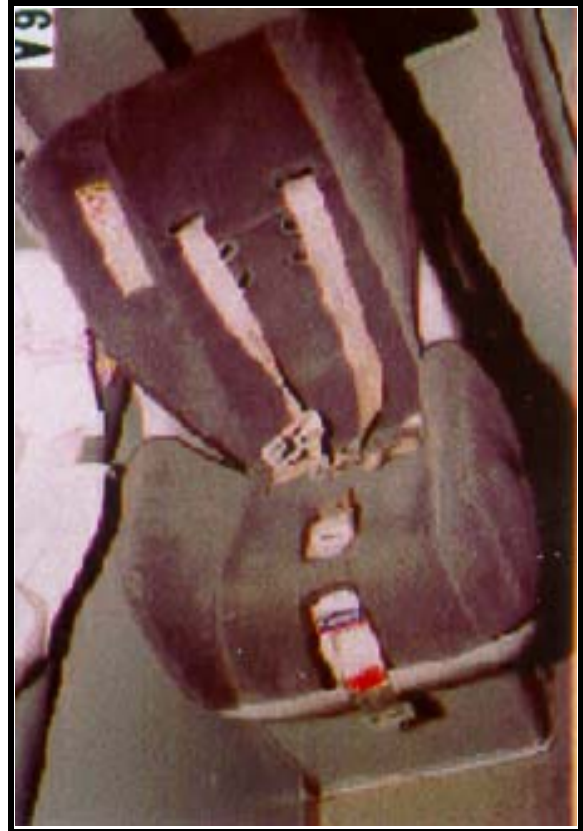
Figure 20. Graco Century 1500 STE convertible car seat

The third row right seat was occupied by the other 2-year-old female. The child was seated in a Graco Century 1500 STE convertible car seat. The manufacturer recommends that the seat be used in the rear facing mode until children weigh at least 9 kg (20 lbs) and are one year of age. For children over 10 kg (22 lbs), the car seat should be used in the forward facing until the child reaches 20 kg (40 lbs). In this case the seat was being used as a forward facing toddler seat. The seat was anchored to the vehicle using the available lap and shoulder belt. The child seat harness was routed through the top slots. The third row right rear seat position was equipped with an emergency locking retractor, which would have necessitated the use of a locking clip. There are no indications that a locking clip was used. There were indications of loading to the lap and shoulder belt itself and to the D pillar lap and shoulder attachment.

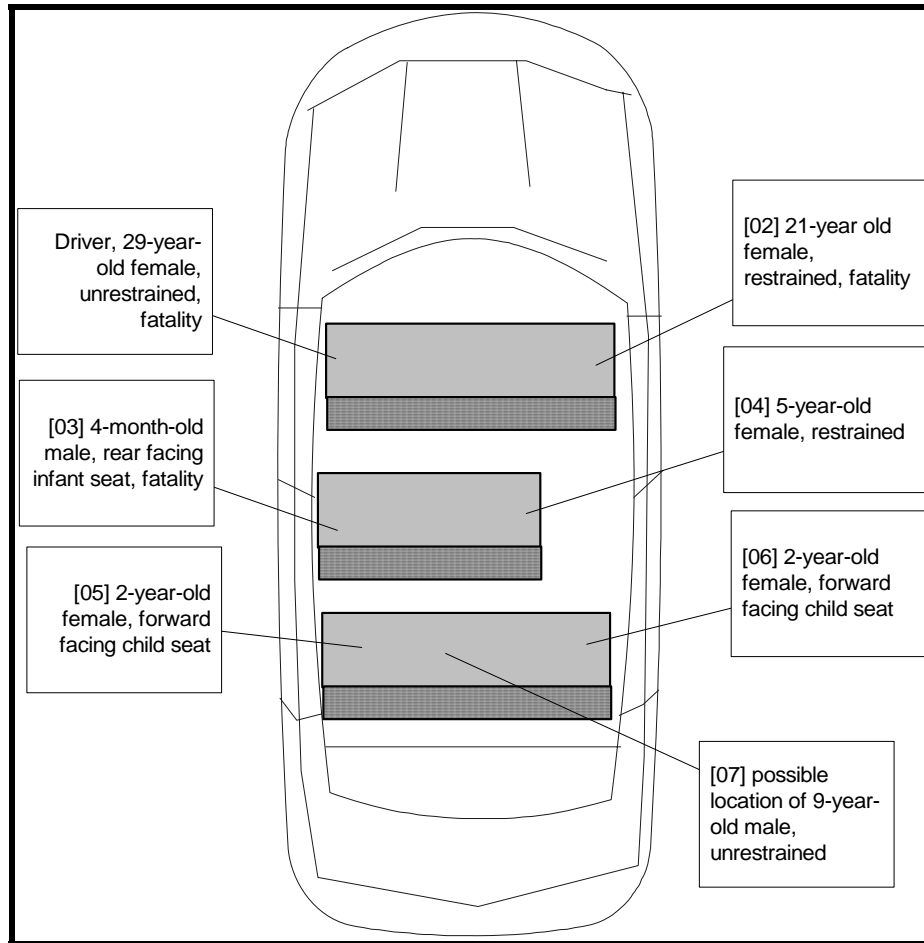
Figure 24. Seating diagram

The 29-year-old female driver of the case vehicle was seated in a forward facing fashion on a fabric covered bucket seat. The seat track position is not known. She was not using the available 3-point lap and shoulder belt. A steering wheel hub mounted frontal air bag was available. At impact, the driver responded to the 11 o'clock direction of force by pitching forward sharply and over-loading the deployed driver's air bag. Her abdomen compressed and deformed the lower steering wheel rim. This action likely caused the aortic transection, mesentery lacerations, liver and bladder lacerations. Her torso engaged the middle and top of the steering wheel. This caused the lung

pivot point. The driver's head pitched forward, hyper-flexing over the steering wheel. This movement likely caused the pons-medullary junction laceration and the cervical fractures. Both of the driver's knees struck the lower instrument panel, indirectly causing bilateral femur fractures and a left pelvis fracture.

The 21-year-old female front right occupant (02) was seated in a normal upright fashion on a fabric covered bucket seat. Based on location of abrasion injuries to her face, she was facing left prior to impact. Based on post-crash photos, it appears that her legs were crossed—left leg over right. The seat had been adjusted to the full forward track position. She was wearing the available 3-point lap and shoulder belt. The seat belt anchorage was in the full down position. A front right passenger air bag was available. At impact, this occupant responded to the 11 o'clock direction of force by pitching forward and to the left. She engaged the loaded torso belt causing the multiple rib fractures and pulmonary contusion. Her abdomen engaged and loaded the lap belt—causing the liver and spleen lacerations. There were abrasions to the shoulder, torso, and abdomen that were likely related to seat belt usage. This occupant slid forward to some degree as her abdomen was compressed and engaged the glove compartment door—causing, indirectly, the right femur fracture. With her torso held in place, her head pitched forward sharply. It appears that she contacted the deployed air bag with the right side of her face—causing an abrasive injury. The pitching forward motion of her head (hyper flexion) and subsequent rearward motion of her head and torso from the air bag and rebound (hyper extension) both likely contributed to the pons medullary laceration and the C1 fracture. The hyper flexion was likely the most significant of the two. The rebound motion was significant. This occupant's head and torso were pushed rearward so that she came to rest with her back on the seat cushion and her head pivoted rearward so that her face was in contact with the seat back.
