**ON-SITE CHILD SAFETY SEAT INVESTIGATION
CENTURY SMART MOVE SE CONVERTIBEL CHILD SAFETY SEAT
GENERAL DYNAMICS CASE NO: CA03-033**

**VEHICLE – 1990 TOYOTA 4 RUNNER
LOCATION - COLORADO
CRASH DATE – JUNE 2003**

Contract No. DTNH22-01-C-17002

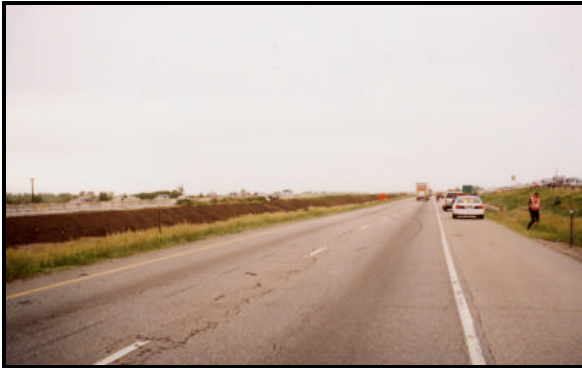
Figure 2: Northbound view on the interstate.

construction crew had constructed a 4.6 m (15.0 ft) wide berm of recycled asphalt and earth that was being used for the highway reconstruction. The berm was an estimated 2.4 m (8.0 ft) in height and was oriented parallel to the roadway. The center of the berm was located 14 m (46 ft) west of the pavement edge of the northbound lanes. The highway speed limit in the construction zone was reduced to 105 km/h (65 mph) from the posted 121 km/h (75 mph) interstate speed limit. **Figures 2 and 3** are views of the roadway configuration and center median.

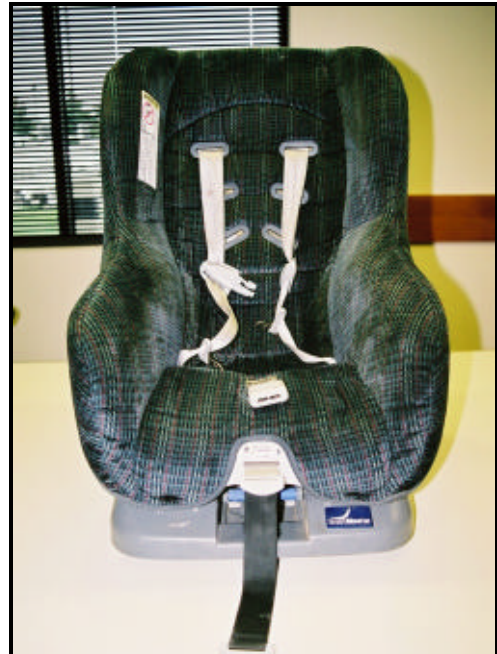
Figure 4: View of the Century Smart Move SE.

The 2 year old male was secured in a Century Smart Move SE convertible seat, **Figure 16**. This seat had a manufacture date of April 15, 1999. The model number was 4709FOX. Portions of the manufacturer's label were torn and missing. The seat was designed for rear-facing use by infants up to 14 kg (30 lb) and for forward facing use by toddlers 9 – 18 kg (20 – 40 lb). The label further detailed that infants to 9 kg (20 lb) *must* be rear facing and that toddlers 9 – 14 kg (20 to 30 lb) *could* remain rear facing so long as their feet did not touch the vehicle's seat back. The seat cradle rotated relative to the base to change from the rear facing to forward facing mode and had four adjustments positions. Two adjustment positions were for each mode. The seat was adjusted to the fourth position. This was the most upright forward facing position.

The seat was equipped with a 5-point harness and a two-piece harness retainer clip. The harness straps were routed through the top slots of the seat back. It was not equipped with a tether strap. Inspection of the harness straps did not reveal any crash related evidence. The length of the right strap measured 48.9 cm (19.3 in) from the top slot to the base. The length of the left strap measured 42.5 cm (16.8in). The chest clip was adjusted 21.6 cm (8.5 in) below the top slot on each strap. The retainer clip opened and closed properly. The straps were slightly roped at the crotch clips. The crotch clips properly fastened and released from the buckle.

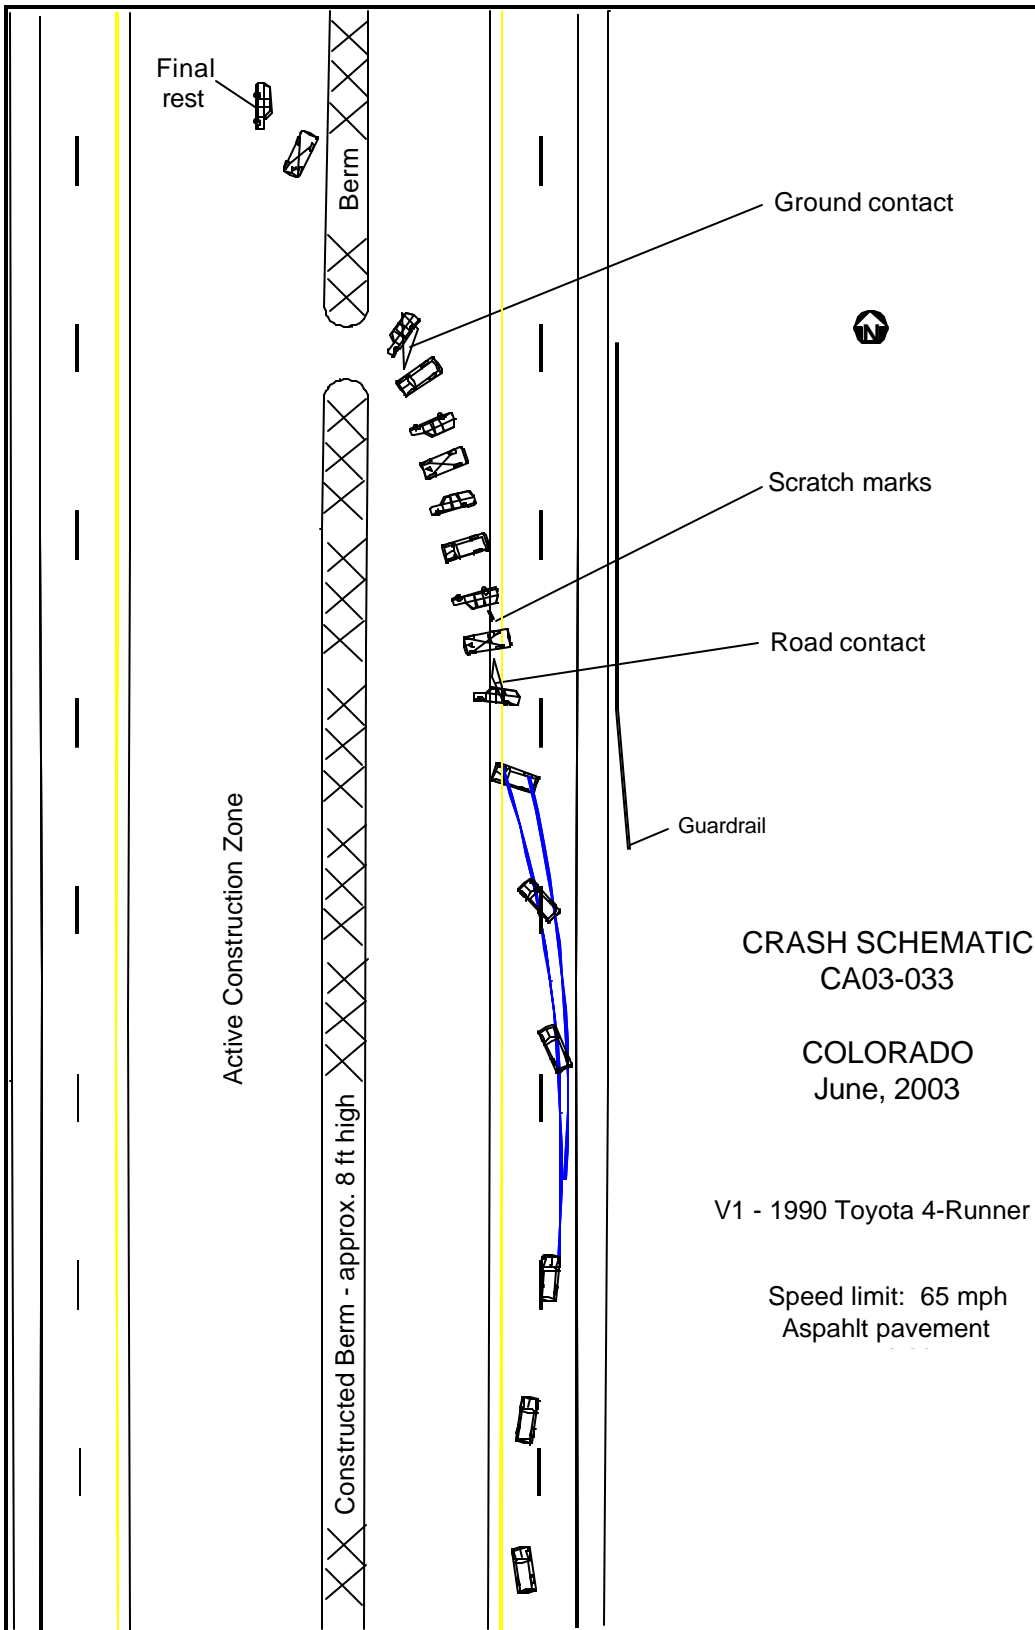
Figure 20: Crash Schematic.

Figure 4 is an on-scene police photograph of the yaw marks looking along the Toyota's northwestward trajectory. At the end of the yaw marks, the Toyota initiated an untripped right side leading rollover. There were no pavement gouges at the end of the yaw marks normally associated to a tripped rollover. The area of first touchdown was located 9 m (30 ft) northwest of the end of the yaw marks on the inboard road shoulder, **Figure 5**. The touchdown zone was identified by a series of small gouges and abrasions dispersed over a 2.4 m x 0.9 m (8.0 ft x 3.0 ft) area. This contact was attributed to the right roof rail and roof area of the Toyota. Two 1.5 m (5.0 ft) long abrasion marks, located on the inboard shoulder 14 m (45 ft) beyond the end of the yaw marks, denote the point where the Toyota entered the median. An area measuring 1.2 m x 5.5 m (4.0 ft x 18.0 ft) located 42.7 m (140.0 ft) beyond the end of the yaw marks was documented during the police investigation as the second point of (significant) impact by the Toyota. The vehicle then vaulted over the 2.4 m (8.0 ft) berm of construction materials. A review of the on-scene police photographs depicted that the berm remained undisturbed throughout the area of the Toyota's trajectory indicative that the vehicle did not significantly contact the berm. The Toyota came to rest on its left side facing south, **Figure 6**. The final rest of the vehicle was located 20 m (230 ft) northwest of the end of the yaw marks and 23 m (74 ft) west of the northbound lanes. Reconstruction of the rollover indicated the Toyota completed 2-3/4 revolutions (11 quarter turns) during the event. A schematic of the crash sequence is attached to the end of this narrative report, **Figure 20**.
