TRANSPORTATION RESEARCH CENTER

ON-SITE CHILD SAFETY SEAT INVESTIGATION

CASE NUMBER - IN-03-034
LOCATION - INDIANA
VEHICLE - 1988 CHRYSLER LEBARON
CRASH DATE - March 2003

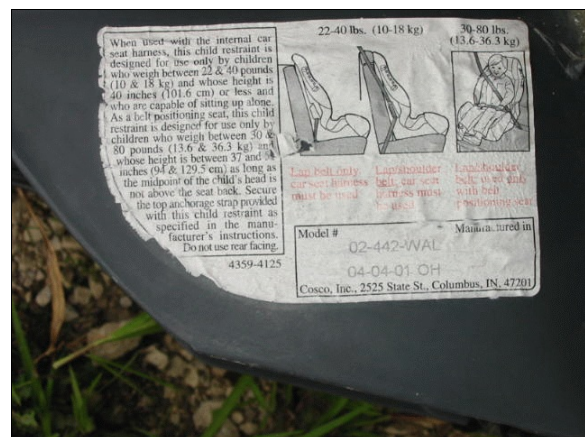
Figure 26: Instructions on Cosco child safety seat providing information pertaining to make/model, height/weight restrictions, and integration of vehicle's safety belts with child seat (case photo #58)
