INDIANA UNIVERSITY

TRANSPORTATION RESEARCH CENTER

ON-SITE CERTIFIED ADVANCED 208- COMPLIANT VEHICLE INVESTIGATION

CASE NUMBER - IN-03-036
LOCATION - TEXAS
VEHICLE - 2003 CHEVROLET TAHOE
CRASH DATE - June 2003

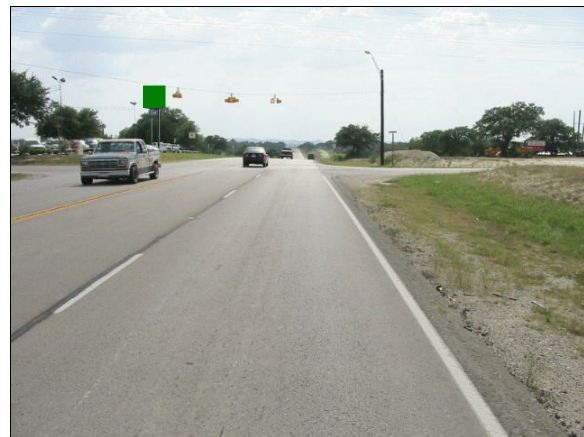
Figure 1: Case vehicle's west-southwesterly travel path in outside lane approaching four-leg intersection where impact occurred (case photo #01)

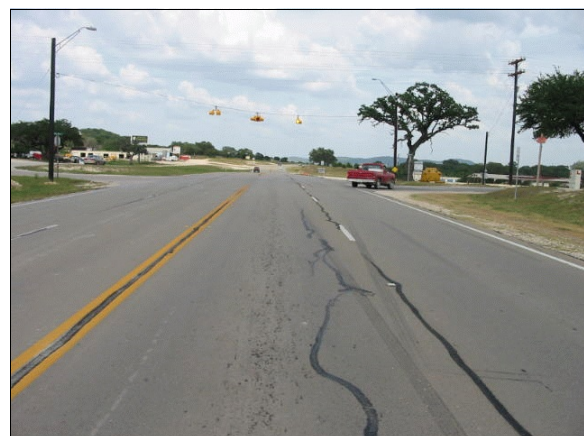
Figure 2: Hyundai's east-northeasterly path of travel in inside northeastern lane approaching four-leg intersection (case photo #05)

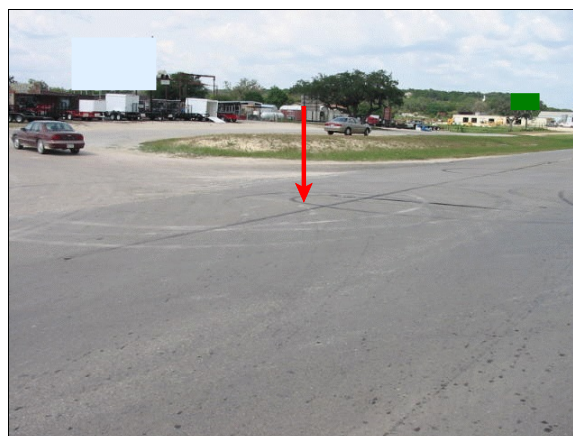
Crash: The front left corner (**Figure 4** and **Figure 5** below) of the case vehicle impacted the front of the Hyundai, causing the case vehicle's driver and front right passenger supplemental restraints (air bags) to deploy. Based on the downloaded **EDR** data, only one stage of the multi-stage air bags was activated. The case vehicle was not equipped with a cutoff switch for the front right passenger supplemental restraint (air bag).

Figure 3: Hyundai's northern travel path from inside northeastern lane across west-southwestern lanes toward northwesterly leg of intersection; Note: arrow indicates approximate point of impact (case photo #06)
