INDIANA UNIVERSITY

ON-SITE CERTIFIED ADVANCED 208- COMPLIANT VEHICLE INVESTIGATION

CASE NUMBER - IN-03-037
LOCATION - OKLAHOMA
VEHICLE - 2003 GMC YUKON XL
CRASH DATE - July 2001

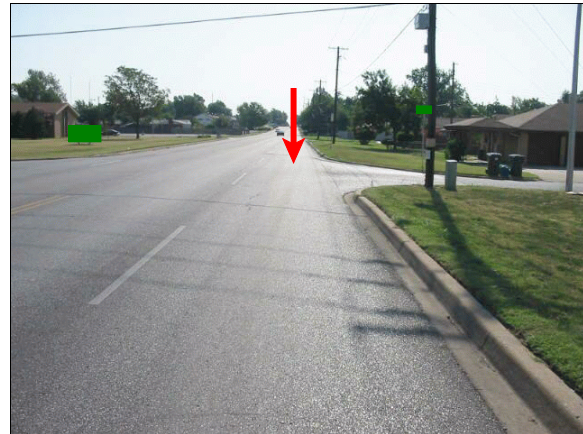
Pre-Crash: The case vehicle was traveling east in the outside lane and was approaching a partially controlled four-leg intersection, intended to proceed straight ahead (**Figure 1**). The Kia had been traveling west in the inside through lane (**Figure 2**) and was making a left-hand turn onto the intersecting roadway, intending to travel south (**Figure 3**). According to the case vehicle's driver, no avoidance maneuvers were made prior

Figure 1: Case vehicle's eastward travel path in outside eastbound lane approaching four-leg intersection; Note: arrow indicates approximate area of impact (case photo #01a)

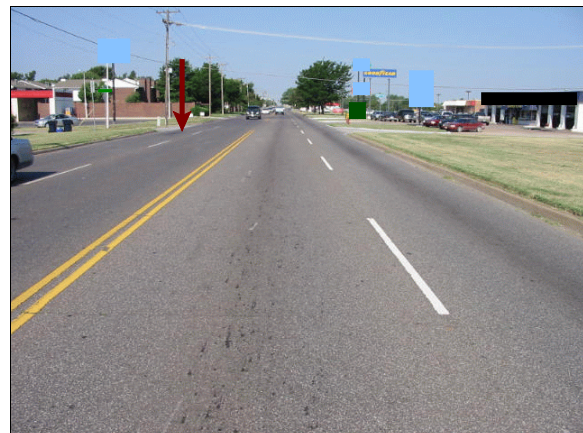
Figure 2: Kia's westward travel path in inside westbound lane prior to making left-hand turn; Note: arrow indicates approximate point of impact in outside eastbound lane (case photo #04)

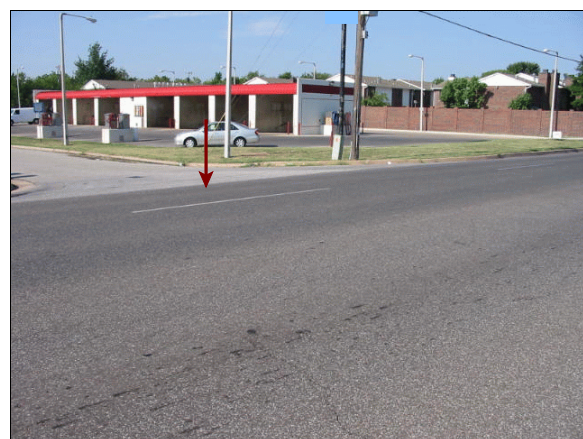
Figure 3: Southwesterly view of Kia's travel path across eastbound lanes during left-hand turn; Note: arrow indicates approximate point of impact (case photo #05)

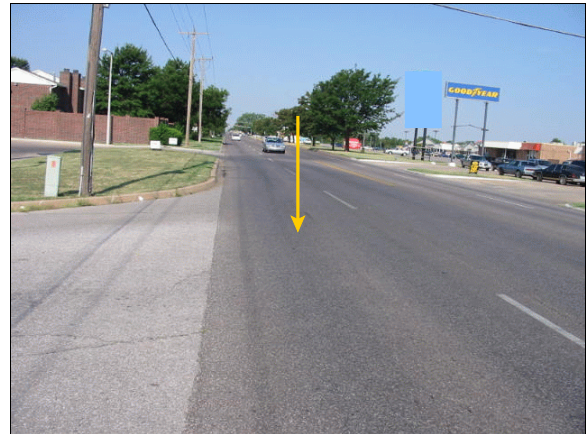
to the crash. Based on the data downloaded from the case vehicle's **EDR**, the case vehicle's driver activated the brake pedal just prior to the crash. The crash occurred in the outside eastern through lane, within the four-leg intersection of the two roadways (**Figure 4**).

Figure 4: Westward view from beyond impact (arrow) of case vehicle's eastward travel path in outside eastbound lane (case photo #03)
