**GENERAL DYNAMICS ON-SITE CHILD SAFETY SEAT INVESTIGATION
SCI TECHNICAL SUMMARY REPORT**

CASE NO. CA03-037

VEHICLE – 1992 FORD TEMPO

CRASH DATE – JUNE 2003

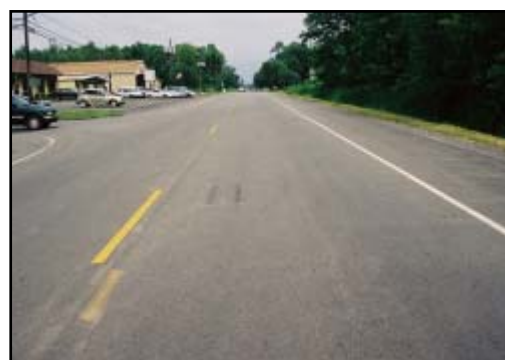
This three-vehicle crash occurred during the daylight hours of June 2003 in the state of New York. The crash occurred at the T-intersection of a two-lane, east/west arterial roadway and a north/south local roadway (**Figure 2**). At the time of the crash, the weather was clear and the asphalt roadway surface was dry. The east/west roadway was configured with one travel lane in each direction that were separated by a broken yellow centerline and bordered by asphalt shoulders. The undivided north/south roadway was configured with one travel lane in each direction and bordered by asphalt shoulders and asphalt driveways. The roadside environment consisted of wooded areas on the south roadside and commercial properties on the north roadside. The posted speed limit for the

Figure 2. Overall view of scene looking east

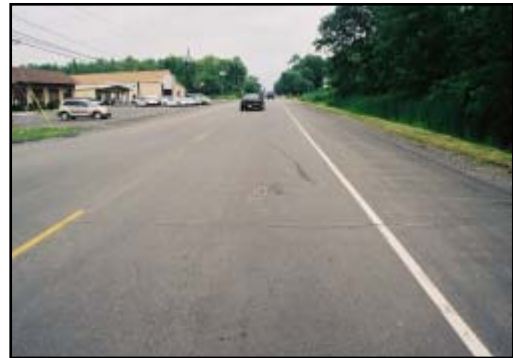
The 20-year-old female driver of the 1992 Ford Tempo brought the vehicle to a controlled stop on the eastbound lane of the west leg of the T-intersection (**Figure 3**). She was planning to initiate a left turn onto the north/south roadway and was waiting for westbound traffic to clear the intersection. It was not known if she had activated the left turn signal. The 19-year-old male driver of the Ford F-350 truck was operating the vehicle in an eastbound direction on the arterial roadway. He did not detect the Ford Tempo that was stopped in the lane ahead of his vehicle. As the Ford F-350 approached the intersection, the driver observed the stopped Tempo in the lane and attempted to steer to the right immediately prior to the collision. There were no pre-crash tire marks from the F-350. A 1996 Ford Thunderbird was traveling in the eastbound lane on approach to the T-intersection at the time of the crash, but was not involved in the initial collision (**Figure 4**).

Figure 3. Eastbound approach for the Tempo and the Ford F-350 truck

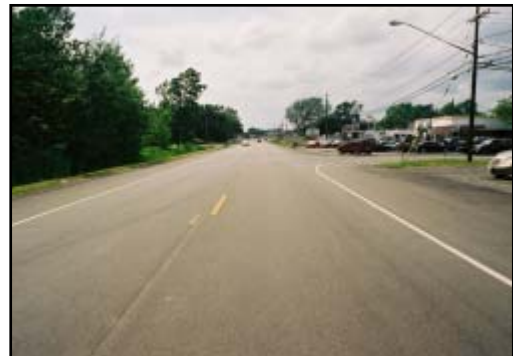
Figure 4. Westbound approach for the Ford Thunderbird

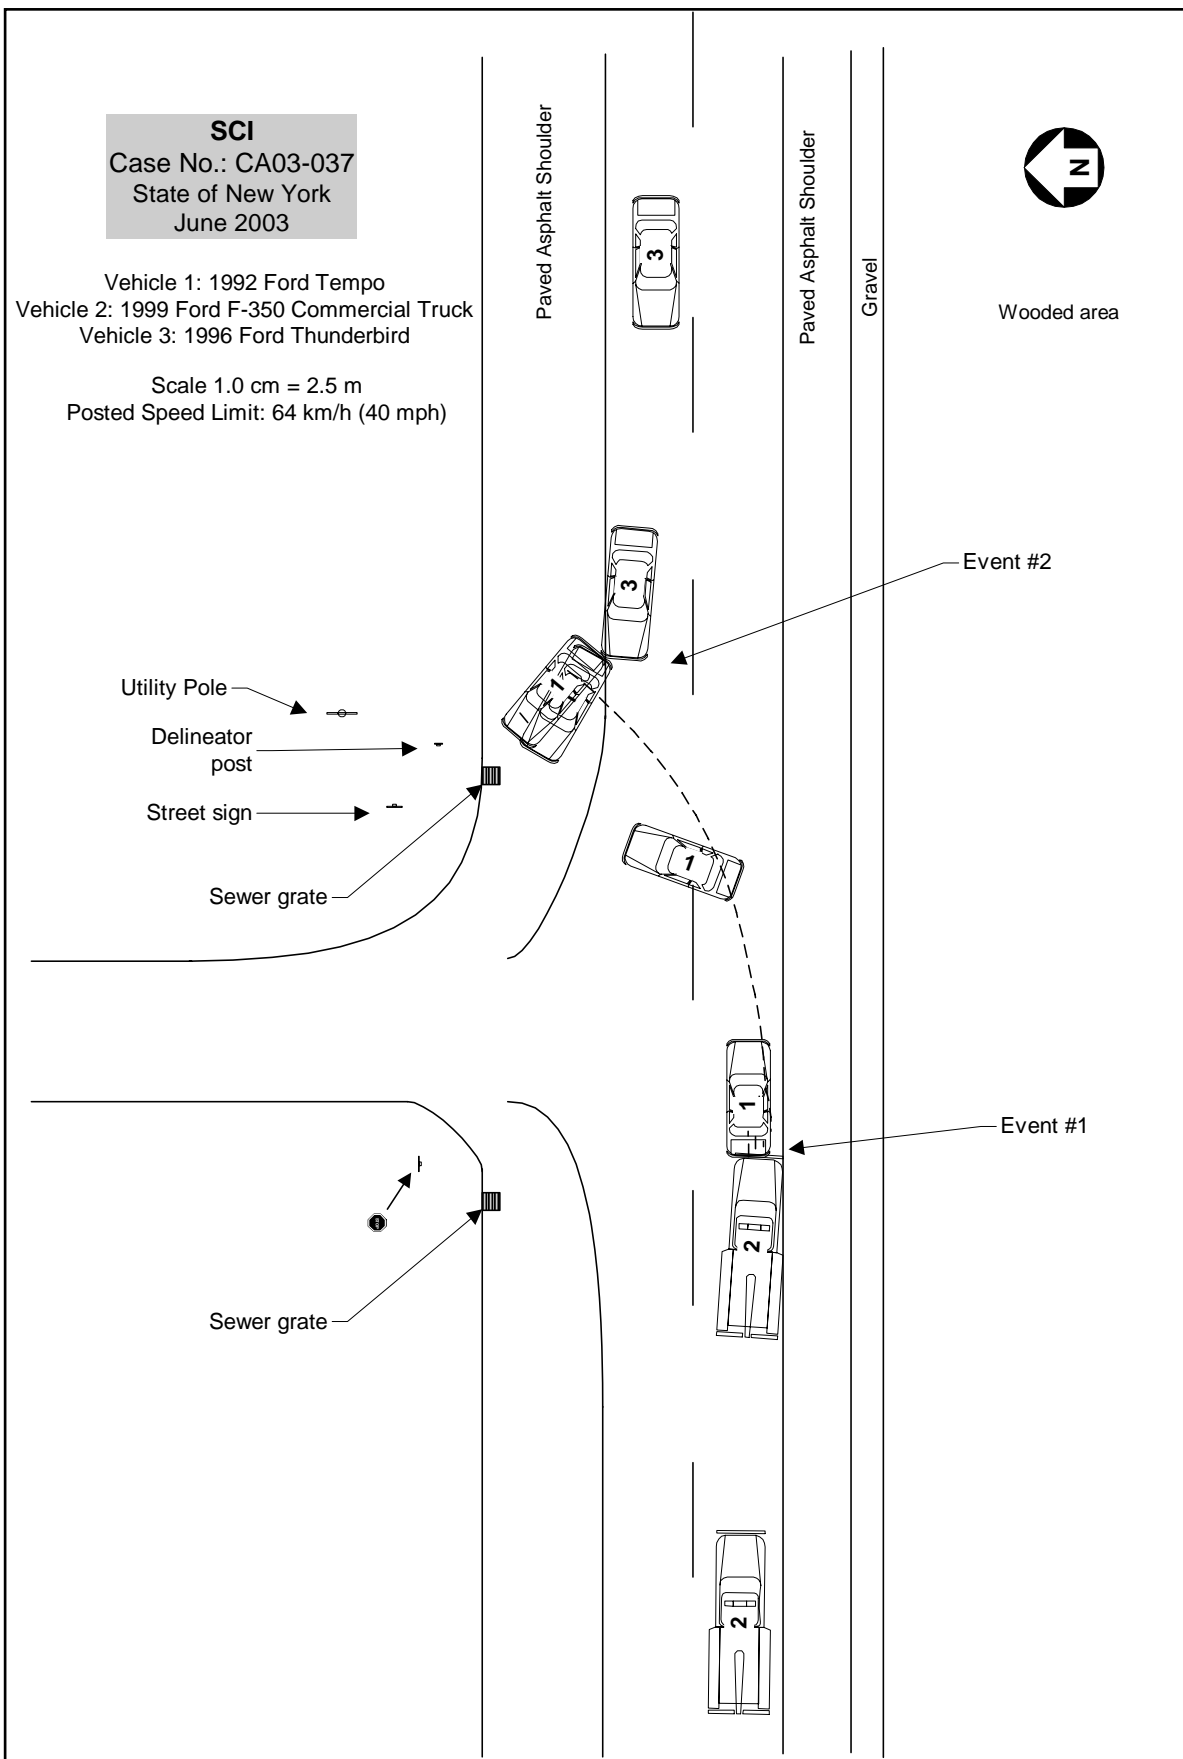
Figure 18. Scene schematic

east/west roadway was 64 km/h (40 mph). The scene schematic is included as **Figure 18** of this report.
