CALSPAN ON-SITE CHILD SAFETY SEAT CRASH INVESTIGATION

CALSPAN CASE NO: CA03-038

VEHICLE: 1994 CHEVROLET CAVALIER

CRASH DATE: JUNE 2003

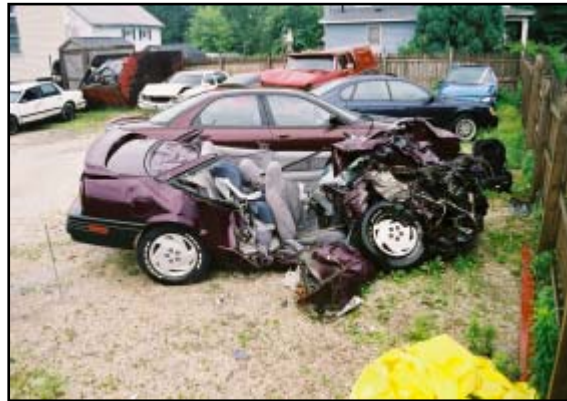
Figure 1. Subject vehicle 1994 Chevrolet Cavalier.

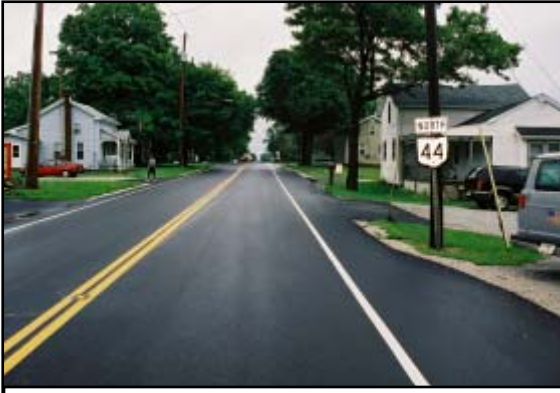
The 26-year-old male driver was operating the Cavalier northbound ascending the slight grade (**Figure 2**). The driver of the Ford was operating the vehicle southbound in the southbound lane. As the driver of the Ford continued southbound, he allowed the vehicle to drift across the double yellow centerline and entered the northbound lane. The driver of the Cavalier observed the Ford traveling in the northbound lane and applied a left steering input in an attempt to avoid the Ford.

Figure 2. Chevrolet's pre-crash travel direction.

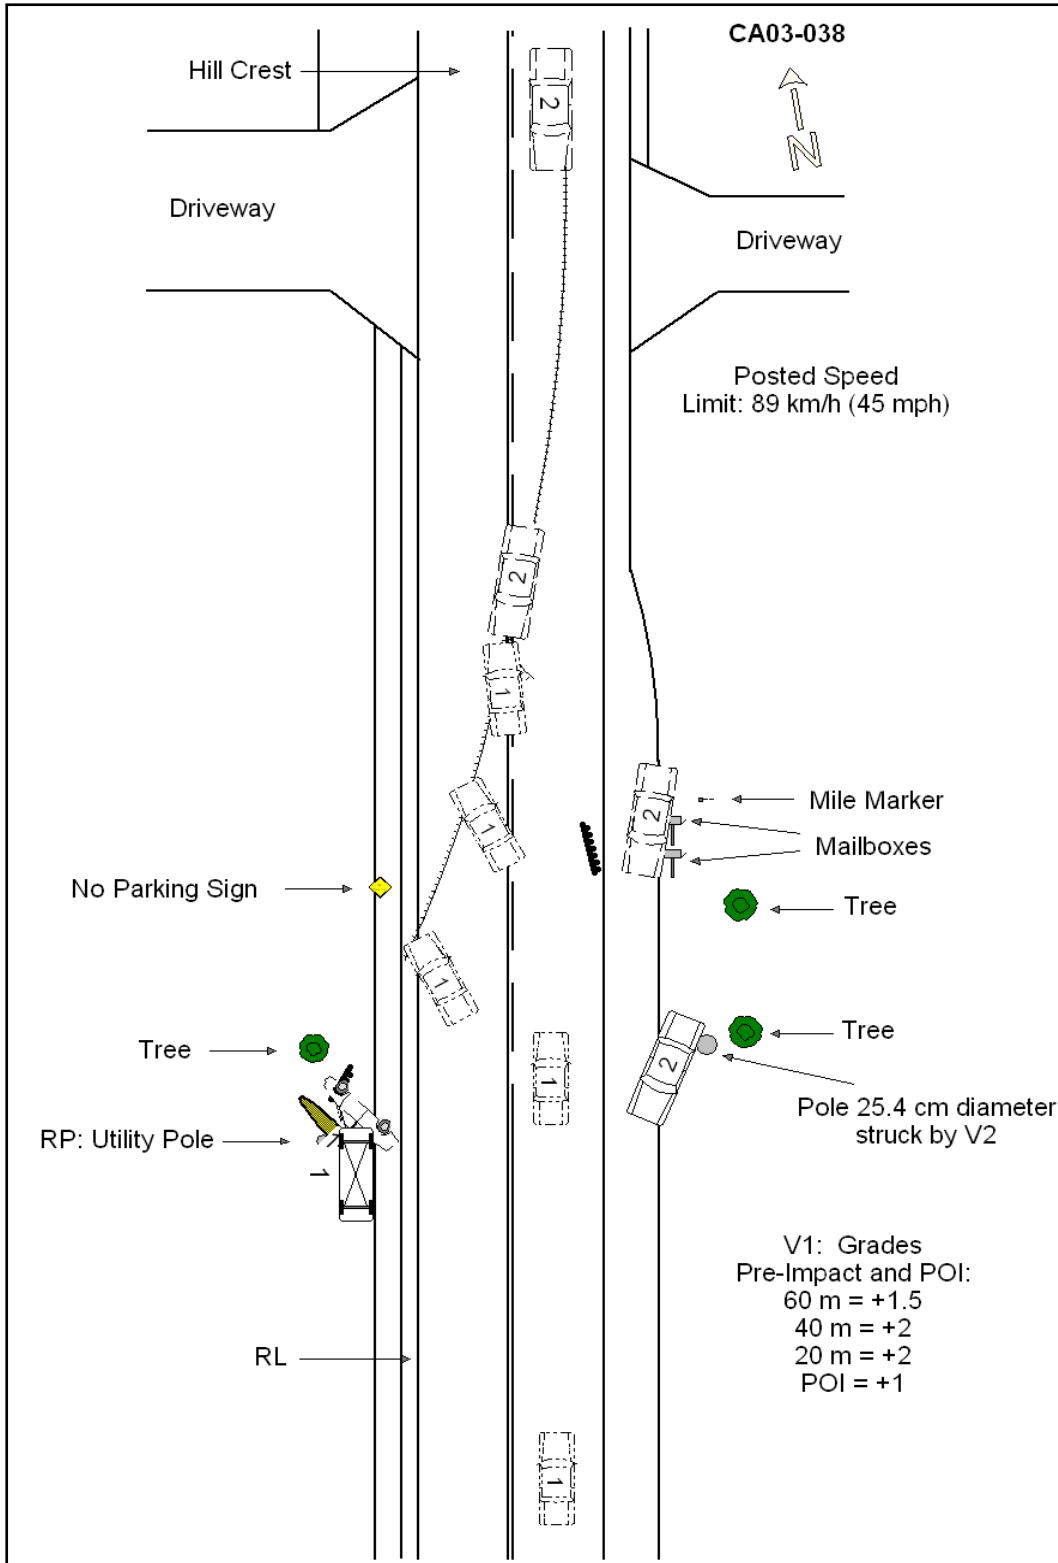
Figure 13: Scene Schematic

mail boxes, trees and wooden utility poles. The posted speed limit for this roadway was 72 km/h (45 mph). The scene schematic is included as **Figure 13** of this report.
