ON-SITE CERTIFIED ADVANCED 208- COMPLIANT VEHICLE INVESTIGATION

CASE NUMBER - IN-03-042
LOCATION - KENTUCKY
VEHICLE - 2003 CHEVROLET K1500 SILVERADO
CRASH DATE - August 2003

1. <i>Report No.</i> IN-03-042		2. <i>Government Accession No.</i>		3. <i>Recipient's Catalog No.</i>	
4. <i>Title and Subtitle</i> On-Site Certified Advanced 208-Compliant Vehicle Investigation Vehicle - 2003 Chevrolet K1500 Silverado Location - Kentucky			5. <i>Report Date:</i> September 7, 2007

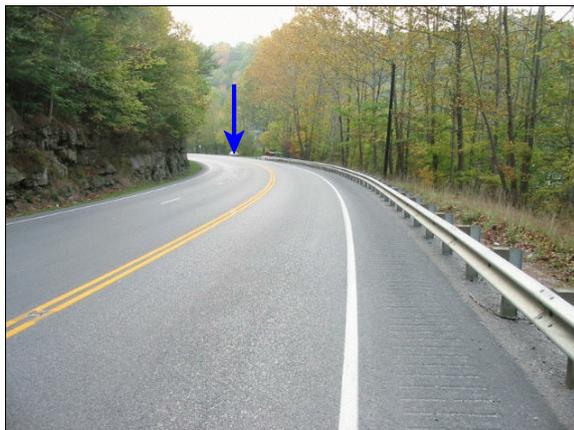
Figure 1: Ford and case vehicle’s west-northwesterly approach to impact area (i.e., arrow) with Peterbilt tractor-semitrailer (case photo #10)

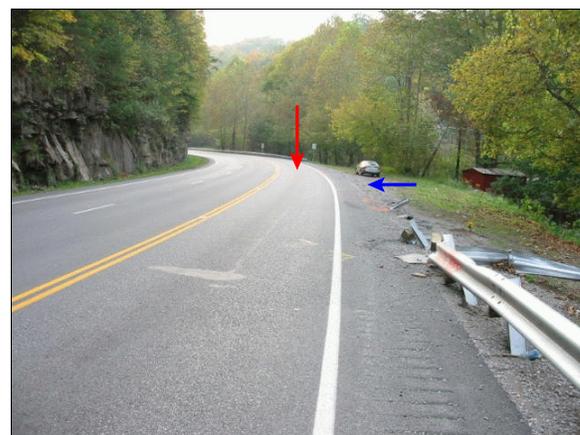
Figure 2: Ford’s and case vehicle’s westerly travel path into initial impact areas (i.e., arrows) with Peterbilt tractor-semitrailer; Note: damaged longitudinal barrier marks Peterbilt’s final rest position (case photo #12)

Pre-Crash: The case vehicle was negotiating a downhill, left-hand curve, traveling in a west-northwesterly direction in the western lane and intended to continue in its western path of travel (**Figure 2** above). The Peterbilt was negotiating an uphill, right-hand curve, traveling in the inside through lane of the three-lane, undivided, U.S. highway and intended to continue in its eastern path of travel. The Ford was also negotiating a downhill, left-hand curve, traveling an undetermined distance ahead of the case vehicle in a west-northwesterly direction in the same western lane of the roadway and intended to continue in its western path of travel (**Figure 4**). According to

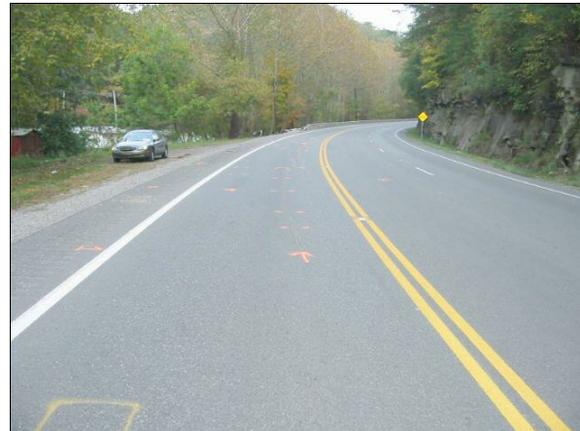
Figure 3: Peterbilt's easterly travel path across centerlines into western lane and approach to areas of impact with Ford and case vehicle (case photo #01)

the Police Crash Report, our scene inspection, and the interview with the case vehicle's driver, the crash sequence began when the Peterbilt traveled to its left over the centerline of the roadway (**Figure 3** above) and began tipping over toward its left side. The case vehicle's driver steered to the right and braked, attempting to avoid becoming involved in the crash. The crash sequence began in the western lane of the roadway.

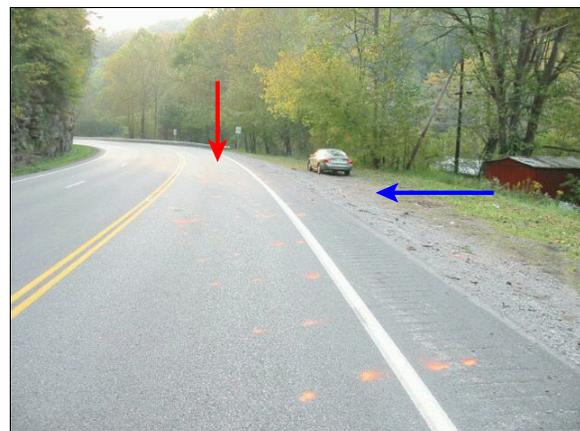
Figure 4: Ford's and case vehicle's westerly travel path into areas (i.e., arrows) of initial impact with Peterbilt tractor-semitrailer (case photo #13)

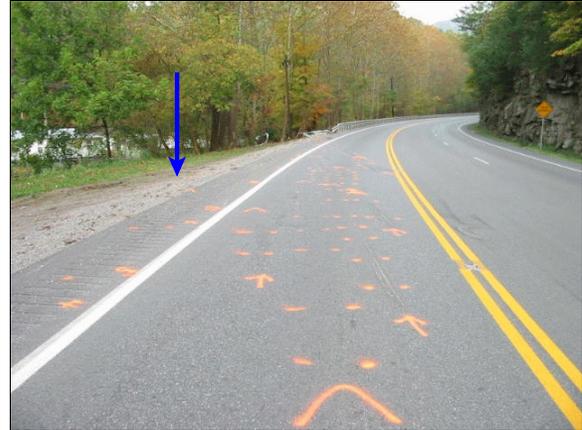
Figure 5: Peterbilt's estimated area of impact with Ford in western travel lane (i.e., foreground), estimated area of impact with case vehicle on northern shoulder (i.e., arrow), and subsequent easterly travel path toward impact with guardrail (case photo #03)

Crash: According to the case vehicle's driver, as the Peterbilt was tipping over onto its left side (**Figure 5**), an unknown portion of the Peterbilt collided with the left frontal portion of the Ford, shearing off the top portion of the Ford pickup's cab. The Peterbilt's semitrailer began to rotate clockwise (i.e., in a jackknifing fashion) after impacting the Ford. The Peterbilt continued forward in its easterly travel path, but it veered off the roadway onto the northern roadside.

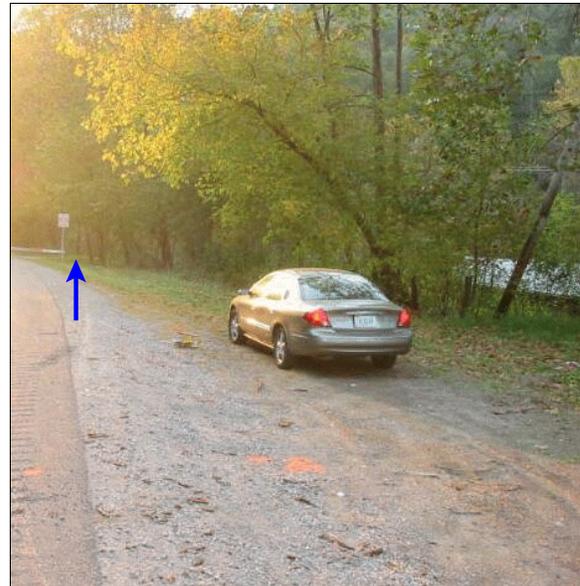
Figure 9: Ford’s westerly travel path on northern roadside after initial impact with Peterbilt truck-tractor; Note: arrow indicates Ford’s final rest position against guardrail and tree (case photo #20c)

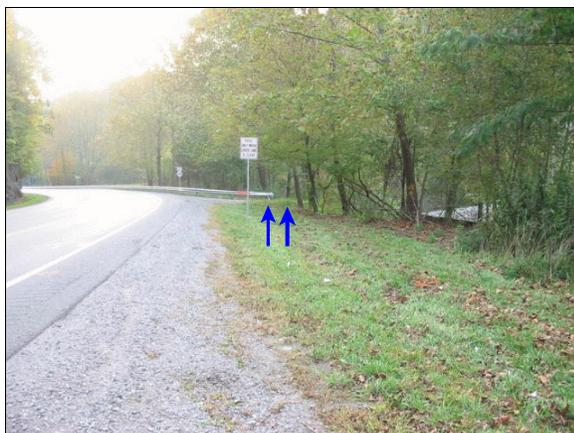
Figure 10: Ford’s westerly travel path on northern roadside continues after initial impact with Peterbilt; Note: arrows indicate impact and final rest position against guardrail & tree (case photo #22)

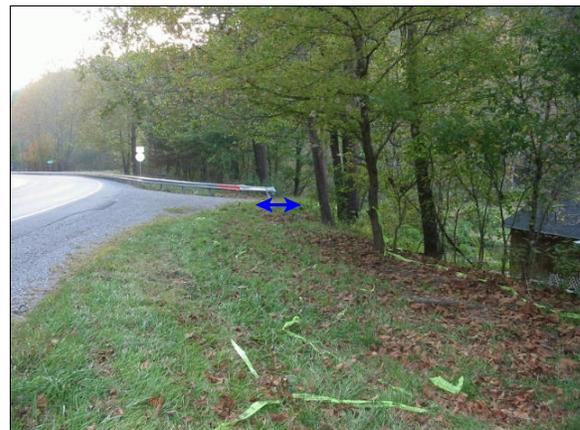
Figure 11: Ford continues its westerly travel path toward impact and final rest position (arrows) against guardrail and tree (case photo #23)

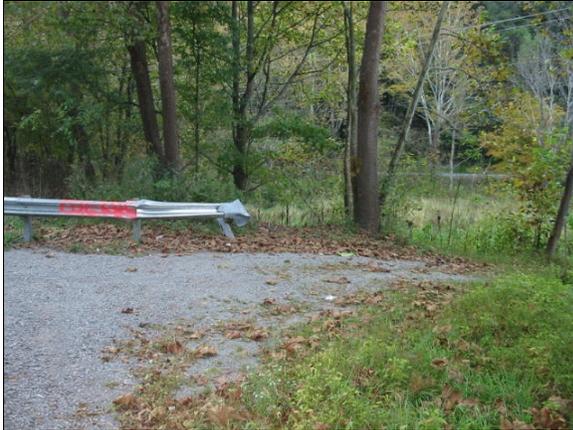
Figure 12: Ford's westerly travel path into guardrail and then tree; Ford came to rest against or near tree (case photo #25)

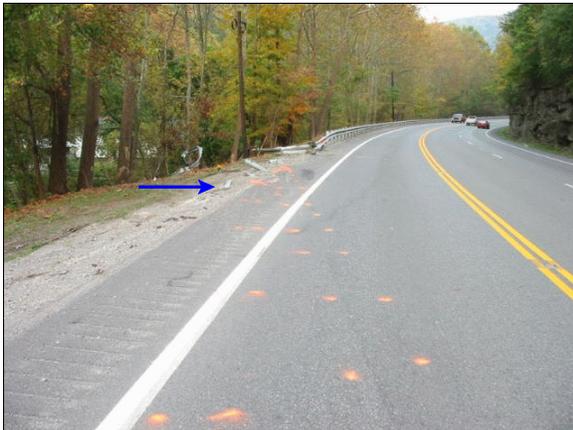
The Peterbilt continued forward in its easterly travel path on the northern roadside (**Figure 13** below) finally rolling over onto its left side before striking and uprooting a significant section of a “W”-beam longitudinal barrier (**Figure 14** below) before coming to rest on its left side on the highway’s northern roadside (**Figure 15** below).

Figure 13: Peterbilt's eastward travel path as it rolled over, landing primarily on the northern shoulder, while continuing to travel forward, impacting and damaging the northern guardrail; Note: arrow shows western-most guardrail support post (case photo #04)

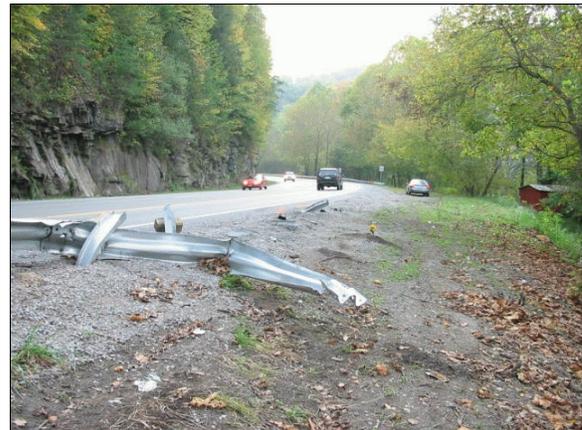
Figure 15: Westerly view from beyond Peterbilt's final rest position showing travel path after failing to negotiate right-hand curve (case photo #07)

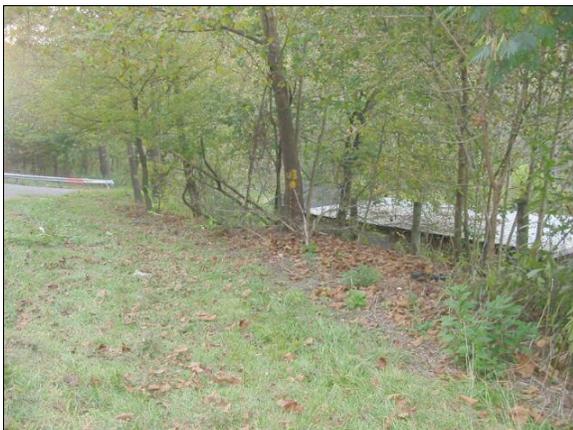
The collision with the semitrailer redirected the case vehicle further to the right (**Figure 16** below) where it impacted a couple of small trees and large tree with its front (**Figure 17** below). The case vehicle came to rest on the northern roadside, near the large tree, heading in a west-northwesterly direction.

Figure 16: Case vehicle's west-northwest travel path toward tree on northern roadside after impacting and being redirected by Peterbilt (case photo #16)

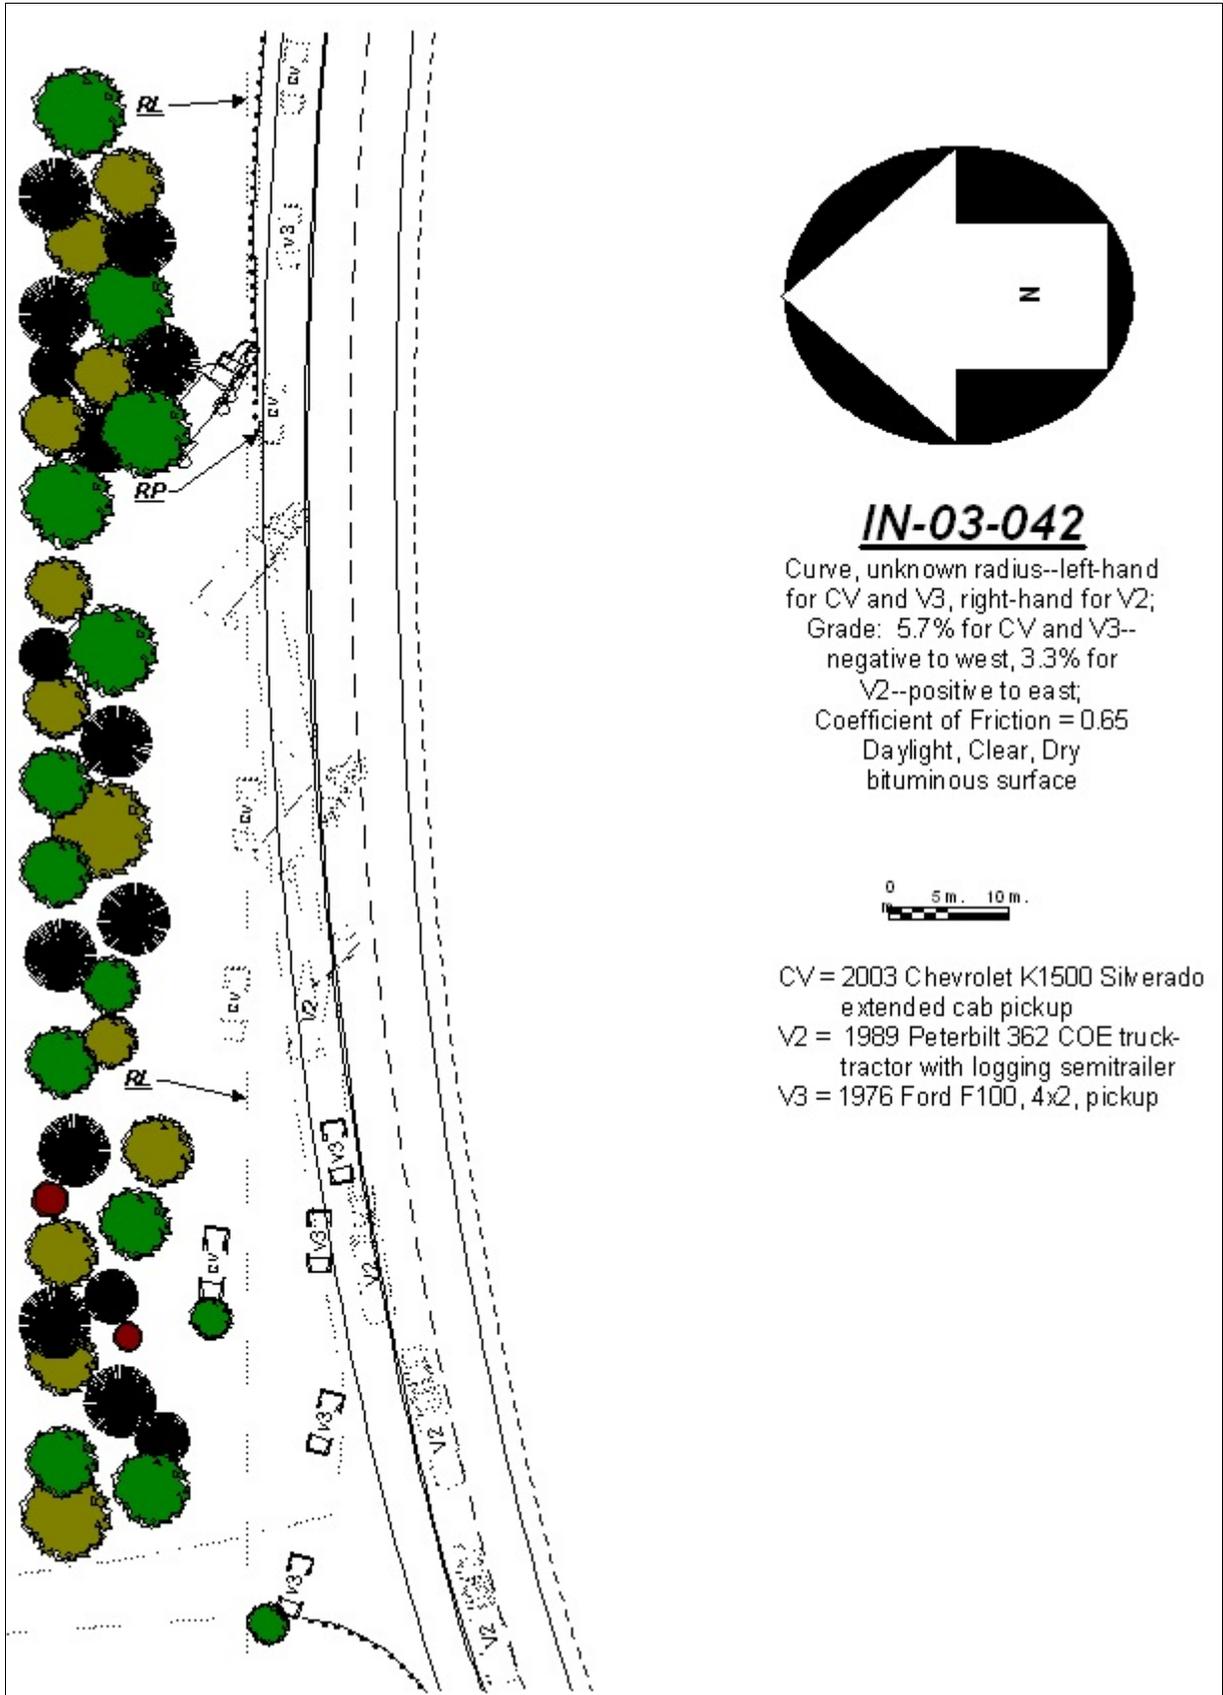
IN-03-042

Curve, unknown radius--left-hand for CV and V3, right-hand for V2;
Grade: 5.7% for CV and V3--negative to west, 3.3% for V2--positive to east;
Coefficient of Friction = 0.65
Daylight, Clear, Dry
bituminous surface
