# INDIANA UNIVERSITY

### ON-SITE SIDE IMPACT INFLATABLE OCCUPANT PROTECTION INVESTIGATION

CASE NUMBER - IN-03-046  
LOCATION - MINNESOTA  
VEHICLE - 1998 NISSAN MAXIMA SE  
CRASH DATE - October 2003

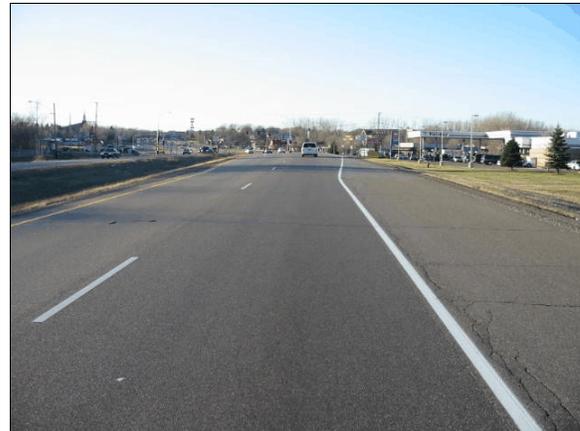
a four-leg intersection (**Figure 1** and **Figure 2**). On the eastern leg of the intersection, the highway had five-lanes with both the eastern and western roadways having two through lanes (**Figure 1** above) while the western roadway had one left-hand turn lane (**Figures 2** and **3**); in addition, there was one channelized right-hand turn lane (**Figures 2** and **3**). The trafficway on which the other vehicle was traveling was a divided, city street, traversing in a south-southwesterly and north-northeasterly directions before approaching the same four-leg intersection (**Figure 4** below). On the northern leg of the intersection, the northern roadway had two through lanes while the southern roadway had one through and one left-hand turn lane; in addition, there was one channelized right-hand turn lane (**Figure 5** below).

**Figure 1:** Case vehicle's west-northwesterly travel path in inside through lane approaching four-leg intersection prior to emergence of turn lanes (case photo #02)

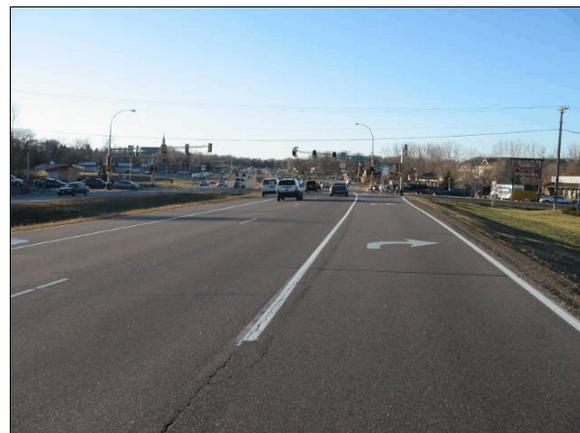
The case vehicle's state highway was curved slightly to the left for west-northwestbound traffic (**Figure 2**) and had a 2.5% grade negative to the west-northwest (i.e., a downgrade in the case vehicle's direction of travel), near the area of impact. The pavement was bituminous, but traffic polished, and the width of the outside western lane, on the eastern leg of the four-leg intersection, was 3.8 meters (12.5 feet). Near the mouth of the intersection, the shoulders were not improved (i.e., dirt, grass—**Figure 3**). The left-hand (i.e., southern) shoulder was associated with a unprotected grassy median. The grassy median was approximately 9.2 meters (30.2 feet) wide and separated the eastern and western roadways. The median was quite deep near its middle (**Figure 1**). The roadway was not bordered by curbs. Pavement markings for the roadway consisted of a solid yellow edge line on the left-hand (southern) side and a solid white edge line on right-hand (northern) side. In addition, the through lanes were divided by a dashed white line and the left-hand and right-hand turn lanes were separated from the through lanes by solid white lane lines. Each turn lane had the appropriate turn arrows painted on the pavement. The estimated coefficient of friction was 0.65. Traffic controls

**Figure 2:** Case vehicle's west-northwesterly travel path in inside through lane approaching four-leg intersection viewed from right-hand turn lane (case photo #04)

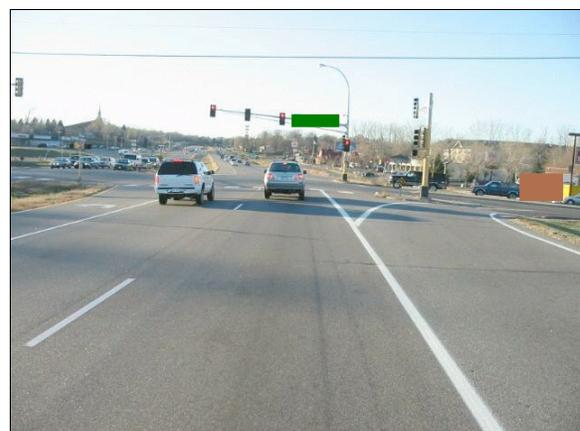
**Figure 3:** Case vehicle's west-northwesterly travel path in inside through lane into four-leg intersection (case photo #05)

**Pre-Crash:** The case vehicle was traveling west-northwest in the outside western through lane and intended to continue in its westerly travel path (Figure 3 above). The GMC had been stopped at a traffic control signal and began traveling south-southwestward in the southern through lane, intending to continue in its southerly travel path (Figure 4 above). The case vehicle's driver steered to the left, attempting to avoid the crash. The crash occurred in the four-leg intersection of the two trafficways (Figures 4 and 5 above and Figures 6 and 7).

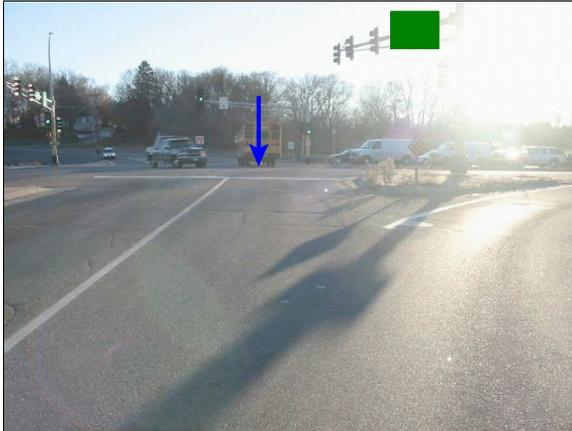
**Figure 4:** GMC's south-southwesterly travel path toward impact area (arrow) in intersection (case photo #10)

The other vehicle's city roadway was straight (**Figure 4**) at the mouth of the intersection (i.e., the southern roadway had just exited a left-hand curve prior to intersection– **Figure 5**). The trafficway had a 2.5% grade positive to the south-southeast (i.e., an upgrade in the GMC's direction of travel), near the area of impact. The pavement was bituminous but traveled, and the width of the southern through lane was 4.4 meters (14.4 feet). At the mouth of the intersection, the southern roadway was bordered by mountable curbs with the curb on the eastern side associated with a 1.7 meter (5.6 foot) raised paved median and the curb on the western side associated with a raised concrete traffic island (**Figure 4**). Pavement markings consisted of a single solid white lane line that separated the through lane from the left-hand turn lane. No centerline (on the left) or edge line (on the right) was used near the mouth of the intersection and no lane line separated the right-hand channelized lane from the through lane. The estimated coefficient of friction was 0.70. Traffic controls consisted of two on-colors, pre-timed, vertical mounted traffic control signals that were located on the southwestern quadrant of the four-leg intersection. Furthermore, there was a **LEFT TURN YIELD ON GREEN** sign (Manual on Uniform Traffic Control Devices, R10-12) which was mounted on the same traffic signal support arm. In addition, a **KEEP RIGHT** sign (MUTCD, R4-7) was mounted on the southern leg of the intersection in the median (**Figure 5**). The speed limit was undetermined. No regulatory speed limit sign was posted near the crash site.

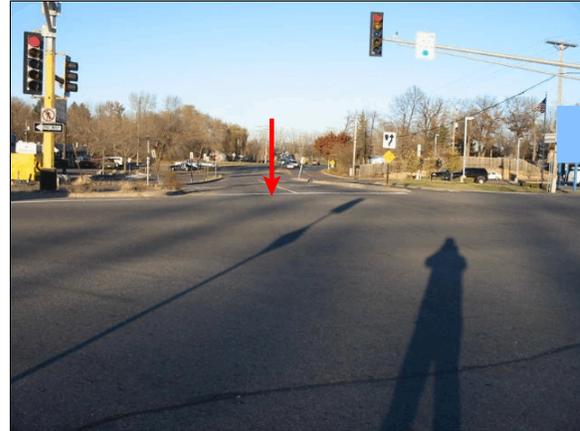
**Figure 5:** Northerly view of GMC's south-southwestern travel path; arrow indicates approximate point of impact (case photo #15)

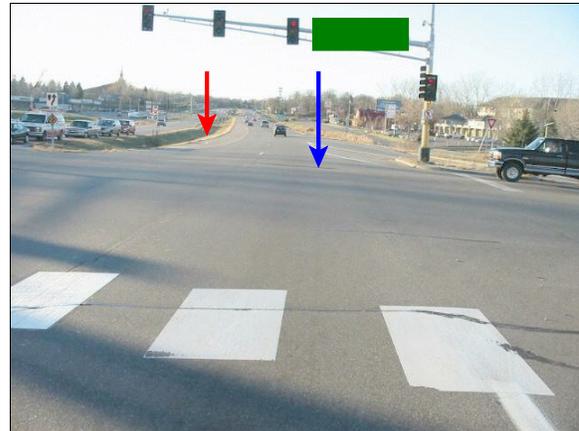
**Figure 6:** Case vehicle's approximate area of impact (blue arrow) within intersection and approximate final rest position (red arrow) in median (case photo #06)

deploy the driver's side (left front), seat back-mounted side impact air bag. The case vehicle most likely continued to rotate clockwise in the median and, according to the Police Crash Report, came to rest heading east-southeast in the median separating the eastern and western roadways (**Figure 6** above).

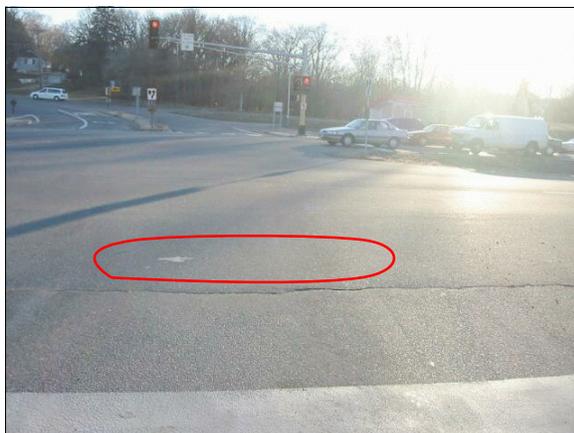
**Figure 7:** Approximate area of impact between GMC's front and right side of case vehicle (case photo #11)

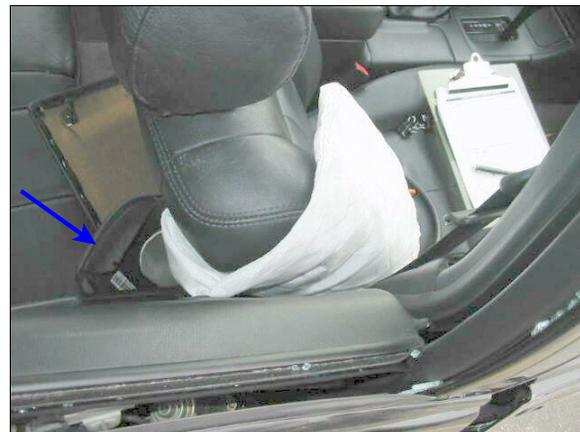
The case vehicle's driver and right front side impact inflatable occupant protection systems (air bags) were located near the top of the driver's and front right passenger's seat backs, respectively. The bags were attached on the posterior surface of the seat back, curling around the edge of the seat back (**Figure 22** and **Figure 23**). An inspection of the driver and right front air bag module's cover flap and the air bag's fabric revealed that the cover flap opened at the designated tear points, and there was no evidence of damage during the deployment to the air bag or the cover flap (**Figure 23**). Both the driver's and right front passenger's air bags were designed without any tethers. Both of the air bags had one vent port, approximately 4 centimeters (1.6 inches) in diameter, located on the outboard surface at the 5 and 7 o'clock positions, respectively (i.e., 5 o'clock for the right front air bag when viewed from the right side of the vehicle and 7 o'clock for the driver's air bag when viewed from the left side of the vehicle). The deployed side impact air bags were essentially rectangular with a height of approximately 29 centimeters (11.4 inches) and a width (i.e., forward excursion) of approximately 40 centimeters (15.7 inches). An inspection of the driver's air bag fabric revealed no contact evidence readily apparent on either the outboard

**Figure 22:** Overhead view of case vehicle's deployed right front side impact air bag; Note: arrow shows bag's cover flap (case photo #50)

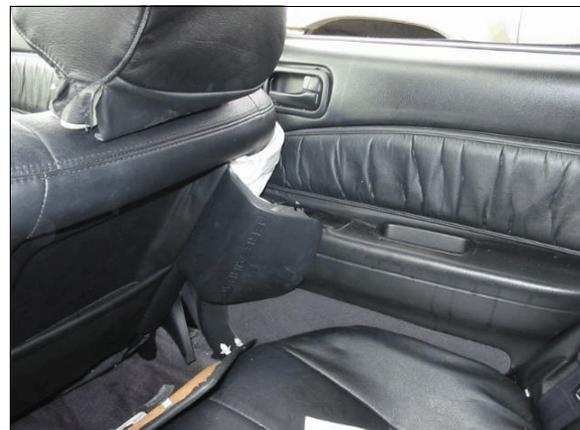
**Figure 23:** Case vehicle's front right seat back showing cover flap for right front side impact air bag (case photo #54)

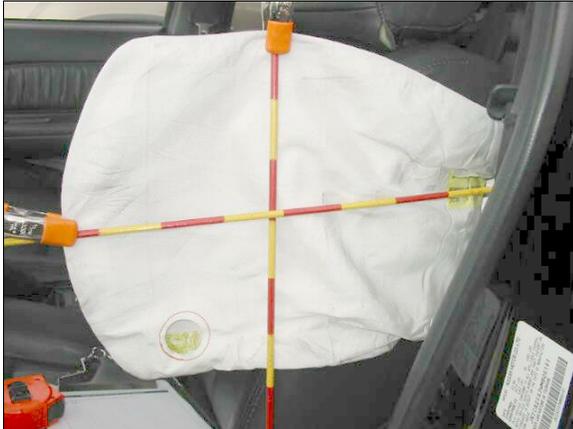
(Figure 24) or inboard (Figure 25) surfaces of the driver side air bag's fabric. An inspection of the right front passenger's air bag fabric revealed only a possible contact area (e.g., scuff) on the outboard (Figure 26) surface of the right front side air bag's fabric (i.e., most likely from the intrusion of the interior surface of the right front door). There was no evidence of occupant contact on the inboard surface (Figure 27).

Figure 24: Outboard side of case vehicle's deployed driver side impact air bag (case photo #55)

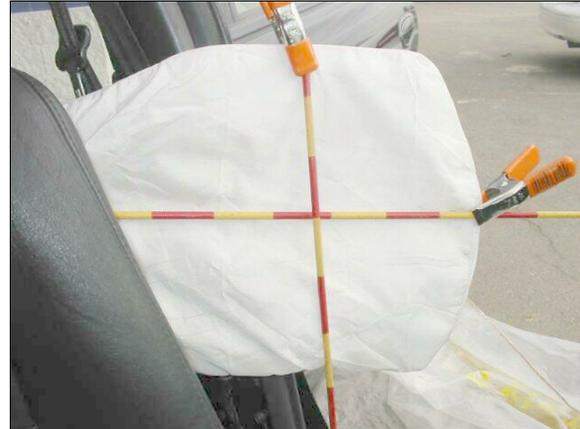
Figure 25: Inboard side of case vehicle's deployed driver side impact air bag (case photo #56)

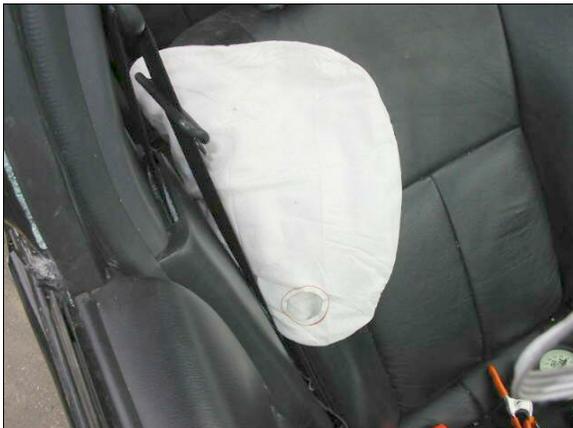
Figure 26: Outboard side of case vehicle's deployed right front side impact air bag (case photo #51)

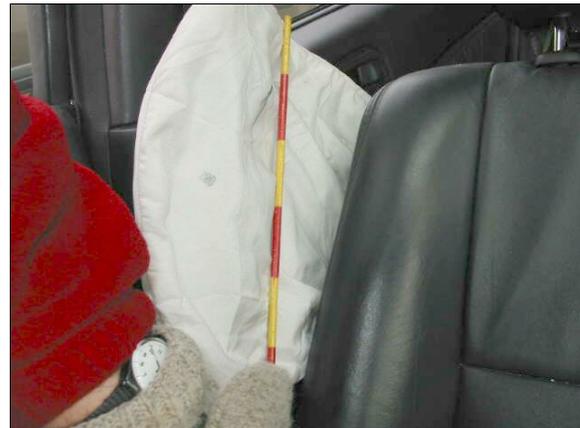
Figure 27: Inboard side of case vehicle's deployed right front side impact air bag (case photo #52)
