**ON-SITE AIR BAG NON-DEPLOYMENT/
DRIVER FATALITY INVESTIGATION**

CASE NO: CA03-046

VEHICLE: 2001 HYUNDAI ELANTRA

CRASH DATE: AUGUST, 2003

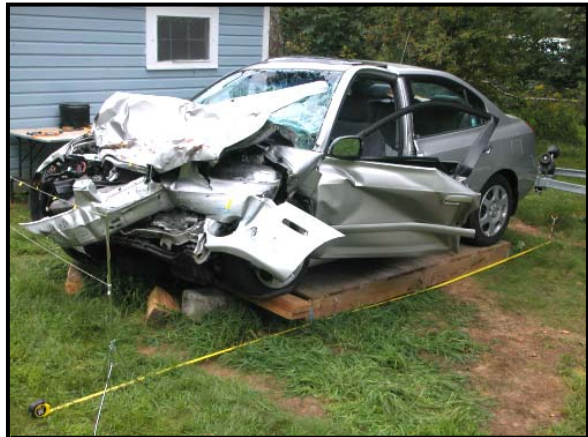
This investigation focused on the issues surrounding the driver air bag non-deployment, and the fatal injury mechanisms of a male driver of a 2001 Hyundai Elantra, **Figure 1**. The Hyundai was involved in a severe frontal impact with a 1995 Chevrolet G20 cargo van. The Hyundai Elantra was equipped with an Advanced Occupant Protection System (AOPS) that consisted of front safety belt pretensioners, redesigned frontal air bags and front right occupant detection. The Hyundai's safety belt pretensioners and frontal air bags failed to deploy as a result of the impact. The Hyundai was occupied by a 27 year old restrained male driver and was the vehicle's sole occupant. Reportedly, the Hyundai drifted left of center precipitating the crash. The Chevrolet van was equipped with a Supplemental Restraint System that consisted of a driver (only) air bag that deployed during the crash. The estimated travel speed of the Hyundai was 89 km/h (55 mph). The Coroner's report listed the Hyundai driver's immediate cause of death as a lacerated aorta and a cervical spine fracture.

Figure 1: Left front view of the Hyundai.
