# INDIANA UNIVERSITY

### ON-SITE CERTIFIED ADVANCED 208- COMPLIANT VEHICLE INVESTIGATION

CASE NUMBER - IN-03-048  
LOCATION - TEXAS  
VEHICLE - 2003 CHEVROLET K1500 SUBURBAN Z71  
CRASH DATE - October 2003

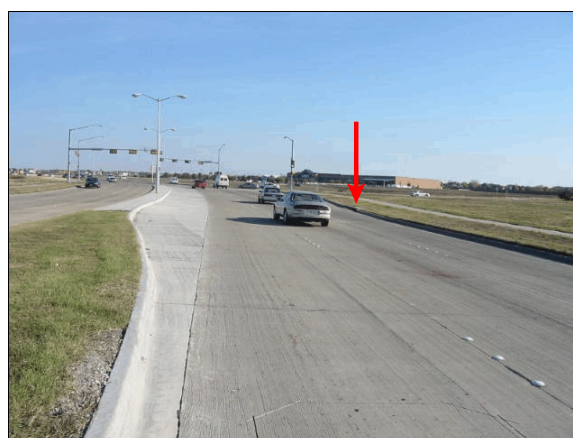
**Figure 1:** Case vehicle's east-southeasterly travel path in inside through lane of eastern roadway, approaching four-leg intersection; Note: left-hand curvature, beginning of left-hand turn lane, and beginning (arrow) of right-hand turn lane (case photo #01)

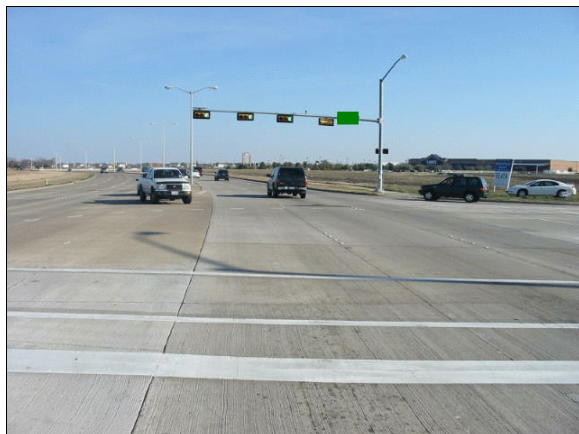
**Figure 2:** Case vehicle's east-southeasterly travel path in inside through lane of eastern roadway into impact area with Ford which was turning left similar to vehicle shown above (case photo #03)

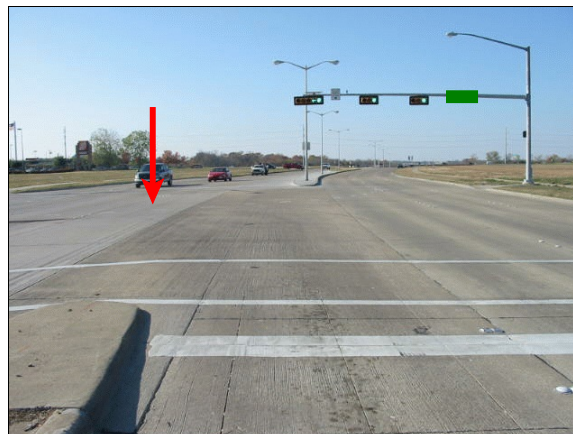
**Figure 3:** Ford's west-northwesterly travel path in right-hand curve just prior to entering four-leg intersection; Note: arrow indicates approximate area of impact with case vehicle (case photo #08)

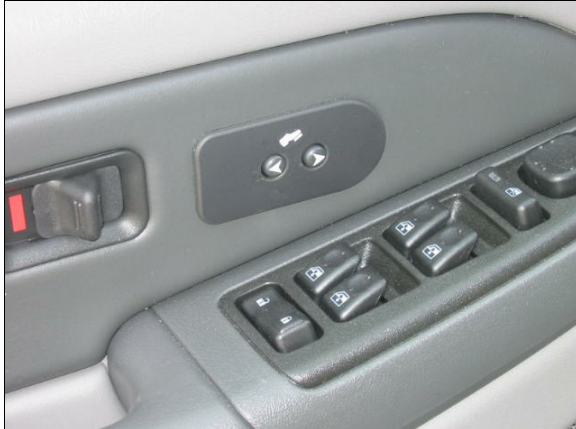
**Figure 7:** Buttons on interior surface of case vehicle's driver door controlling adjustable foot pedals (case photo #45)

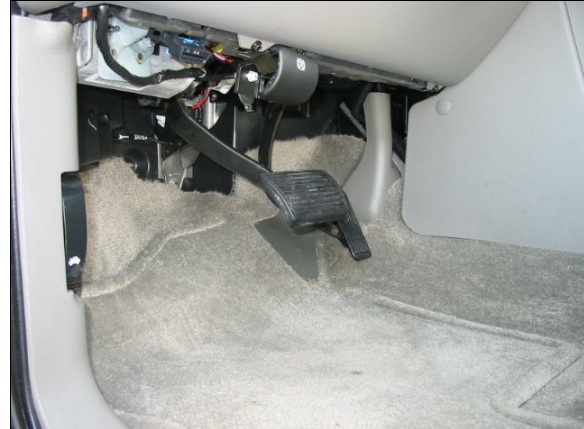
**Figure 8:** Adjustable foot controls for case vehicle's driver—exact position of pedals is unknown (case photo #46)
