**GENERAL DYNAMICS ON-SITE AIR BAG NON-DEPLOYMENT
INVESTIGATION**

GENERAL DYNAMICS CASE NO. – CA03-057

SUBJECT VEHICLE – 1995 PONTIAC GRAND PRIX

CRASH DATE – OCTOBER 2003

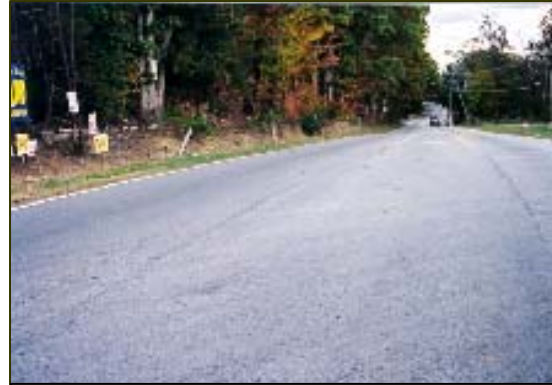
and the south leg was divided by a double yellow centerline. The east road edge consisted of an earthen embankment that transitioned to a level area that was scattered with numerous small diameter trees, shrubs, and a rotted tree trunk. The posted speed limit for north/south roadway was 56 km/h (35 mph). **Figure 2** is an overall view of the crash site. The scene schematic is included as **Figure 14** of this report.

Figure 2. Overall southbound view of the crash site.

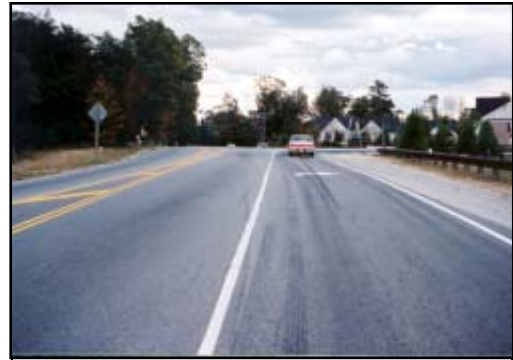
The 21-year-old male driver of the Pontiac was operating the vehicle southbound (**Figure 3**) on the three-lane roadway, negotiating the left curve on approach to the “T” intersection. The driver lost directional control of the vehicle as he attempted to negotiate the curve. The Pontiac began a counterclockwise (CCW) rotation across the south and northbound travel lanes. A centrifugal (yaw) right front tire mark of the Pontiac was found on the roadway and measured approximately 56.0 m (184.0’) in length. A right rear tire mark was also present on the roadway and measured approximately 51.8 m (170.0’) in length. The police reported pre-impact speed (based on critical curve yaw marks) was 121 km/h (75 mph). The EDR in this vehicle was not capable of recording pre-crash data.

Figure 3. Pontiac's southbound approach to the crash site.
