**GENERAL DYNAMICS ON-SITE CERTIFIED ADVANCED-208 COMPLIANT  
VEHICLE CRASH INVESTIGATION**

**SCI TECHNICAL SUMMARY REPORT**

**GENERAL DYNAMICS CASE NO. – CA03-055**

**SUBJECT VEHICLE – 2003 CHEVROLET SILVERADO**

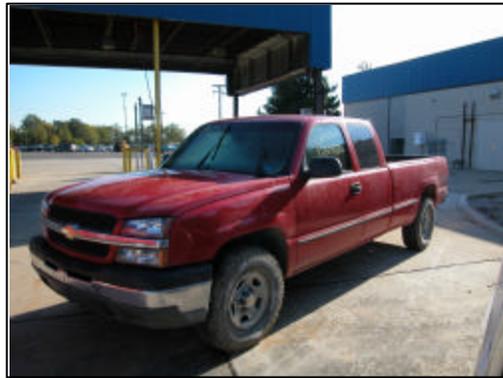
**Figure 1. 2003 Chevrolet Silverado.**

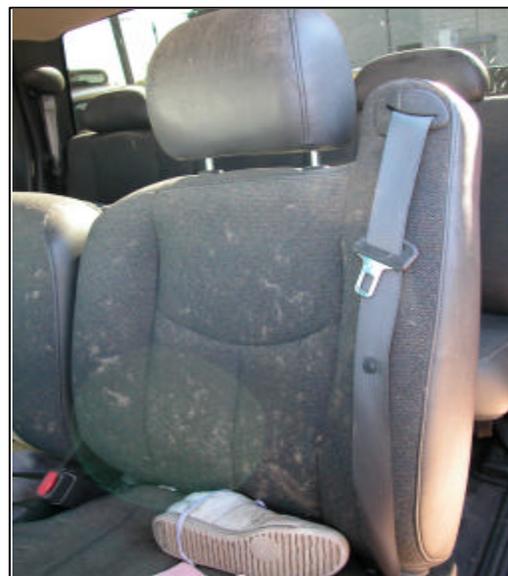
**Figure 8. Integrated driver's 3-point lap and shoulder belt.**

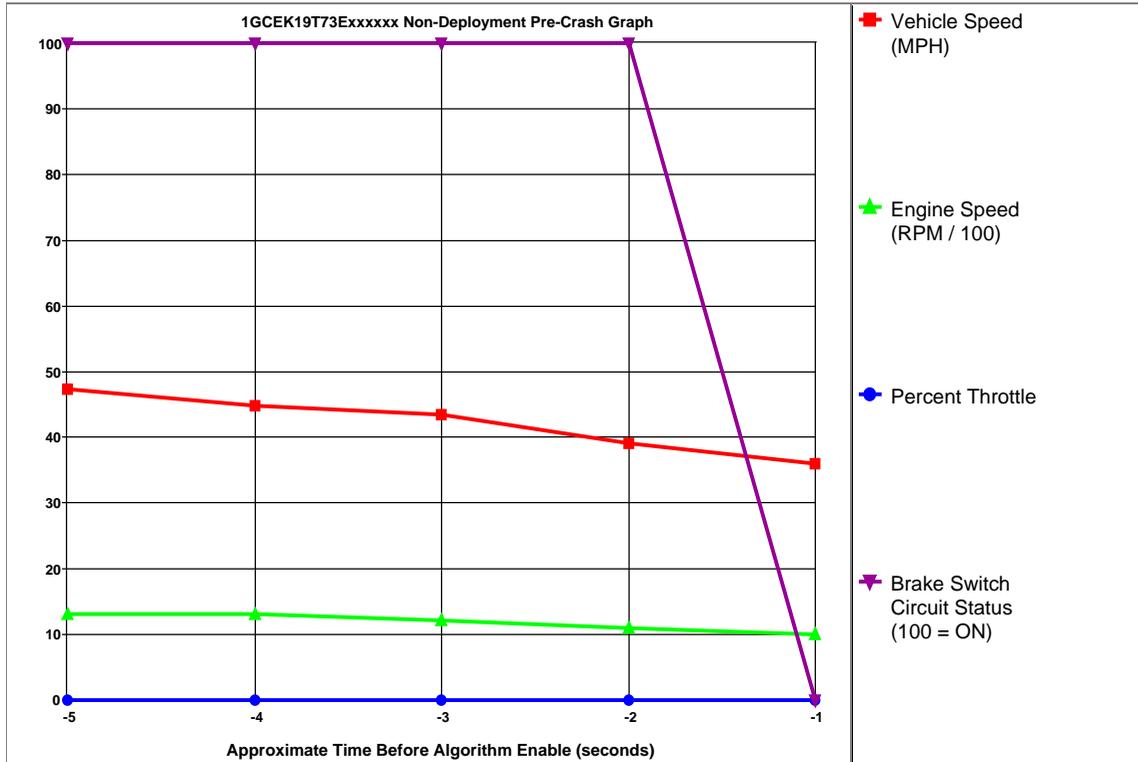
Seconds Before AE	Vehicle Speed (MPH)	Engine Speed (RPM)	Percent Throttle	Brake Switch Circuit Status
-5	47	1280	0	ON
-4	45	1280	0	ON
-3	44	1152	0	ON
-2	39	1088	0	ON
-1	36	960	0	OFF

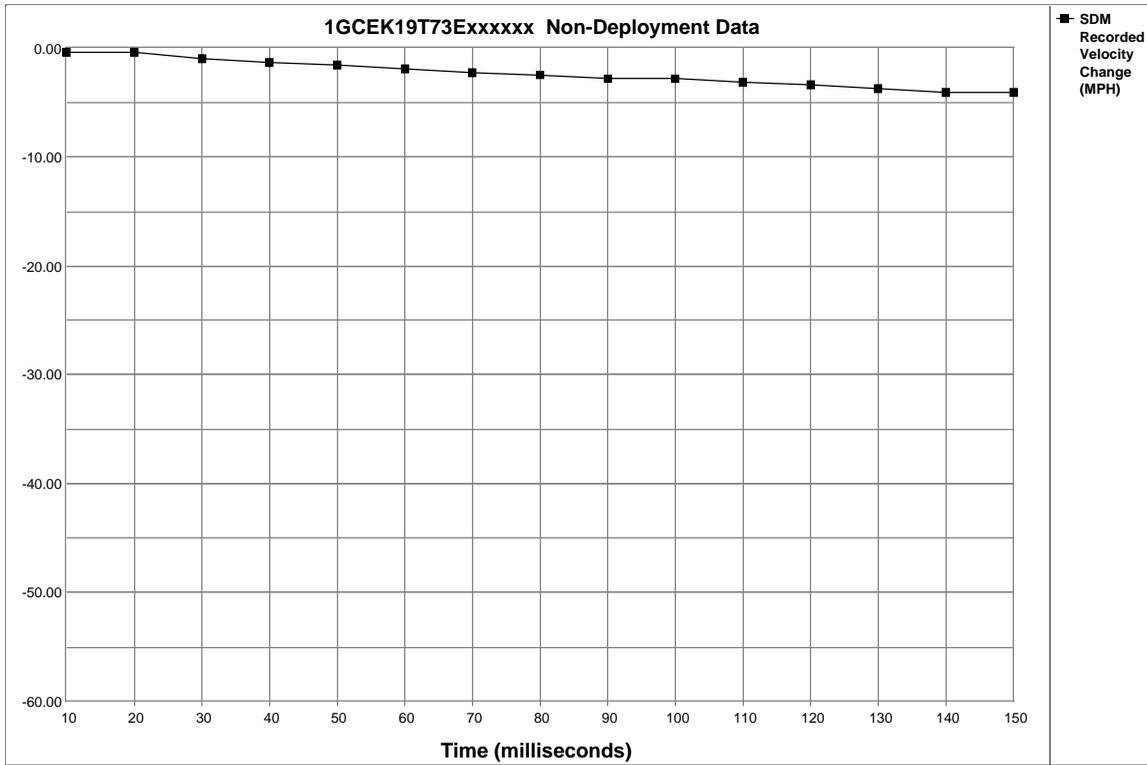
Time (milliseconds)	10	20	30	40	50	60	70	80	90	100	110	120	130	140	150
Recorded Velocity Change (MPH)	-0.31	-0.31	-0.93	-1.24	-1.55	-1.86	-2.17	-2.48	-2.79	-2.79	-3.10	-3.41	-3.72	-4.03	-4.03
