**CALSPAN ON-SITE CHILD SAFETY SEAT/SIDE IMPACT INFLATABLE CURTAIN  
DEPLOYMENT INVESTIGATION**

**CASE NO.: CA03-058**

**VEHICLE: 2003 SATURN L200**

**CRASH DATE: OCTOBER 2003**

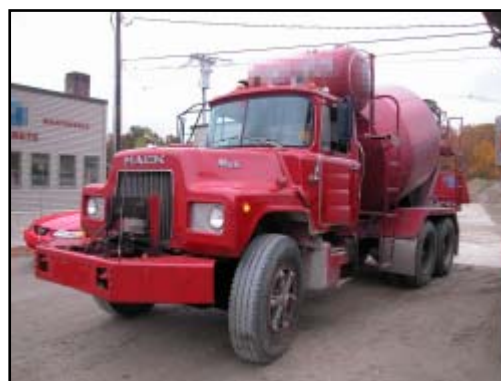
**Figure 2. 1984 Mack concrete delivery truck**

The 1984 Mack concrete delivery truck (**Figure 2**) was identified by the VIN: 1M2B180C4EA (production sequence omitted). The truck was a 6 x 4, model DM690SX incomplete chassis, with a 455 cm (179") wheelbase and equipped with a concrete mixer drum. The truck was configured with a 6-cylinder, 672 cubic inch diesel engine, a 5-speed manual transmission, a dual air brake system, and 12.00 R24 tires on 20 cm (8") cast steel spoke wheels. The truck was also configured with an extended front bumper that measured 241.3 cm (95.0") in width, 29.8 cm (11.8") in height, and 66.7 cm (26.3") in depth. The face of the bumper was constructed of 3 mm (1/8") thick steel, which measured 127.0 cm (50.0") in width across the frame rails. The outboard aspects were angled rearward starting 73.7 cm (29.0") inboard of the edge. A hydraulic pump was located in the center aspect of the bumper and the center of the bumper was reinforced with 6 mm (1/4") thick steel beams. The bumper height measured 72.4 cm (28.5"), and the front overhang of the truck measured 158.0 cm (62.3").

The unloaded weight of the concrete delivery truck was 15,105 kg (33,300 lb). At the time of the crash, the truck was loaded with eight yards of concrete, weighing 13,426 kg (29,600 lb), which resulted in a total weight of 28,531 kg (62,900 lb).

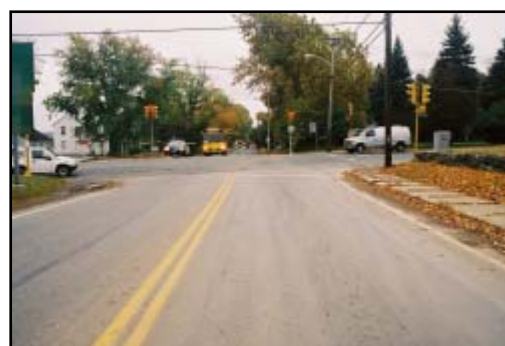
**Figure 3. Southbound approach for the Saturn L200**

The 34-year-old female driver of the Saturn L200 was operating the vehicle in a southbound direction on approach to the four-leg intersection. The traffic signal for north/south traffic was in the red phase and the driver brought the vehicle to a controlled stop behind a non-contact vehicle, also stopped at the intersection (**Figure 3**). The 1984 Mack concrete delivery truck was traveling southbound and the driver had brought the vehicle to a stop on the north leg of the intersection. The 68-year-old female driver of the Lexus was

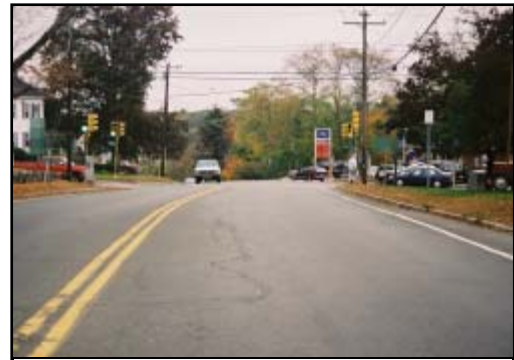
**Figure 4. Eastbound approach for the Lexus ES300.**

operating the vehicle in an eastbound direction on approach to the intersection (**Figure 4**) when the traffic signal cycled to red for east/west traffic. When the traffic signal cycled to the green phase for north/south traffic, the non-contact vehicle proceeded into the intersection and made a left turn. The driver of the Saturn proceeded into the intersection but did not detect the Lexus approaching from the right. The pre-crash data downloaded from the Saturn's EDR supported the pre-crash scenario and reported a vehicle speed of 5 km/h (3 mph) four seconds before impact and a vehicle speed of 23 km/h (14 mph) two seconds prior to impact. Six seconds pre-crash through ten seconds pre-crash showed a vehicle speed of zero for the Saturn. The concrete delivery truck proceeded slowly into the intersection and stopped while the driver waited for northbound traffic to clear the intersection. The driver of the Lexus disregarded the red traffic signal for eastbound traffic and continued into the intersection.

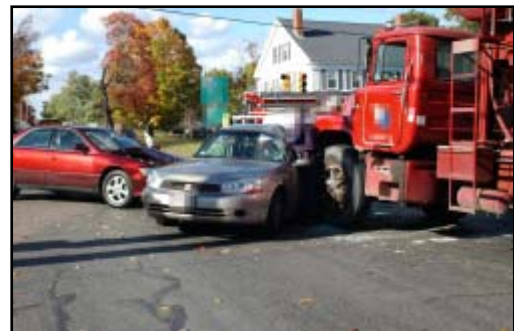
**Figure 5. On-scene photograph looking northbound showing final rest positions**

The left side aspect of the Saturn came to rest against the front aspect of the concrete delivery truck and the front of the Lexus came to rest against the right side of the Saturn (**Figure 5**). The child passenger removed the safety belt and was removed from the vehicle by rescue personnel through the backlight. The driver of the Saturn did not sustain injury and removed the safety

belt but could not exit the vehicle as the Saturn was captured between the Lexus and the Mack truck, which caused the doors to be jammed shut. The Lexus was moved rearward away from the right side aspect of the Saturn and the front driver attempted to exit the vehicle through the right front door. Since the right front door was jammed shut, the driver crawled into the rear seat and exited the vehicle through the right rear door that was pried open by rescue personnel. The driver of the Lexus was removed from the vehicle by rescue personnel. The driver of the concrete delivery truck was not injured and exited the vehicle under his own power. The Saturn and Lexus were towed from the scene and the Mack concrete delivery truck was driven from the scene to its destination.

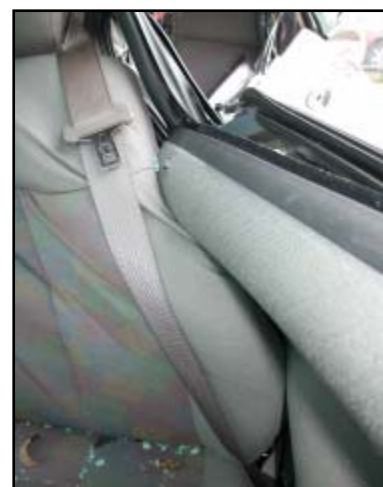
**Figure 10. View of driver's safety belt**

The 2003 Saturn L200 was configured with manual 3-point lap and shoulder belts for the driver and front right passenger seating. The driver's safety belt (**Figure 10**) was configured with a sliding latch plate, an Emergency Locking Retractor (ELR), and an adjustable D-ring that was located 2.5 cm (1.0") below the full-up position. The front right safety belt was configured with a sliding

The driver was utilizing the safety belt at the time of the crash, which was supported by the vehicle inspection and the EDR output. Following the crash, the driver released the safety belt buckle and exited the vehicle. The safety belt partially retracted onto the ELR retractor and would not extend at the time of the SCI inspection. Minor abrasions were present on the plastic-covered latch plate from occupant loading. The D-ring could not be evaluated for abrasions due to intrusion.

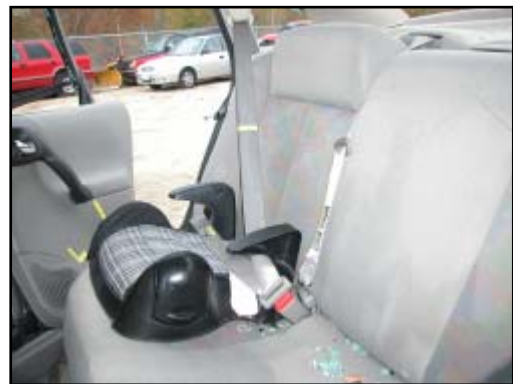
**Figure 12. BPB in position with the vehicle's safety belt**

The Cosco High Rise BPB was positioned on the right side of the rear bench seat in the Saturn L200 (**Figure 12**). The model number was 22-298-HRS, the date of manufacture was August 07, 2002, and the BPB was not on the NHTSA recall list. The BPB was a backless booster that was configured with an adjustable shoulder belt positioner that consisted of a clip on the end of a strap attached behind the booster base. The adjuster was designed to adjust the angle of the shoulder belt by routing the shoulder belt through the clip and adjusting the strap length so the shoulder belt could be centered across the child's chest. The manufacturer's label stated that the BPB was rated for children who weighed 14 – 45 kg (30 – 100 lb) and whose height was less than 132 cm (52"), as long as the midpoint of the child's head was not above the vehicle seat back. The 4-year-old child positioned in the BPB was within the recommended height and weight guidelines.

The BPB was purchased new and had been used daily for approximately one year prior to the crash. The driver placed the BPB into the vehicle prior to the crash and restrained the child passenger using the vehicle's manual 3-point lap and shoulder belt, and removed the slack in the

belt by pulling on the webbing. The BPB's shoulder belt adjuster strap was not utilized. The BPB did not sustain damage as a result of the crash.

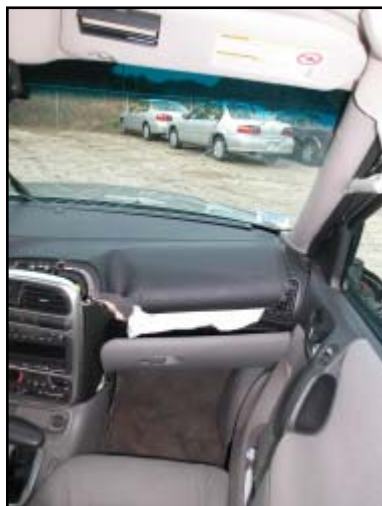
**Figure 14. Front right passenger's air bag cover**

The front right passenger's air bag deployed from a mid-mount module configured with a rectangular cover flap hinged at the top aspect. The vinyl cover flap measured 30.5 cm (12.0") in width and 21.6 cm (8.5") in height. Due to the lateral intrusion at the right A-pillar, the vinyl cover of the instrument panel continued to tear beyond the outline of the cover flap, and the right corner of the instrument panel intruded under the open cover flap (**Figure 14**). An additional tear that measured 15.3 cm (6.0") in length radiated forward and to the left from the bottom left aspect of the cover flap. A 5.1 cm (2.0") tear radiated forward from the top right corner of the cover flap. The front right passenger's air bag (**Figure 15**) measured 40.6 cm (16.0") in width and 66.0 cm (26.0") in height in its deflated state.

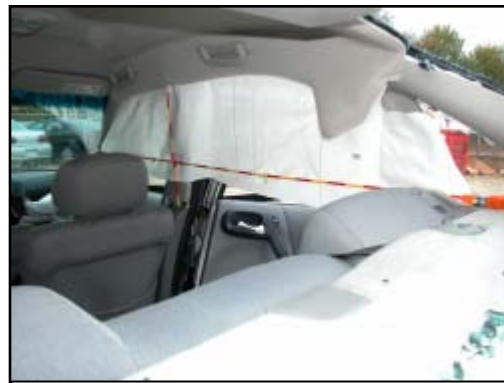
**Figure 17. Deployed right side IC**

The 2003 Saturn L200 was also equipped with a side impact Inflatable Curtains (IC). The right and left side IC's deployed as a result of the right side impact with the Lexus and the left side impact with the concrete delivery truck, respectively. The IC's (**Figures 16 and 17**) deployed downward from the roof side rails through the separation of the outboard edges of the headliner between the A- and C-pillars. The headliner separation measured 127.0 cm (50.0") in length and 7.6 cm (3.0") laterally on each side. Both IC's measured 162.6 cm (64.0") in length and 40.6 cm (16.0") in height in their deflated state. The IC's were tethered on the front and rear outboard aspects. The front tether was triangular in shape and was attached via two stitch points on the outboard aspect of each IC. The tether was tapered at the forward aspect and was anchored to a square plastic tube that measured 1.3 cm (0.5") in width and extended 23.5 cm (9.3") rearward from each A-pillar. A 17.8 cm (7.0") long tether that measured 1.3 cm (0.5") in width was stitched to the rear outboard aspect of each IC and was anchored to the interior C-pillars.

The stored gas inflators for the IC's were mounted longitudinally on the center aspect of the D-pillars beneath the interior trim panels.

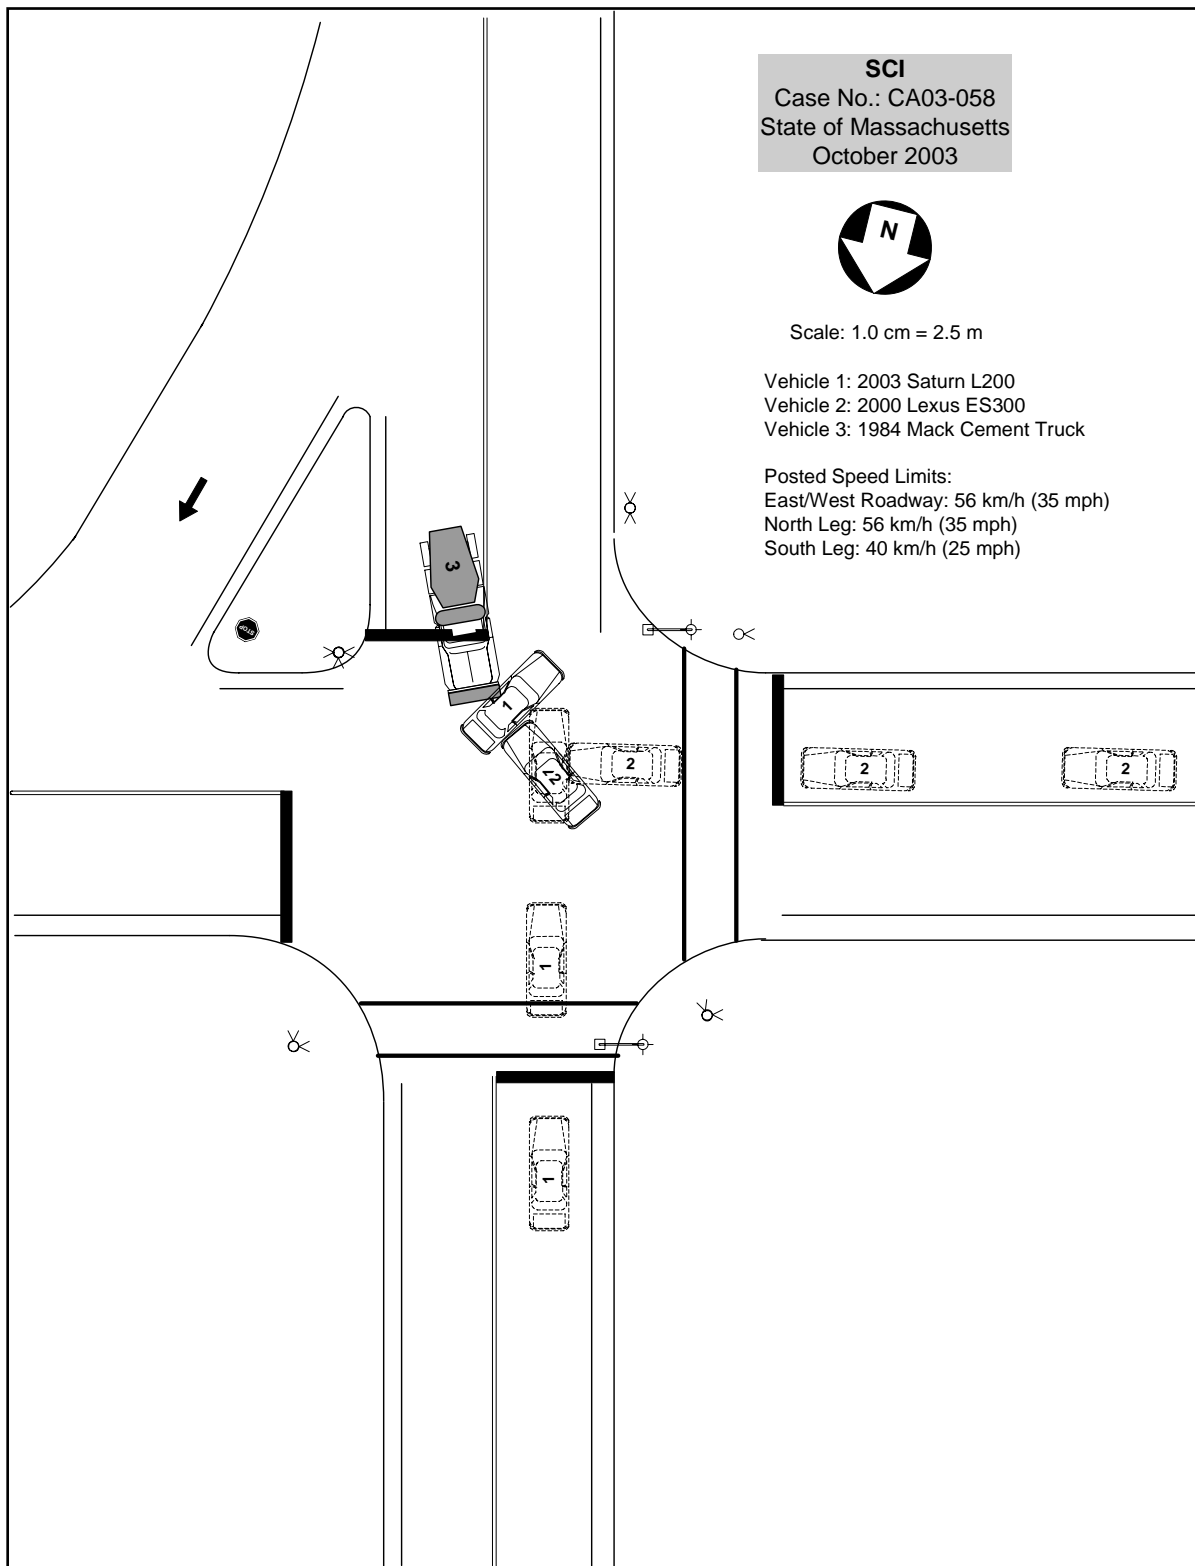
Figure 19. Scene schematic

the north leg of the intersection was 56 km/h (35 mph) and the posted speed limit for the south leg of the intersection was 40 km/h (25 mph). The scene schematic is included as **Figure 19** of this report.
