**CALSPAN REMOTE ALTERNATIVE FUEL VEHICLE CRASH
INVESTIGATION**

CASE NO: 2004-11-080F

VEHICLE: 2004 TOYOTA PRIUS

CRASH DATE: APRIL 2004

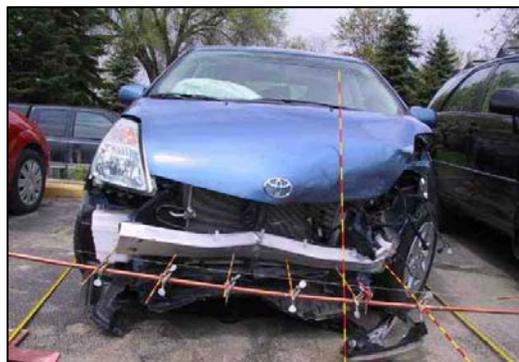
This remote investigation focused on the performance of the hybrid fuel system that was present in a 2004 Toyota Prius (**Figure 1**). The Prius was equipped with a gas/electric hybrid drive train, which was configured with a 1.5 liter gasoline engine coupled with an electric drive motor. The vehicle was designed to run on battery power, gasoline, or a combination of both, dependant on the throttle input and desired speed. The 2004 Toyota Prius was involved in a moderate severity intersection crash with a 2000 Dodge Intrepid. A 53-year-old female driver who was restrained by a manual three-point lap and shoulder safety belt occupied the Prius. The driver was operating the vehicle in an eastbound direction on the outboard lane of a three-lane undivided roadway and was approaching a four-leg intersection that was controlled by three-phase traffic signals. A 17-year-old driver of the Intrepid was traveling westbound on the outboard lane of the same roadway approaching the same intersection. The driver of the Intrepid attempted to initiate a left turn across the path of the Prius. After realizing that a collision was imminent, the driver of the Intrepid counter-steered right in an effort to keep the principal impact off of the right side of the vehicle, thereby protecting the front right passenger. As the driver initiated the correction, the front of the Prius contacted the front of the Intrepid. The impact was sufficient to deploy the redesigned frontal air bag system in the Prius. The driver of the Prius was not injured and was not medically treated. The NASS inspection of the Prius revealed no loose, or severed fuel or electrical lines in the engine compartment or the undercarriage. There was a 12-volt battery and a Nickel-Metal-Hybrid battery located behind the rear seat bight. There were no apparent electrical shorts or leakages in the battery storage area fastened inside the trunk. The hybrid power train system is discussed in greater detail later in this report.

Figure 1 – Subject vehicle 2004 Toyota Prius

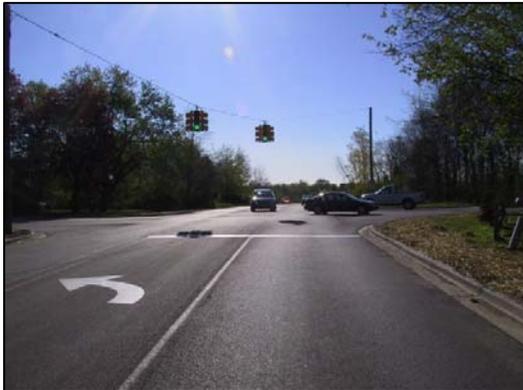
The 53-year-old female driver of the 2004 Toyota Prius was traveling eastbound on the outboard lane of a three-lane undivided roadway (**Figure 2**). The 17-year-old driver of the 2000 Dodge Intrepid was traveling westbound on the outboard lane of the same roadway (**Figure 3**). Both vehicles were approaching an intersection controlled by a three-phase traffic control signal. The driver of the Prius was intending to continue straight through the intersection under the green signal while the driver of the Intrepid was initiating a left turn to travel southbound on a three-lane roadway that intersected this roadway.

Figure 2- Eastbound approach of the 2004 Toyota Prius.

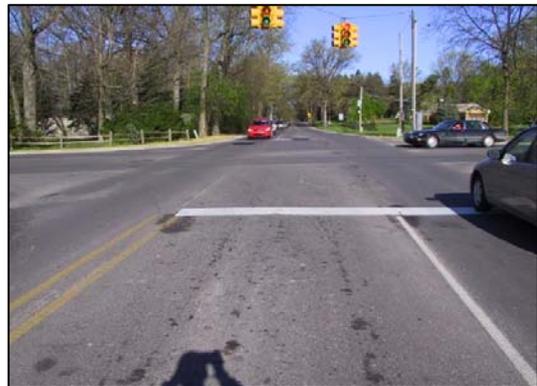
Figure 3 - Westbound approach of the 2000 Dodge Intrepid.

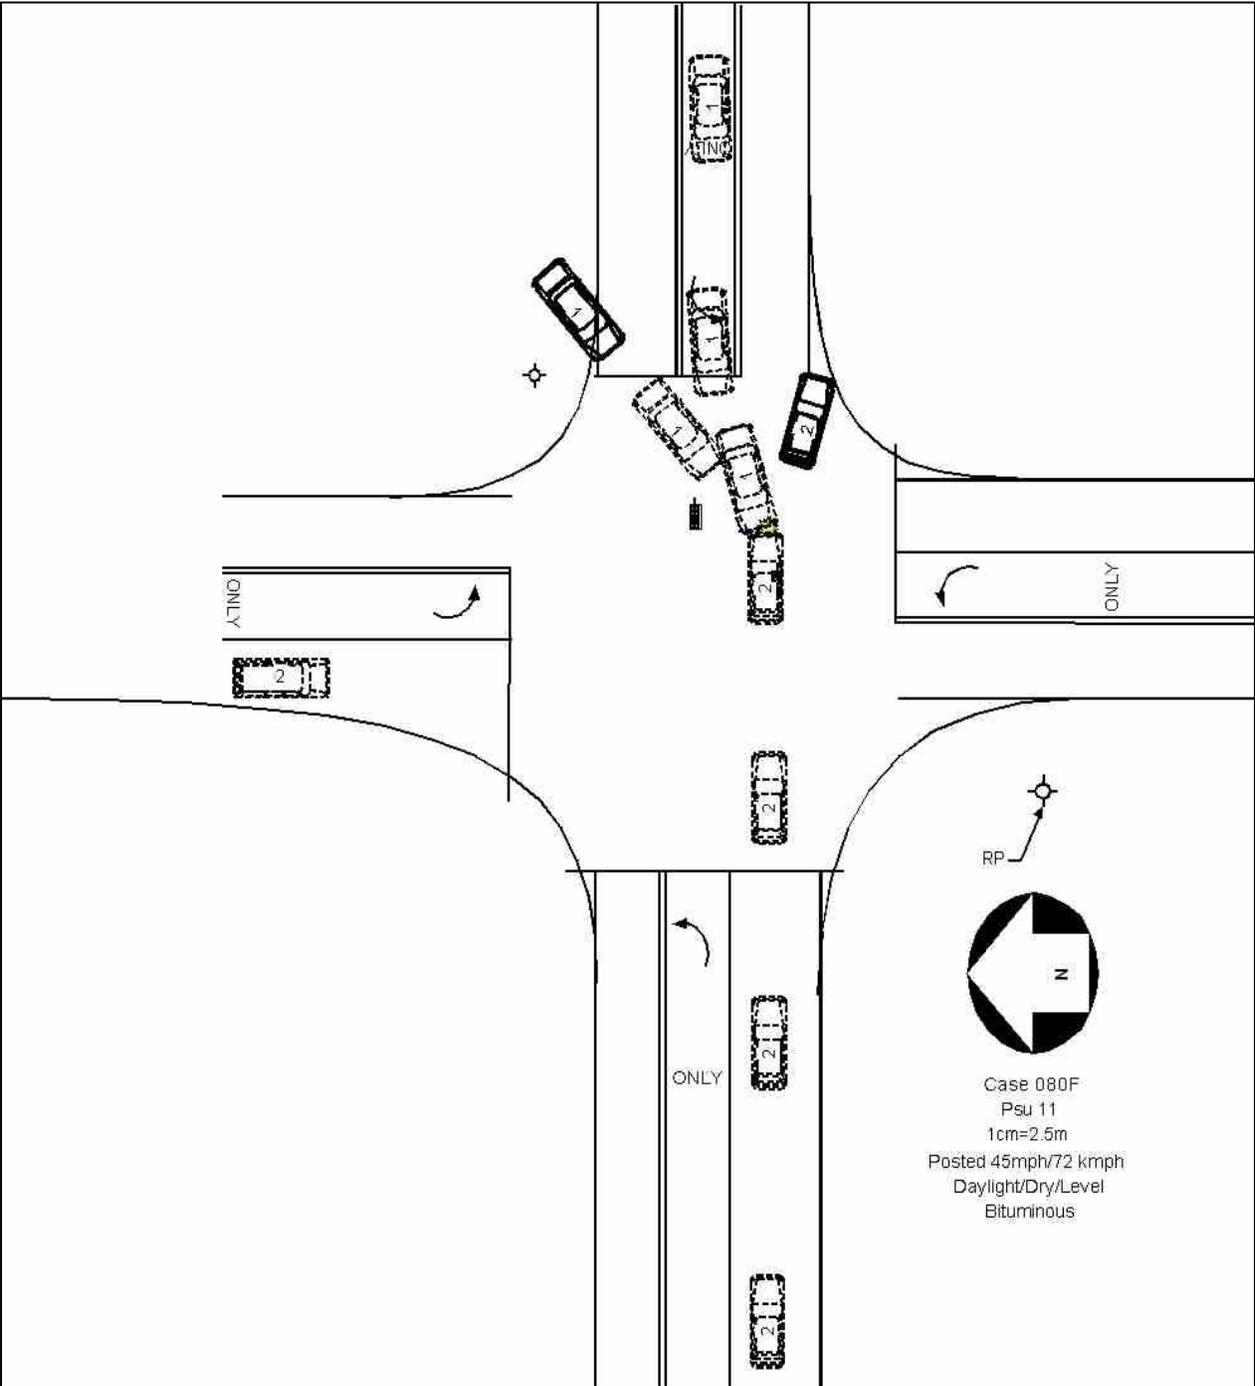
Figure 10 - NASS Scene Schematic

This crash occurred on a three-lane, east/west roadway in a residential area during daylight hours. The roadway was configured with one eastbound and one westbound lane separated by a center left turn lane. The roadway was surfaced with asphalt and was delineated by double-yellow lines contiguous to the turn bay and solid white fog lines. The center turn bay had arrow markings to channel traffic. The travel lanes were 4.0 m (13.1') in width and the center turn bay was 3.5 m (11.5') wide; paved shoulders that were 0.5 m (1.6') in width bordered the roadway. The roadway intersected with a dimensionally similar three-lane road and was controlled by a three-phase traffic control signal. The environment along the roadway consisted of residential homes and natural growth. At the time of the crash, the road surface was dry and there were no adverse atmospheric conditions. Both vehicles were traveling on the east/west roadway; the Prius was intending to continue straight through the green signal while the Intrepid intended to turn left. The speed limit for the straight and level east/west roadway was posted at 72 km/h (45 mph). The Crash Schematic is included as **Figure 10** at the end of this narrative report.
