**CALSPAN REMOTE CERTIFIED ADVANCED 208-COMPLIANT CRASH  
INVESTIGATION**

**NASS/SCI COMBO CASE NO.: 04-12-083J**

**SUBJECT VEHICLE: 2003 GMC SIERRA PICKUP TRUCK**

**CRASH DATE: MAY 2004**

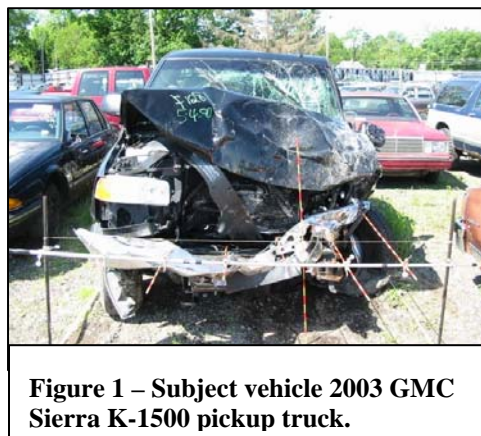
This remote crash investigation focused on the performance of the Certified Advanced 208-Compliant (CAC) frontal air bag system in a 2003 GMC Sierra K-1500 series extended cab pickup truck (**Figure 1**). The manufacture of this vehicle has certified that this 2003 GMC Sierra meets the advanced requirements of the Federal Motor Vehicle Safety Standard (FMVSS) No. 208. The CAC safety system included dual stage frontal air bags, seat track positioning sensors, seatbelt buckle switches, and a front right seat occupant-detecting sensor. Additionally, the Sierra was equipped with an air bag cutoff switch. The Sierra also contained a Sensing and Diagnostic Module (SDM) for the safety system, which had event data recording capabilities. This module was downloaded during the NASS inspection and its output is discussed in the *Electronic Data Recorder (EDR)* section of this report. A 55-year-old male driver occupied the Sierra. The Sierra was traveling in a northerly direction of a two-lane residential roadway while a 1987 GMC P4500 step van, operated by a 34-year-old male, was southbound in the opposite direction. The step van reportedly hydroplaned on the wet road surface and lost control by rotating counterclockwise and entering the northbound lane into the path of the Sierra. The Sierra's front end impacted the front of the step van. The impact was sufficient to command a stage-1 deployment of the driver's frontal air bag. The driver sustained a left femur fracture and open fractures to his right tibia and fibula. The driver was transported by ambulance to a local hospital and admitted for 22 days.

**Figure 1 – Subject vehicle 2003 GMC Sierra K-1500 pickup truck.**

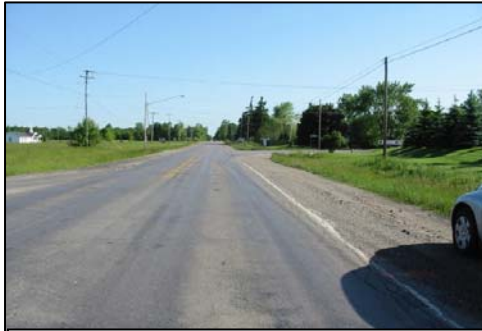
The restrained 55-year-old male driver of the 2003 GMC Sierra was operating the vehicle northbound on the tow-lane roadway (**Figure 2**). The 34-year-old male driver of the 1987 GMC P4500 step van was southbound (**Figure 3**) in the opposite direction on the same roadway. As the driver of the step van continued southbound, he applied his brakes to slow down, hydroplaned, and lost control on the wet roadway. The step van began to rotate counterclockwise, crossed the centerline of the roadway, and entered the northbound lane. The driver of the Sierra applied his brakes in an attempt to avoid the step van at one second prior to impact, evidenced by the EDR report.

**Figure 2 – Northbound approach of the 2003 GMC Sierra.**

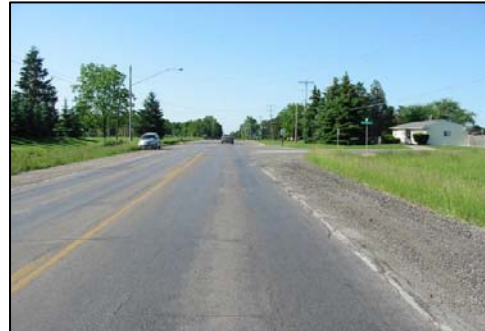
**Figure 3 – Southbound approach of the 1987 GMC P4500 step van.**

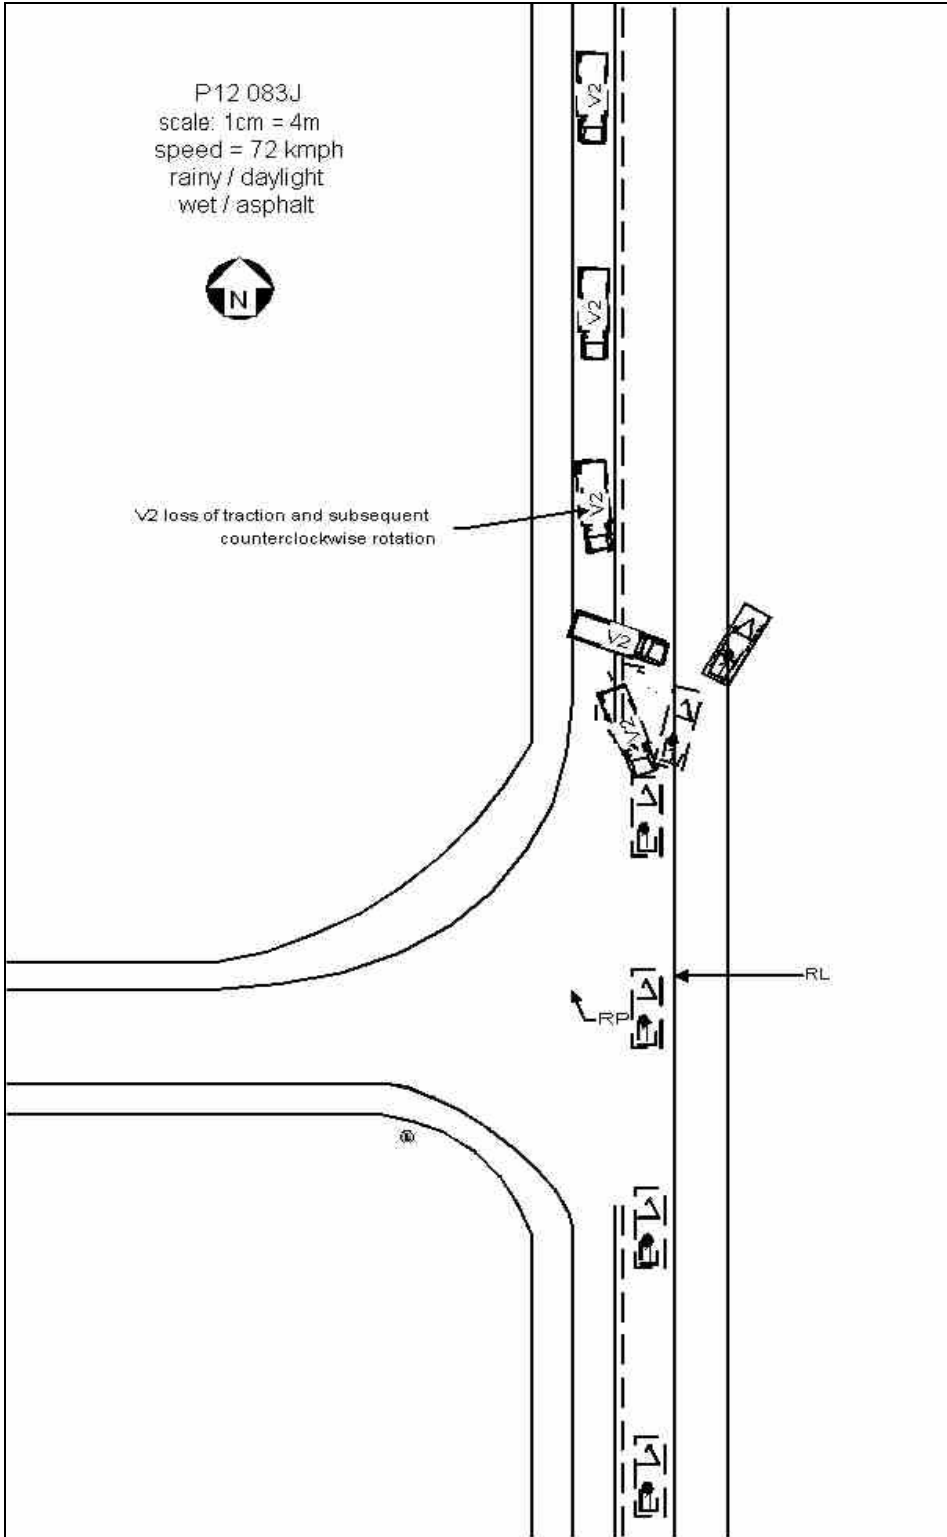
**Figure 10. NASS Scene Schematic**

This two-vehicle crash occurred during the afternoon hours of May 2004. At the time of the crash, it was raining and the roadway was wet. The crash occurred in the northbound lane of a two-lane residential roadway. The roadway was surfaced with worn asphalt and solid and broken yellow lines delineated the travel lanes. The roadside environment consisted of gravel shoulders and natural growth accompanied by sporadic dwellings. The travel lanes were 3.5 m (11.5') in width. The east shoulder was 3.6 m (11.8') wide and the west shoulder was 2.8 m (9.2') in width. The posted speed limit for traffic was 72 km/h (45 mph). The scene schematic is included as **Figure 10** of this report.

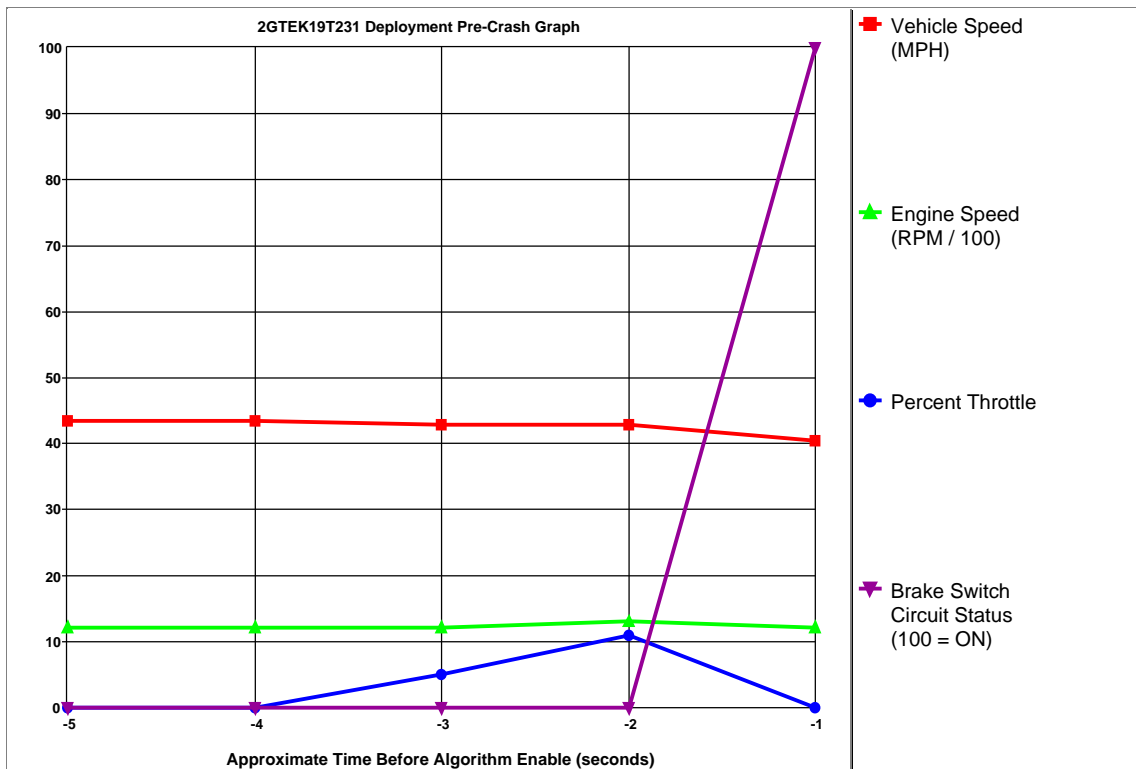
Seconds Before AE	Vehicle Speed (MPH)	Engine Speed (RPM)	Percent Throttle	Brake Switch Circuit Status
-5	44	1216	0	OFF
-4	44	1216	0	OFF
-3	43	1216	5	OFF
-2	43	1280	11	OFF
-1	40	1152	0	ON

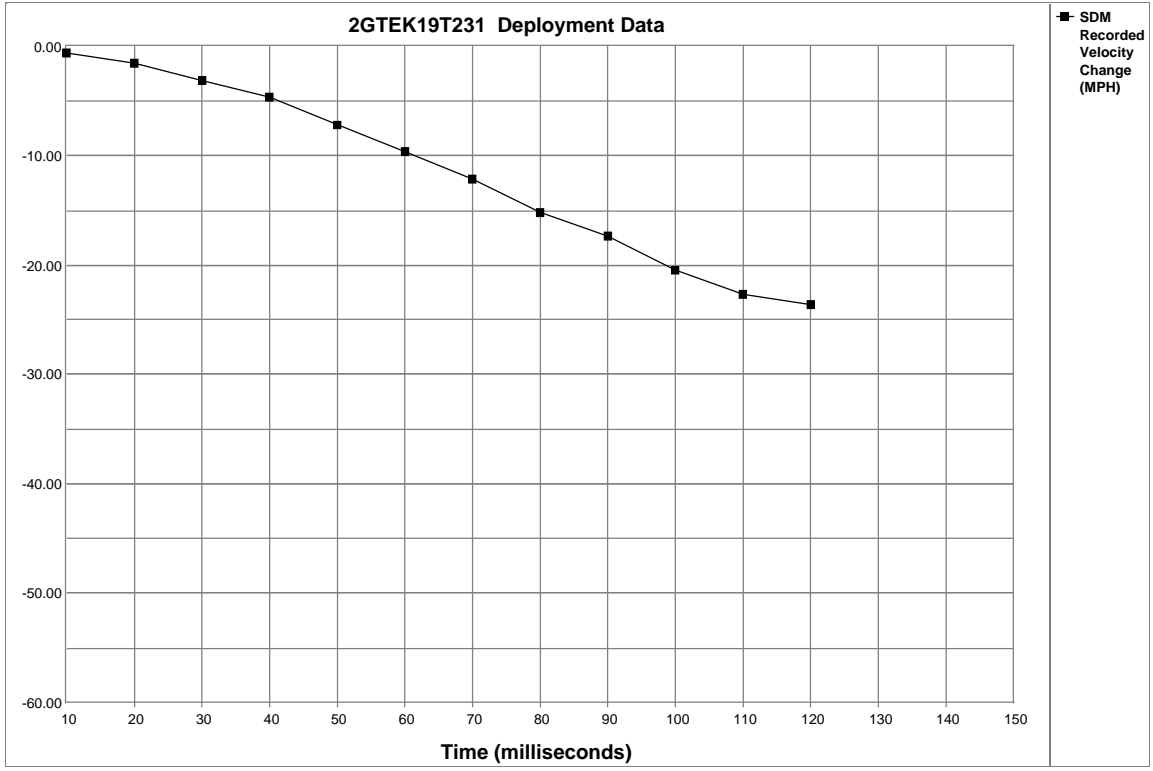
Time (milliseconds)	10	20	30	40	50	60	70	80	90	100	110	120	130	140	150
Recorded Velocity Change (MPH)	-0.62	-1.55	-3.10	-4.65	-7.13	-9.61	-12.09	-15.19	-17.36	-20.46	-22.63	-23.56	N/A	N/A	N/A
