**CALSPAN ON-SITE NASS/SCI COMBO ADAPTIVE CONTROL
VEHICLE CRASH INVESTIGATION**

CASE NO: 2004-13-108D

VEHICLE: 1998 FORD E-150 VAN

CRASH DATE: APRIL 2004

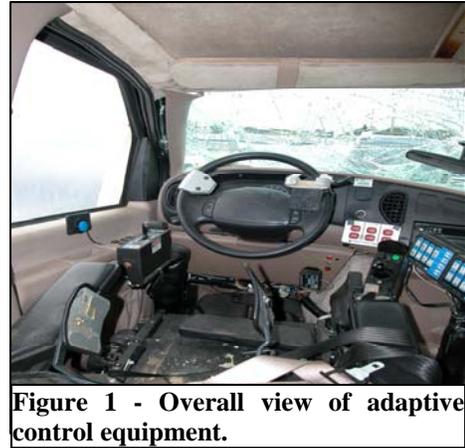
This SCI on-site investigation focused on the type and performance of the adaptive control equipment (**Figure 1**) that was installed in a 1998 Ford E-150 conversion van. The vehicle was involved in a roadside departure crash with a guardrail and a subsequent rollover. The driver of the van was a 72-year old male who was restrained by a modified manual safety belt system. The driver was a paraplegic with limited mobility of his upper extremities. He was seated in a motorized wheelchair that was secured to the vehicle with an E-Z Lock wheelchair restraint system. The driver was exiting an interstate roadway onto a highway at

Figure 1 - Overall view of adaptive control equipment.

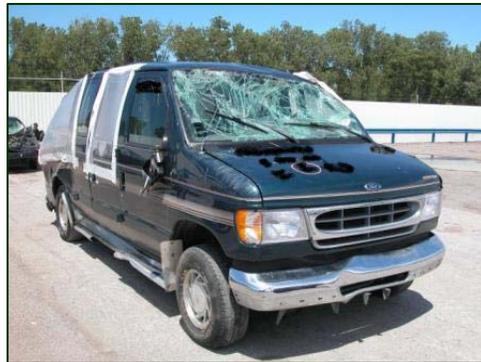
The 1998 Ford E-150 van was a post-manufacturer conversion van (**Figure 2**). The conversion company was Adventure Vans, a member of the Recreational Vehicle Industry Association (RVIA) with a Member No. of 2538023. The Ford was manufactured in 9/98 and was identified by Vehicle Identification Number (VIN): 1FDRE1429WH. The vehicle's odometer read 65,126 km (40,469 miles) at the time of the SCI inspection. The vehicle was four-door, full-size van with a second (double) two side hinged rear doors. The van was equipped with a 6-cylinder, 4.3-liter engine linked to an automatic transmission. The rear-wheel drive vehicle was equipped with 38 cm (15") alloy wheels and Michelin LTX M/S P235/75R15 tires. The specific tire information at the time of the SCI vehicle inspection was as follows:

Figure 2. Ford E-150 conversion van.

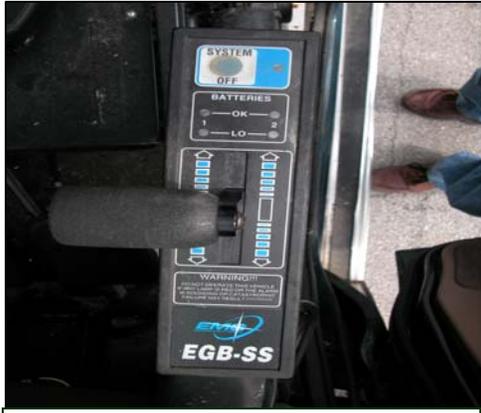
The adaptive hand controls included a left hand operated remote throttle and brake controller. The throttle and brake controller had a T-handle that moved forward for throttle and aft for braking (**Figure 3**). The T-handle had a fore-and-aft travel of 5 cm (2.1") and returned to the center neutral position. The unit was labeled EMC EGB-SS with the Serial Number of 4122. The hand control was mounted on a steel stalk that was bolted to the left floor of the vehicle adjacent to the sill. A servo motor/controller was mounted under the left instrument panel to the toe pan of the Ford. This unit transferred the left hand inputs to the throttle and brake system of the vehicle. A nylon roller was mounted on a cam to the right side of the servo unit. This roller engaged the brake pedal arm to apply the brakes following driver input. The van was equipped with a zero or low-effort braking system. A cable transferred inputs from the servo unit to the top arm of the OEM accelerator pedal.

Figure 3. Adaptive hand control for throttle and brake functions.

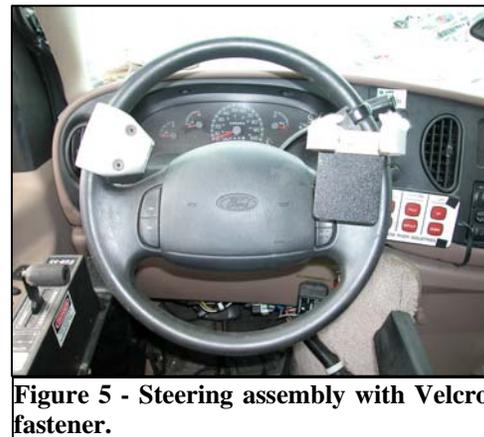
Two steering wheel assist devices were mounted to the wheel rim at the 10 and 2 o'clock positions. There was no appliance attached to the bracket at the 10 o'clock sector. This bracket typically accepts a spinner knob or a tri-pin device. At the 2 o'clock sector was a swivel wrist pad with a cuff that presumably fit the right wrist or hand of the driver (**Figure 5**). The adaptive controls were monitored by the AEVIT system, which utilized two computers to monitor the steering and throttle/brake systems.

Figure 5 - Steering assembly with Velcro fastener.

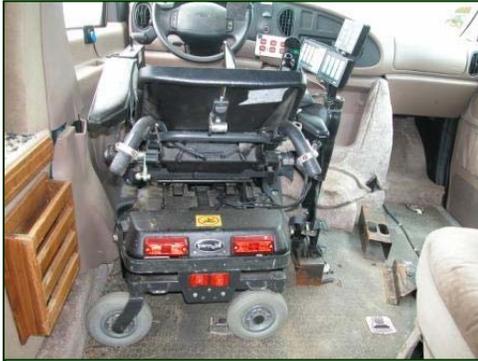
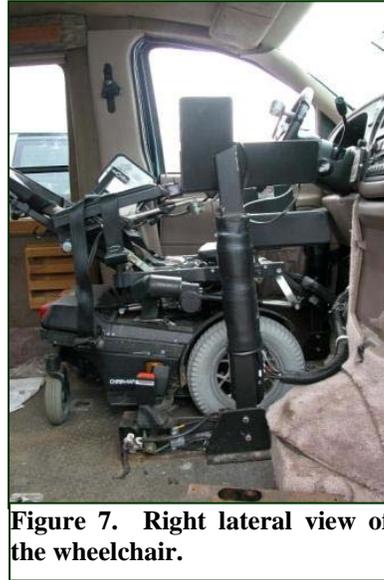
to accommodate the occupant's legs. The calf pads were positioned 13 cm (5") forward of the seat cushion and were 17 cm (6.5") in length and 11 cm (4.5") in width. The footrests were 23 cm (9") in length and 19 cm (7.5") in width and were power adjustable. The footrests were positioned under and behind the OEM brake pedal. The wheelchair was not damaged in the crash. **Figures 6 and 7** are views of the motorized wheel chair secured in the driver's position.

Figure 6. Motorized wheelchair secured into the EZ-Lock restraint device.

Figure 7. Right lateral view of the wheelchair.

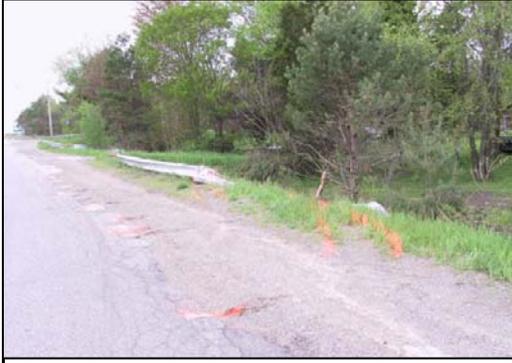
wheelchair foot rests interfered with the brake pedal travel, thus limiting the braking function of the vehicle. In response to the absence of braking, the driver steered sharply left at the intersection at a driver-estimated speed of 56 km/h (35 mph) and departed the right side of the intersecting roadway (**Figure 8**).

Figure 8 - Vehicle's approach to impact.

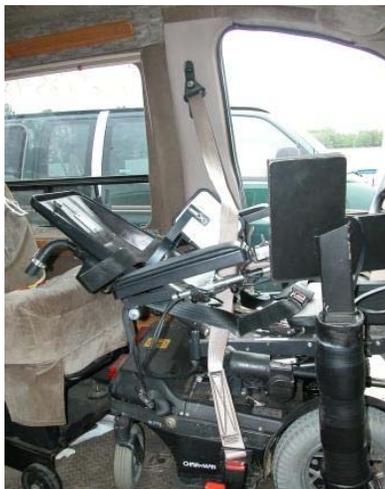
OEM lower B-pillar location. The belt was routed through the B-pillar mounted D-ring that was adjustable. At the time of the SCI vehicle inspection, the D-ring was adjusted to the full-up position. The OEM-style sliding latch plate was identified by a stamped number of L058 and was sewn to the shoulder belt webbing in an OEM type pattern. The wavy stitch pattern indicated that the belt was sewn with a machine, but fed through by hand. Rescue personnel cut the shoulder belt webbing 120 cm (47") above the sliding latch plate. The remainder of the belt webbing retracted onto the retractor. **Figure 15** is a view of the shoulder belt routed through the wheelchair.

Figure 15. Routed positions of the manual safety belts.

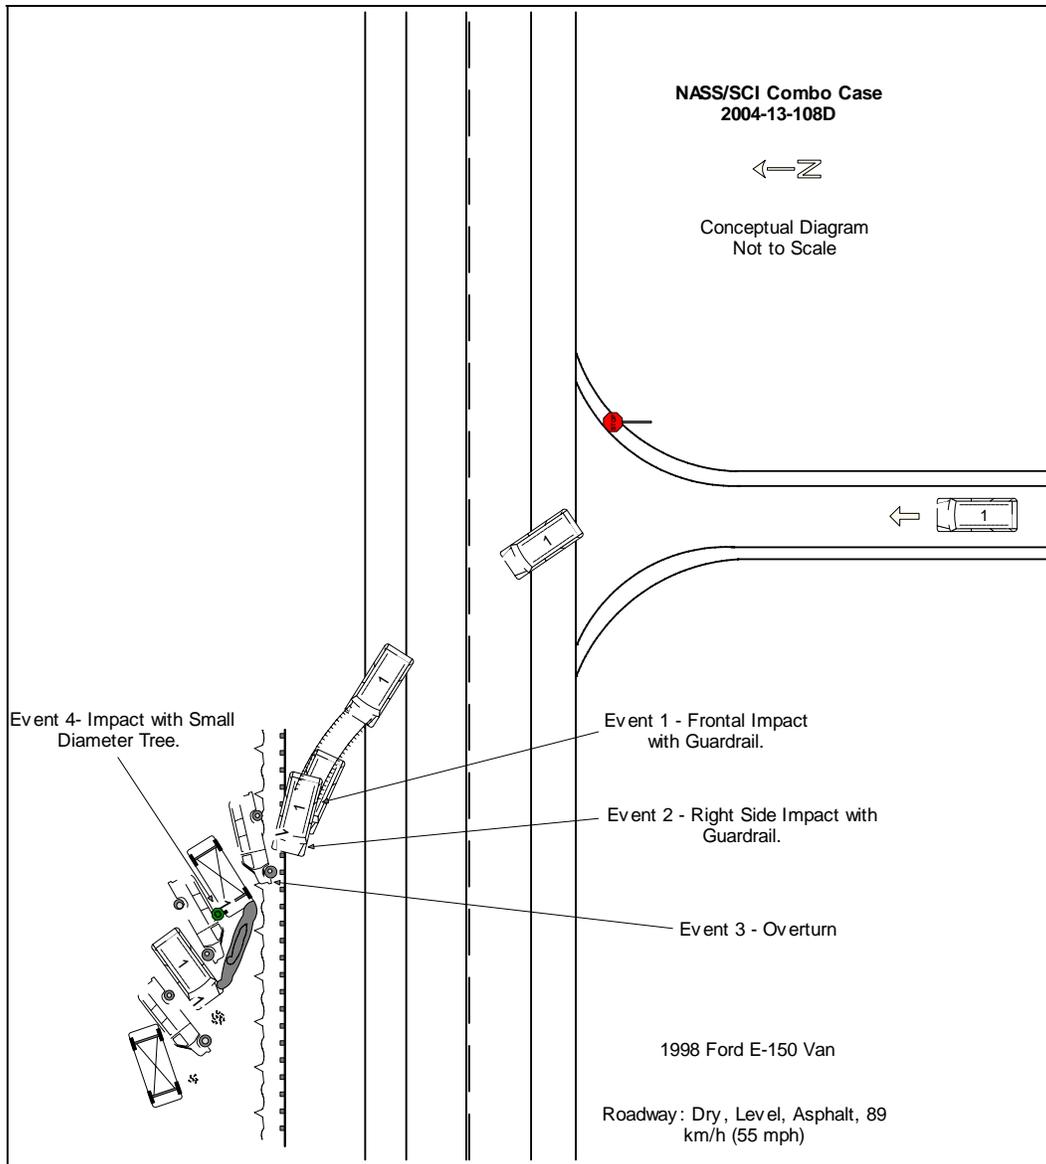
Figure 18. SCI Revised Scene Schematic

This single vehicle crash occurred during daylight hours of April 2004 in the state of Michigan. At the time of the crash there were no adverse weather conditions and the asphalt roadway was dry. The crash site consisted of a one lane exit ramp from an interstate highway that intersected a two lane road forming a T-intersection. A stop sign the mouth of the exit ramp regulated traffic flow onto the two lane road. A guardrail was positioned on the north roadside bordering the two-lane roadway. It was located 3 m (9.8') outboard of the roadway. Beyond the guardrail, the roadside sloped downward into a ditch. Multiple small diameter trees and other natural growth were present beyond the roadway. There was no posted speed limit for the exit ramp traffic. The SCI revised scene schematic is included as **Figure 18** at the end of this narrative report.
