SCI/NASS COMBINATION 208-COMPLIANT INVESTIGATION

CASE NUMBER - NASS-2004-49-132G

VEHICLE - 2004 LEXUS RX330

CRASH DATE - April 2004

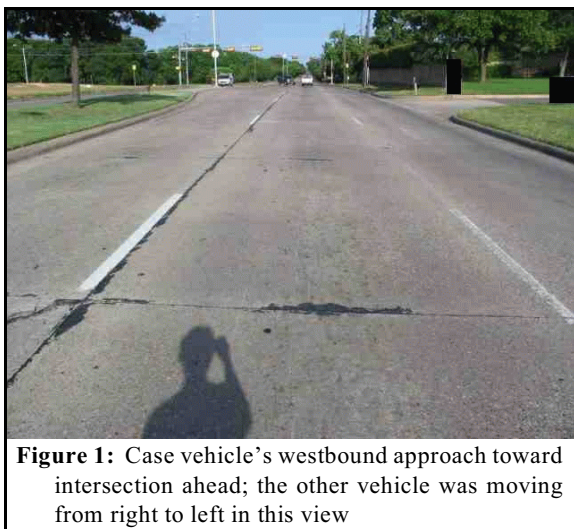
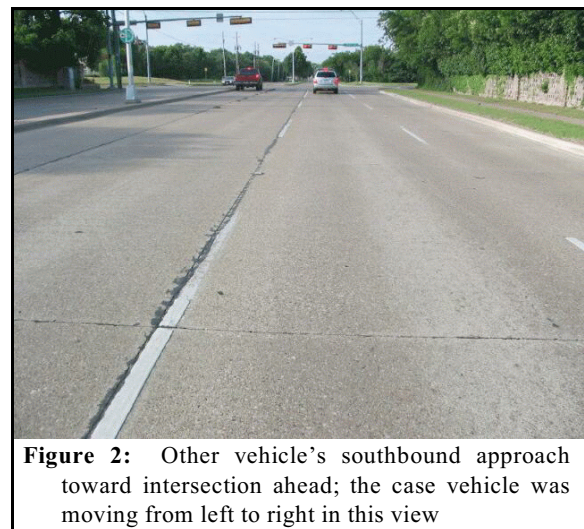
The case vehicle's front impacted the other vehicle's left side, causing the case vehicle driver's steering-wheel mounted and knee bolster-mounted air bags to deploy. The other vehicle's dual

frontal air bags also deployed. The case vehicle rotated counterclockwise approximately 270 degrees while sliding southward and came to rest straddling the north/south trafficway's concrete divider on the south leg of the intersection, heading north. The other vehicle rotated counterclockwise approximately 150 degrees while sliding to the southwest, departed the roadway at the southwest corner where it was redirected by the curb, and came to rest in the grass on the roadside heading east.
