## TRANSPORTATION RESEARCH CENTER

## ON-SITE CERTIFIED ADVANCED 208- COMPLIANT VEHICLE INVESTIGATION

CASE NUMBER - IN-04-008  
LOCATION - Texas  
VEHICLE - 2004 NISSAN QUEST  
CRASH DATE - March 2004

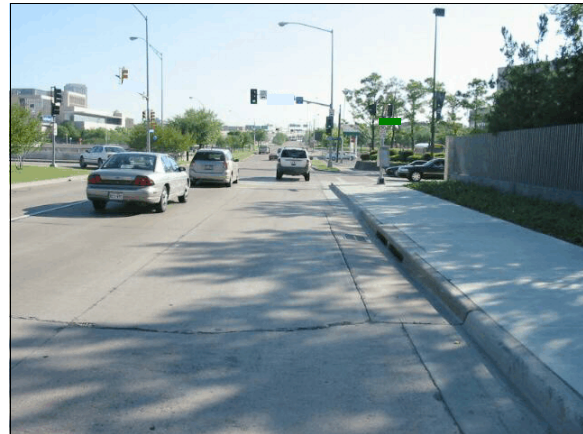
**Pre-Crash:** The case vehicle was traveling east in the right outside travel lane (**Figure 1**), and the driver was intending to continue straight ahead. The front right occupant estimated the case vehicle's travel speed at approximately 48 km.p.h. (30 m.p.h.). The Ford was traveling north in the left center travel lane (**Figure 2**), and the driver was intending to continue straight ahead. The front right passenger stated that the case vehicle's driver took no actions to avoid the crash. The crash occurred in the four-leg intersection of the two roadways.

**Figure 1:** Case vehicle's approach to the four-leg intersection in outside eastbound lane

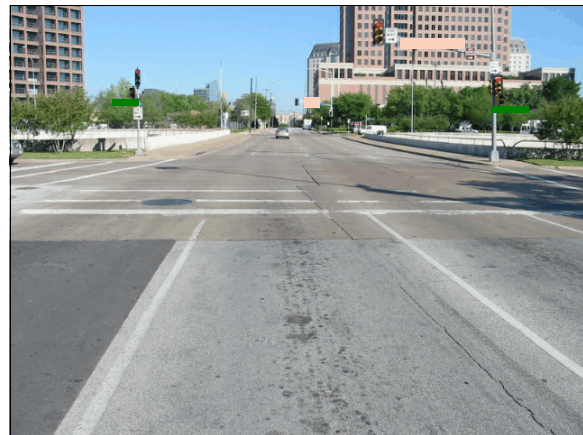
**Figure 2:** Ford's approach to the four-leg intersection in the northbound left center lane

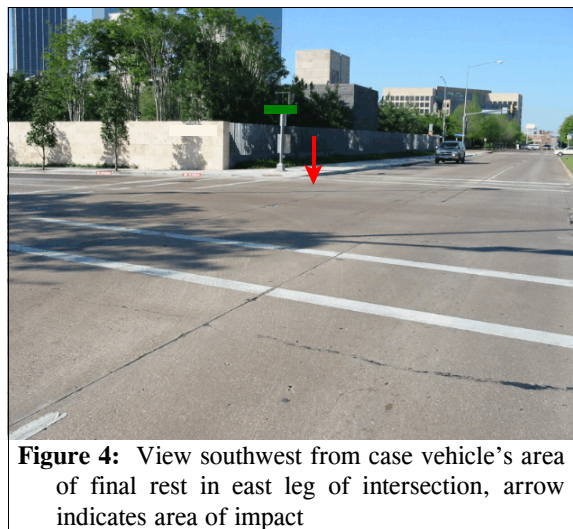
**Post-Crash:** As a result of the impact, the case vehicle rotated clockwise approximately 180 degrees, traveled northeast and came to rest in the east leg of the intersection, facing west (**Figure 4** below). The Ford rotated clockwise, traveled northeast and came to rest in the intersection facing northeast.

**Figure 4:** View southwest from case vehicle’s area of final rest in east leg of intersection, arrow indicates area of impact

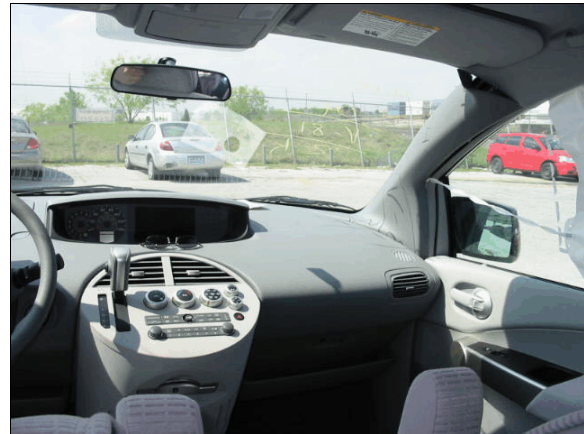
The driver's air bag was located in the steering wheel hub (**Figure 9**) and the front right passenger's air bag was located in the top of the instrument panel (**Figure 10** below). Neither of these air bags deployed in this crash because the case vehicle's crash sensing algorithm most likely determined that the longitudinal crash pulse would not be severe enough to require their deployment. This observation is supported by the results of the WinSMASH reconstruction that is presented above.

**Figure 10:** Case vehicle's front right seating area, front right passenger air bag located in top of right instrument panel

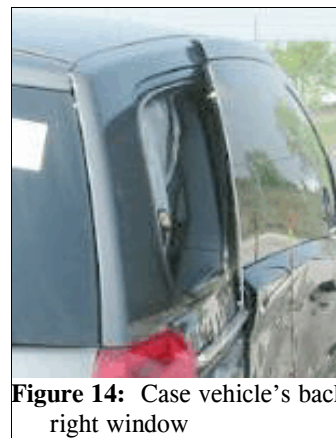
**Figure 14:** Case vehicle's back right window
