**GENERAL DYNAMICS ON-SITE ADVANCED 208-COMPLIANT VEHICLE  
INVESTIGATION  
SCI TECHNICAL SUMMARY REPORT**

**CASE NO. CA04-009**

**VEHICLE – 2004 CADILLAC ESCALADE**

**CRASH DATE – JANUARY 2004**

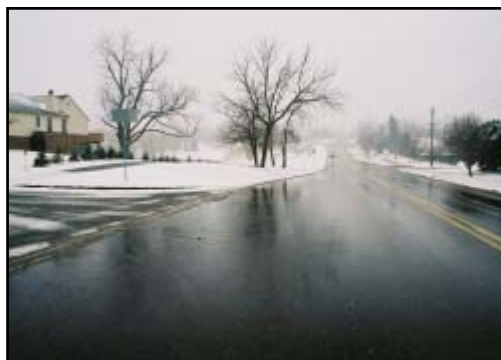
**Figure 2. Northbound approach for the 2004 Cadillac Escalade**

The 67-year-old male driver was operating the 2004 Cadillac Escalade in a northbound direction on the two-lane roadway. He stated that he was listening to a book-on-tape prior to the crash. As the Escalade approached the 3-leg intersection, the driver fell asleep and relinquished control of the vehicle. The Escalade drifted left across the centerline, traversed the southbound lane, and traversed the mouth of the T-intersection (**Figure 2**). It traveled over the reduced-height curb at the northwest corner of the intersection and onto the sloped west roadside. The Escalade continued in a tracking mode on the roadside toward the trees. The EDR-recorded pre-crash vehicle speed five seconds prior to the Algorithm Enable (AE) was 66 km/h (41 mph) and the EDR-recorded pre-crash vehicle speed one second prior to AE was 69 km/h (43 mph). There were no attempted pre-crash avoidance maneuvers.

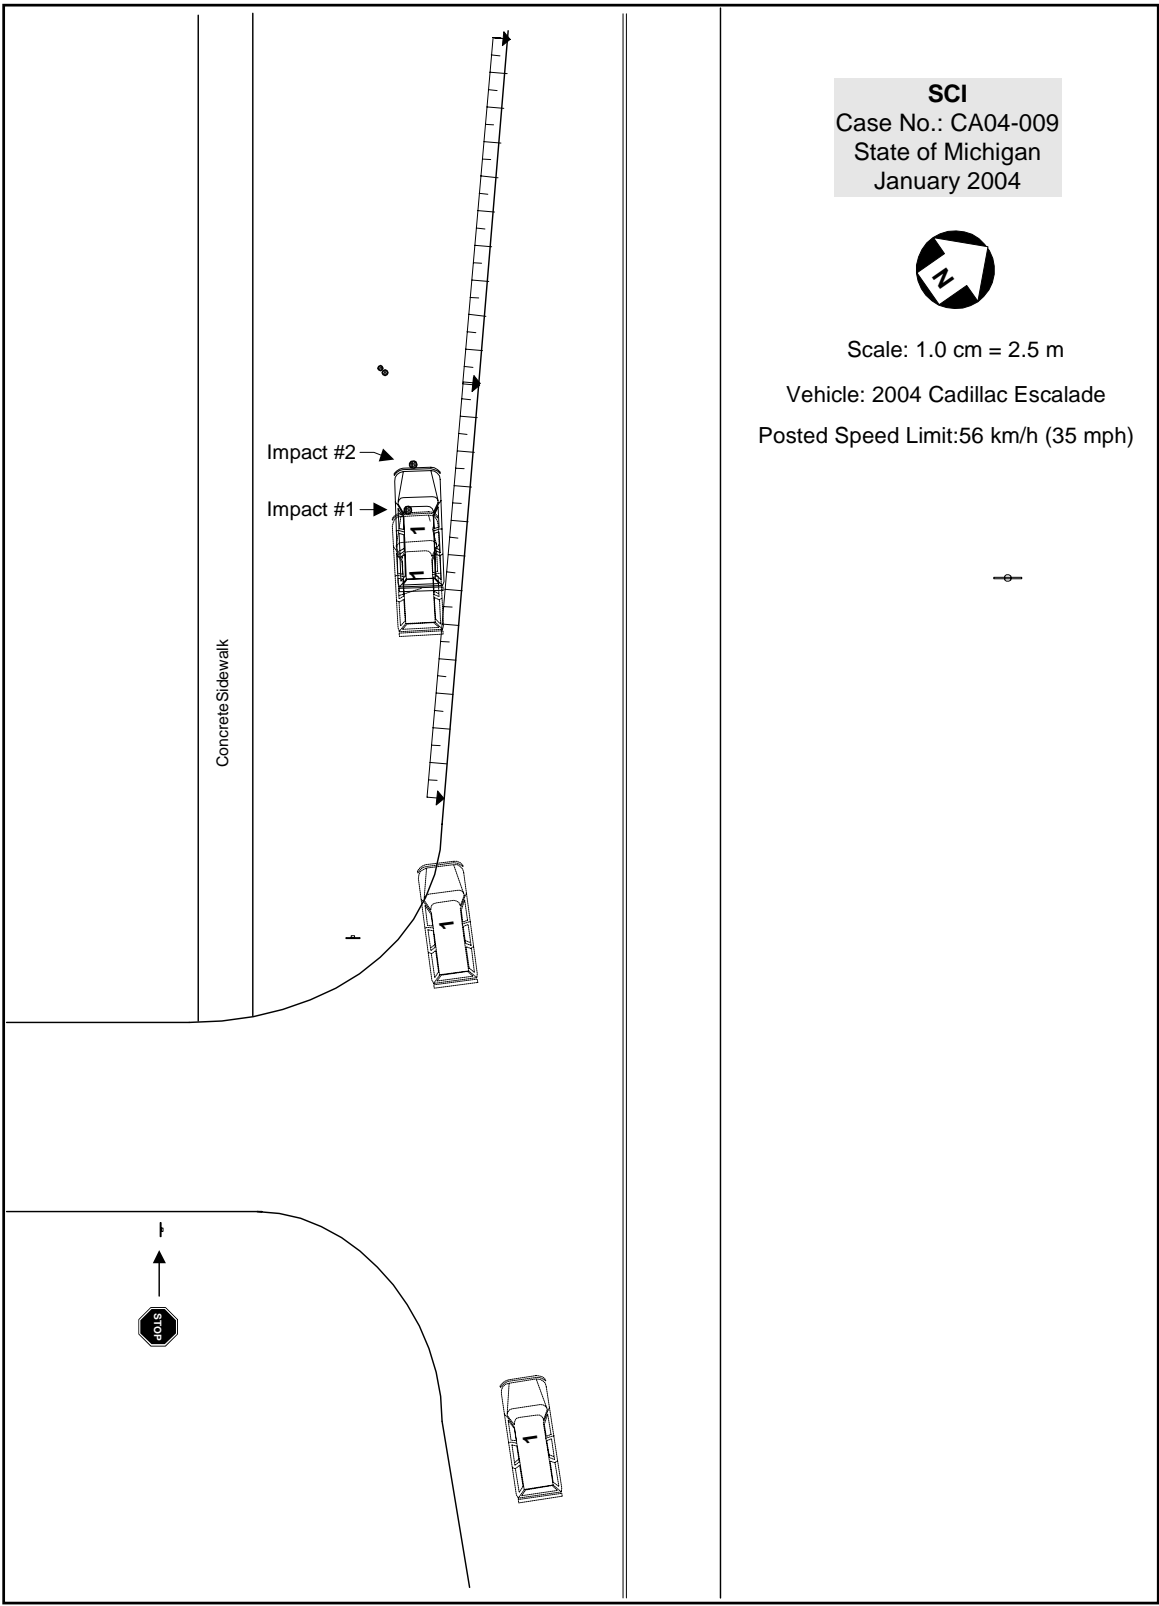
Figure 9: Scene schematic

shallow concrete drainage channels with receivers. The drainage channels measured 0.9 m (3.0') in width. The roadway was straight and exhibited a slight negative northbound grade. The west side of the roadway gradually widened an additional distance of 3.9 m (12.8') at the mouth of the intersection, to accommodate traffic entering and exiting the east/west roadway. The east/west roadway was configured with two lanes and bordered by concrete curbs that extended around the corners of the mouth of the intersection and gradually terminated at the north/south road edge. The curbs measured 20.0 cm (7.9") in height along the east/west roadway. The west roadside exhibited a positive slope from the roadway that measured 0.7 m (2.3') in elevation over a width of 3.0 m (9.8') from the road edge. A group of trees was present on the top aspect of the sloped roadside. The struck trees were located 2.4 m (7.9') from the road edge and measured 34.0 cm (13.4") in diameter. The first struck tree was located 22.5 m (73.8') north of the northwest corner of the intersection. The second tree was located 2.0 m (6.6') behind the first tree, with respect to the Escalade's trajectory. The posted speed limit for the north/south roadway was 56 km/h (35 mph). The scene schematic is included as **Figure 9** at the end of this report.

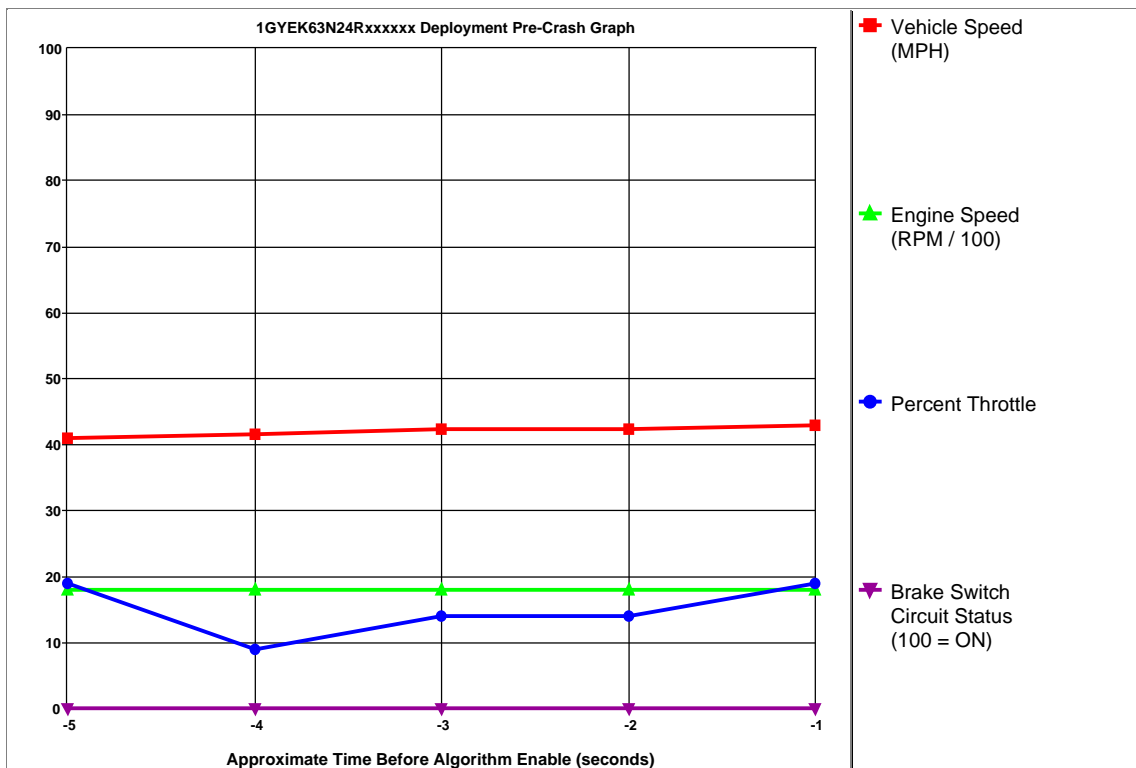
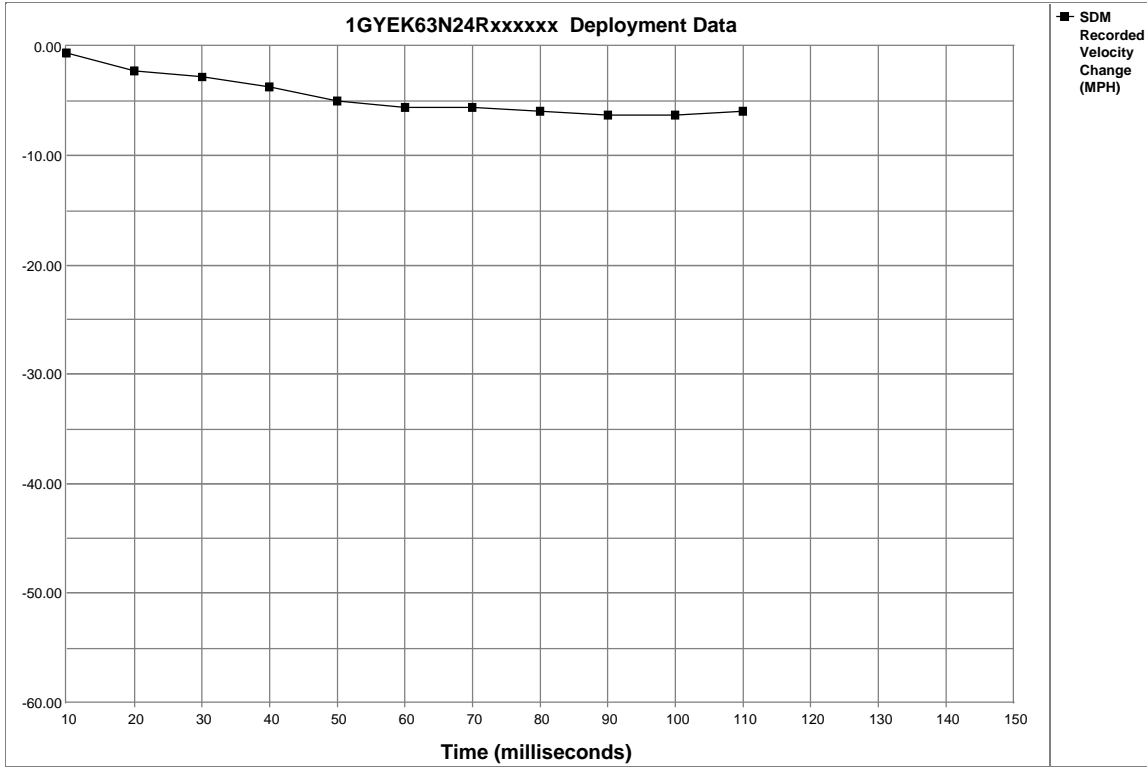
SIR Warning Lamp Status	OFF
Driver's Belt Switch Circuit Status	BUCKLED
Passenger's Belt Switch Circuit Status	UNBUCKLED
Ignition Cycles At Deployment	674
Ignition Cycles At Investigation	677
Maximum SDM Recorded Velocity Change (MPH)	-6.38
Algorithm Enable to Maximum SDM Recorded Velocity Change (msec)	157.5
Driver First Stage Time Algorithm Enabled to Deployment Command Criteria Met (msec)	10
Driver Second Stage Time Algorithm Enabled to Deployment Command Criteria Met (msec)	12.5
Passenger First Stage Time Algorithm Enabled to Deployment Command Criteria Met (msec)	Suppressed
Passenger Second Stage Time Algorithm Enabled to Deployment Command Criteria Met (msec)	Suppressed
Time Between Non-Deployment And Deployment Events (sec)	N/A
Frontal Deployment Level Event Counter	2
Automatic Passenger SIR Suppression System Status	Air Bag Suppressed
Event Recording Complete	Yes
Multiple Events Associated With This Record	No

Seconds Before AE	Vehicle Speed (MPH)	Engine Speed (RPM)	Percent Throttle	Brake Switch Circuit Status
-5	41	1792	19	OFF
-4	42	1792	9	OFF
-3	42	1792	14	OFF
-2	42	1792	14	OFF
-1	43	1792	19	OFF

Time (milliseconds)	10	20	30	40	50	60	70	80	90	100	110	120	130	140	150
Recorded Velocity Change (MPH)	-0.62	-2.17	-2.79	-3.72	-4.96	-5.58	-5.58	-5.89	-6.20	-6.20	-5.89	N/A	N/A	N/A	N/A

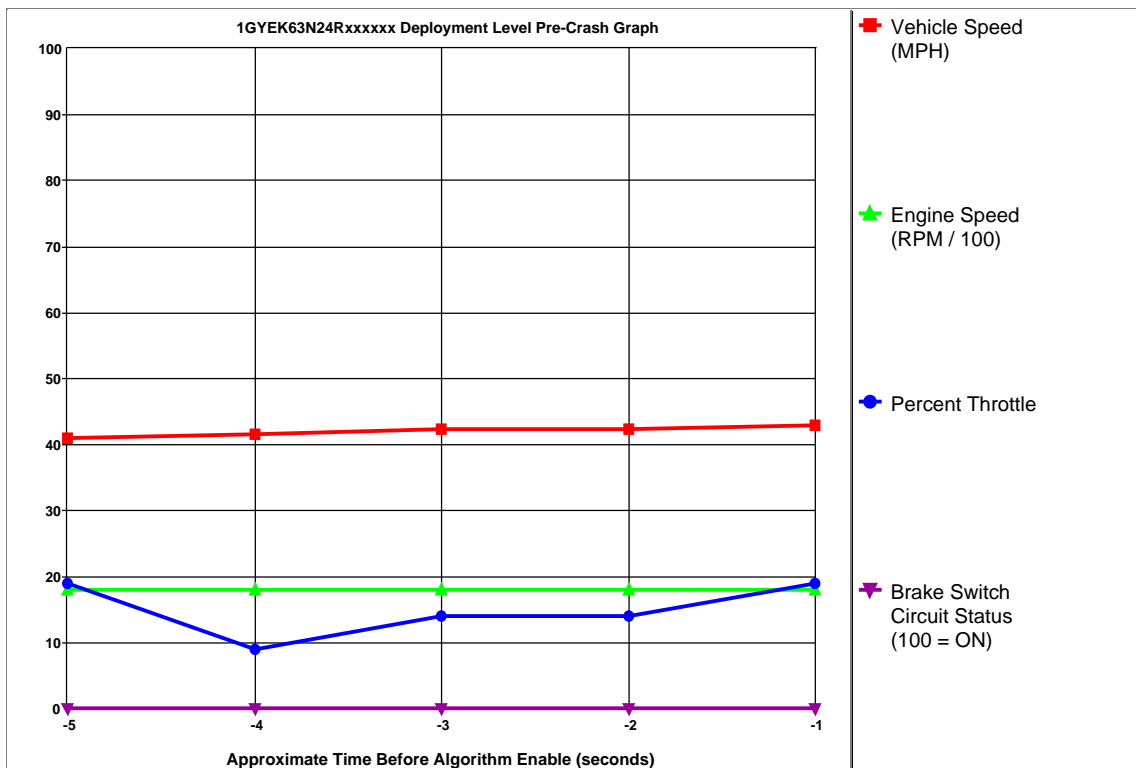
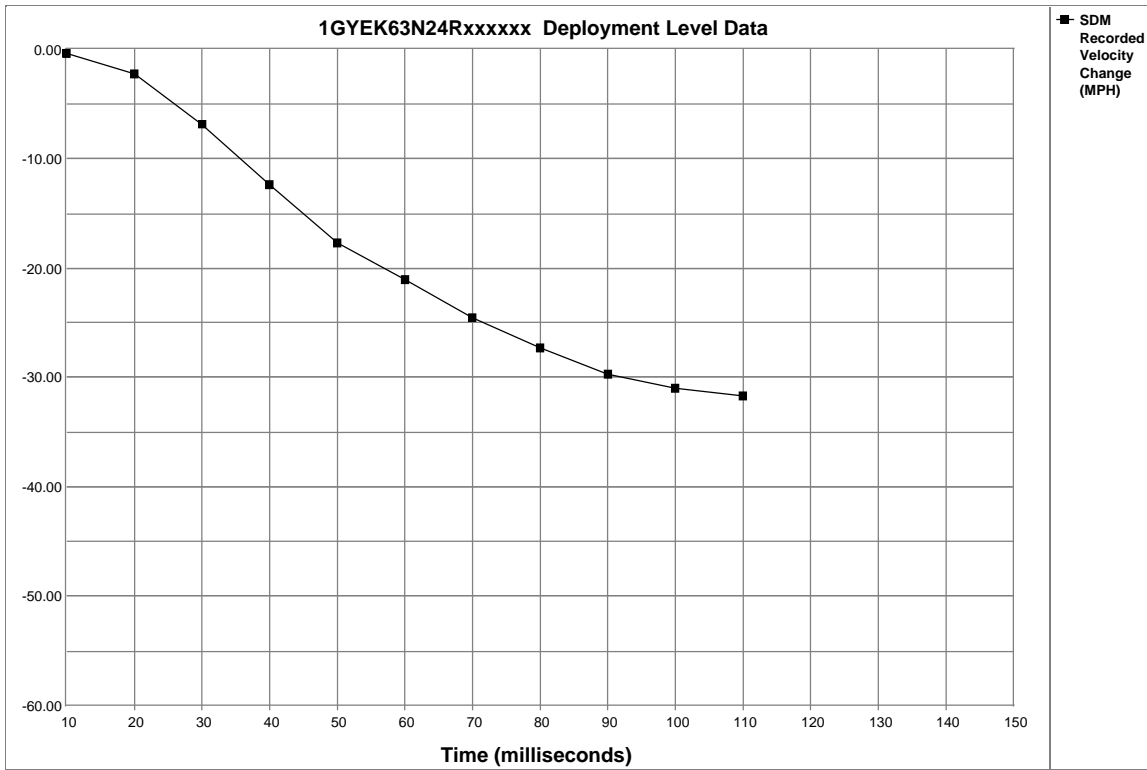
## System Status At Deployment Level

SIR Warning Lamp Status	OFF
Driver's Belt Switch Circuit Status	BUCKLED
Passenger's Belt Switch Circuit Status	UNBUCKLED
Ignition Cycles At Deployment Level	674
Ignition Cycles At Investigation	677
Maximum SDM Recorded Velocity Change (MPH)	-33.25
Algorithm Enable to Maximum SDM Recorded Velocity Change (msec)	137.5
Driver First Stage Time Algorithm Enabled to Deployment Command Criteria Met (msec)	12.5
Driver Second Stage Time Algorithm Enabled to Deployment Command Criteria Met (msec)	N/A
Passenger First Stage Time Algorithm Enabled to Deployment Command Criteria Met (msec)	Suppressed
Passenger Second Stage Time Algorithm Enabled to Deployment Command Criteria Met (msec)	N/A
Frontal Deployment Level Event Counter	2
Automatic Passenger SIR Suppression System Status	Air Bag Suppressed
Time Between Deployment And Deployment Level Events (sec)	.3
Event Recording Complete	Yes
Multiple Events Associated With This Record	Yes

Seconds Before AE	Vehicle Speed (MPH)	Engine Speed (RPM)	Percent Throttle	Brake Switch Circuit Status
-5	41	1792	19	OFF
-4	42	1792	9	OFF
-3	42	1792	14	OFF
-2	42	1792	14	OFF
-1	43	1792	19	OFF

Time (milliseconds)	10	20	30	40	50	60	70	80	90	100	110	120	130	140	150
Recorded Velocity Change (MPH)	-0.31	-2.17	-6.82	-12.40	-17.67	-21.08	-24.49	-27.28	-29.76	-31.00	-31.62	N/A	N/A	N/A	N/A
