# INDIANA UNIVERSITY

## TRANSPORTATION RESEARCH CENTER

## ON-SITE CERTIFIED ADVANCED 208- COMPLIANT VEHICLE INVESTIGATION

CASE NUMBER - IN-04-010  
LOCATION - Texas  
VEHICLE - 2004 TOYOTA CAMRY  
CRASH DATE - March 2004

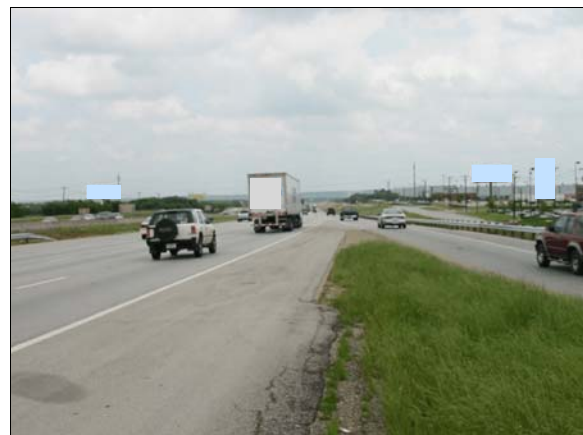
**Crash Environment:** The trafficway on which both vehicles were traveling was a eight-lane, divided, Interstate highway, traversing in an east-west direction and curving gently to the left for eastbound traffic (**Figure 1**). Both the eastbound and westbound roadways had four through lanes and paved shoulders. In addition, the eastbound roadway had an entrance ramp while the westbound roadway had an exit ramp. The trafficway was divided by a grass median, and there was a concrete median barrier along the inside shoulder of the westbound traffic way. Each travel lane was approximately 3.7 meters (12 feet) wide and the speed limit was 105 km.p.h. (65 m.p.h.). Roadway marking consisted of broken white lane lines, solid white edge lines and solid yellow median edge lines. At the time of the crash the light condition was daylight, the atmospheric condition was raining, and the roadway pavement was wet bituminous with a slight negative grade for eastbound traffic. Traffic density was moderate and the site of the crash was primarily urban commercial. See the Crash Diagram at the end of this report.

**Figure 1:** Easterly view from gore of entrance ramp and through lanes showing overview of crash scene, exact location of impact was not determined

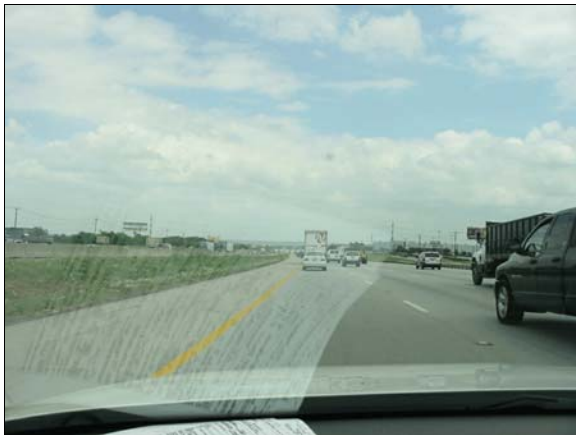
**Pre-Crash:** The case vehicle was traveling east in the inside through lane (**Figure 2**) at a driver estimated speed of 97 km.p.h. to 105 km.p.h. (60 to 65 m.p.h.), and the driver was intending to continue straight ahead. The Ford was traveling east in the eastbound entrance ramp (**Figure 3** below), and the driver was intending to merge into the outside through lane. The Ford began to rotate counterclockwise on the rain slick roadway just prior to entering the highway. It continued to rotate and traveled diagonally across all four eastbound lanes of traffic. It is unknown if the case vehicle's driver made any avoidance maneuvers prior to the crash, however it is likely that she applied the brakes. The crash occurred within the interchange area, in the inside through lane of the eastbound roadway.

**Figure 2:** Case vehicle's eastbound travel path in inside through lane approaching crash area

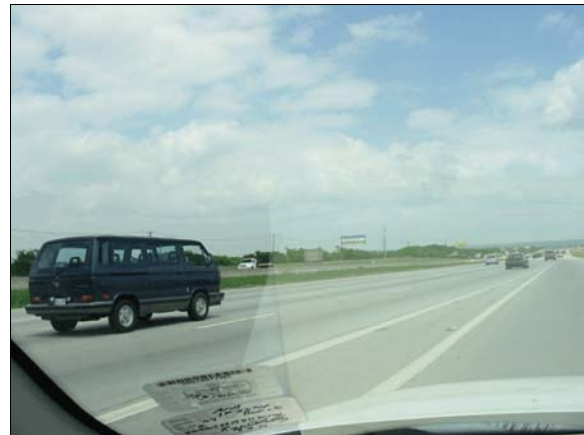
**Figure 3:** Overview of Ford's travel path from on ramp to crash area
