**GENERAL DYNAMICS ON-SITE SIDE IMPACT INFLATABLE OCCUPANT
PROTECTION INVESTIGATION**

GENERAL DYNAMICS CASE NO: CA04-015

VEHICLE: 2002 GMC YUKON

CRASH DATE: MARCH 2004

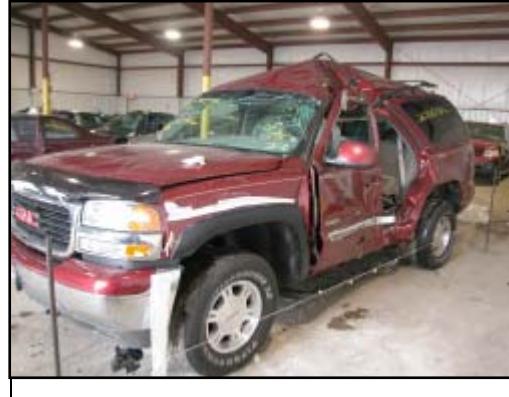
This on-site investigation focused on the performance of the side impact inflatable occupant protection system in a 2002 GMC Yukon (**Figure 1**). The system consisted of seat back mounted side impact air bags for the front seating positions. In addition, the GMC was equipped with redesigned frontal air bags that did not deploy and an Event Data Recorder (EDR) that was downloaded (Non-Deployment Event) during this on-site investigative effort. The EDR printout is included as **Attachment A** of this report. The GMC was occupied by an unrestrained 38-year-old female driver. The GMC was involved in a run-off-road collision with a utility pole and brush. As a result of the crash, the left side seat back mounted side impact air bag deployed. The driver sustained moderate severity injuries and was transported to a local hospital where she was hospitalized for one day. The GMC sustained moderate damage and was towed from the crash site.

Figure 1. Subject vehicle 2002 GMC Yukon.

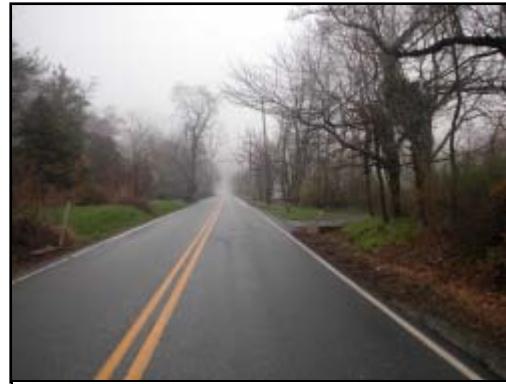
The unrestrained 38-year-old female driver of the GMC was operating the vehicle downhill on the snow covered eastbound lane (**Figure 2**). As the driver continued eastbound, she lost directional control of the vehicle and began a clockwise rotation. The driver stated to the SCI investigator that she lost control on a patch of “black ice” on the snow-covered road. The GMC departed the south roadside and began to travel in a southeast trajectory. An unrelated tire mark was documented on the roadside that measured 1.1 meters (3.6 feet). Based on the EDR Non-Deployment data, the vehicle speed was 70.8 km/h (44.0 mph) five-seconds prior to Algorithm Enable (AE).

Figure 2. GMC's eastbound approach to the crash site.

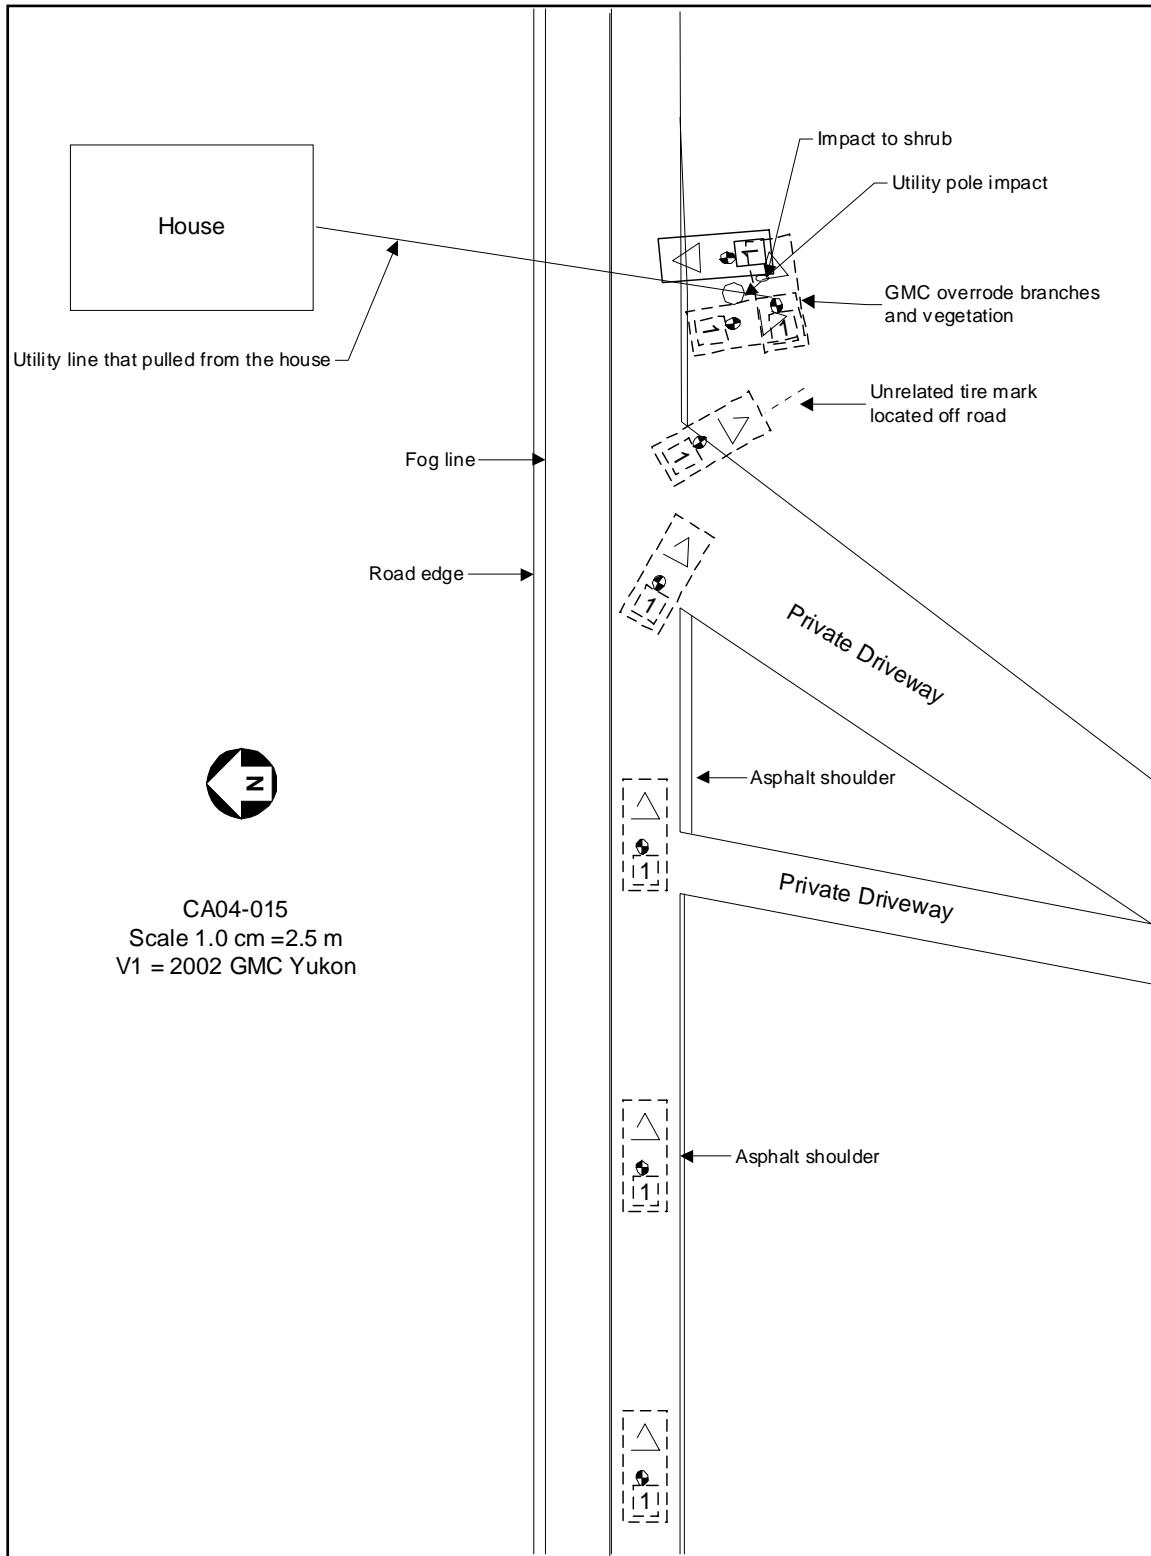
Figure 14. Scene schematic

This run-off-road crash occurred during the morning hours of March 2004. At the time of the crash, snow was falling and the asphalt road surface was snow covered. The crash occurred off-road of an east/westbound two-lane, two-way, rural roadway. The east/westbound roadway was delineated by a double-yellow centerline and was bordered by white fog lines. The eastbound lane had a negative grade. The south roadside consisted of a 0.5-meter (1.6 feet) asphalt shoulder, grass, several trees, and a utility that was located 2.4 meters (7.9 feet) south of the road edge. The posted speed limit for the north/south roadway was 72 km/h (45 mph). The scene schematic is included as (**Figure 14**) of this report.
