Child Safety Seat Fatality Investigation / Vehicle to Vehicle
Dynamic Science, Inc. / Case Number: DS04015
2004 Volkswagen Beetle
Oregon
July, 2004

1. Report No. DS04015	2. Government Accession No.	3. Recipient Catalog No.	
4. Title and Subtitle Child Safety Seat Fatality Investigation		5. Report Date April 18, 2005

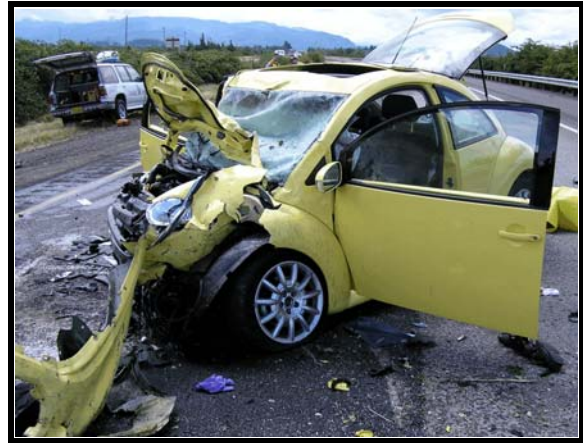
Figure 3. Final rest, Volkswagen Beetle (looking south)

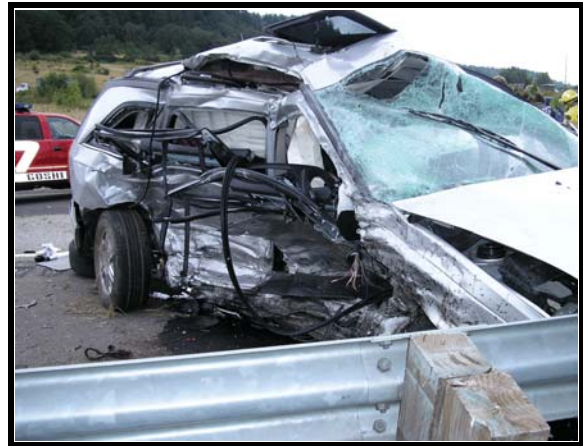
Figure 4. Final rest, Chrysler Pacifica

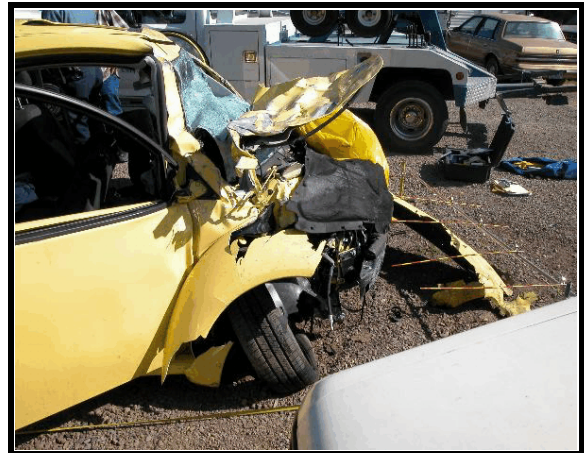
Figure 5. Right side, Volkswagen Beetle

This vehicle sustained 150.0 cm (59.0 in) of direct contact to the front bumper corner from the impact with the right side Chrysler Pacifica. The residual crush measured along the bumper was as follows: C1=26.0 cm (10.2 in), C2=46.0 cm (18.1 in), C3=65.0 cm (25.6 in), C4=73.0 cm (28.7 in). The maximum crush was measured at C1. The principle direction of force was within the 11 o'clock sector and was an estimated 340 degrees. There was end shift to the right. The damaged components included the bumper fascia and reinforcement bar, hood, grille, and radiator. Both wheelbases were shortened; the left by 15.0 cm (5.9), the right by 51.0 cm (20.0 in). The front right door was jammed shut. The windshield was damaged and cracked. The front right window was disintegrated from impact forces.

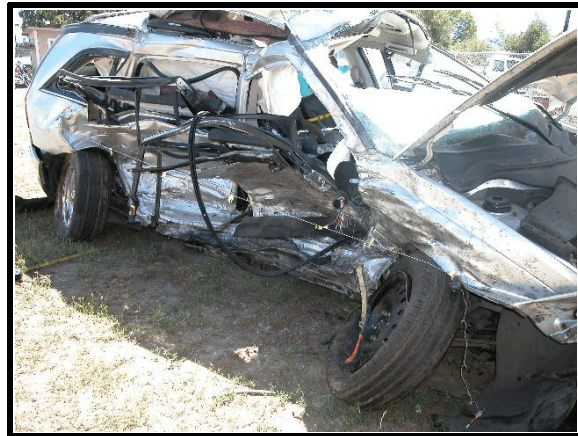
Figure 7. Right side, Chrysler Pacifica

This vehicle sustained 277.0 cm (109.0 in) of direct contact to the right side from the impact with the front of the Volkswagen. The damage began at the right rear axle and extending forward. The residual crush measured at the mid door level was as follows: C1=0 cm (0 in), C2=64.0 cm (25.2 in), C3=78.0 cm (30.7 in), C4=79.0 cm (31.1 in), C5=45.0 cm (17.7 in), C6=0 cm (0 in). The maximum crush was measured at C4. The principle direction of force was within the 2 o'clock sector and was an estimated 70 degrees. All the glazing on the right side was disintegrated from impact forces. Both right side doors were jammed shut. The right side wheelbase was shortened by 45.0 cm (17.7 in). The windshield was damaged and cracked.

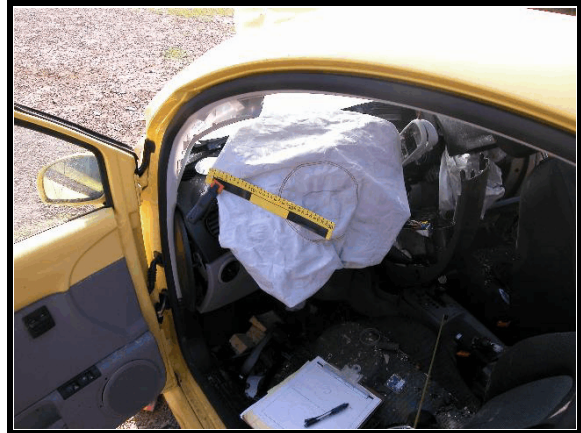
The Volkswagen Beetle was equipped with dual stage frontal air bags for the driver and front right passenger positions that deployed as a result of the frontal impact with the Pacifica. The driver's air bag was housed in the steering wheel hub with an inverted U configuration module cover. The driver's air bag was circular in shape and measured 56.0 cm (22.0 in) in diameter in its deflated state. The air bag was vented by a single, circular vent port at the 12 o'clock position. The air bag was tethered by a single internal strap. The right side of the air bag sustained minor cuts from contact with the windshield. There were no visible contacts or damage to the module cover.

Figure 11. Driver's air bag

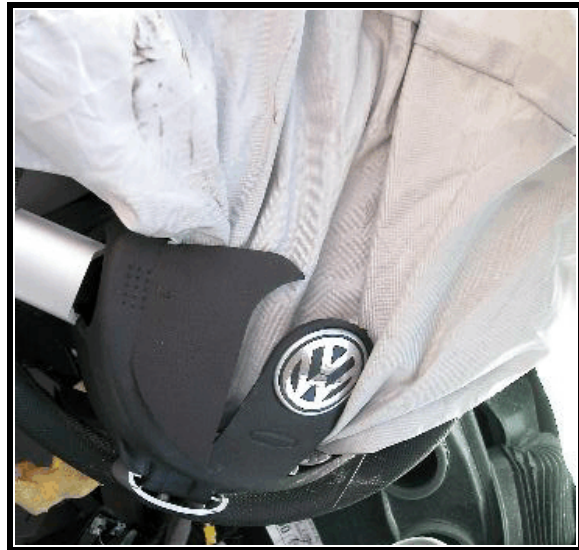
Figure 12. Driver's air bag module cover

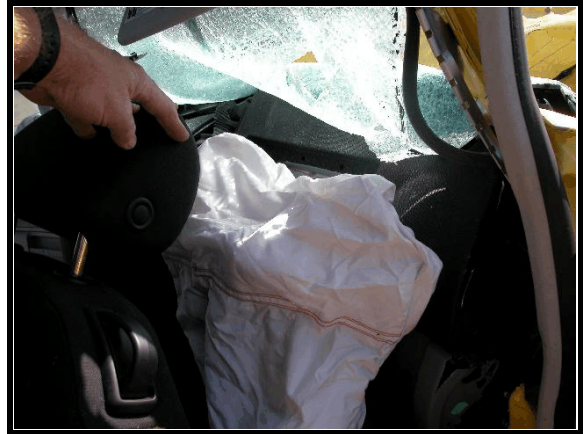
The front right passenger's air bag was housed in the mid instrument panel with a single cover flap. The flap measured 34.0 cm (13.4 in) wide by 17.0 cm (6.7 in) high. The flap is attached at the base of the flap to the instrument panel by a single, horizontal flap that measured 24.0 cm (9.5 in) wide by 13.0 cm (5.1 in) in length. The front right passenger's air bag was vaguely rectangular in shape and measured 58.0 cm (22.8 in) high by 40.0 cm (15.7 in) wide. The bag had a single circular vent port on the right side. There were no tethers. There was no contacts or damage to the air bag or the module cover.

Figure 13. Front right passenger air bag

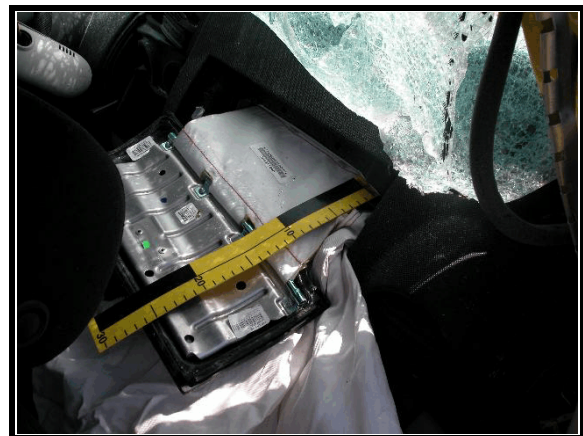
Figure 14. Back side of passenger air bag module cover—showing tether to base of cover

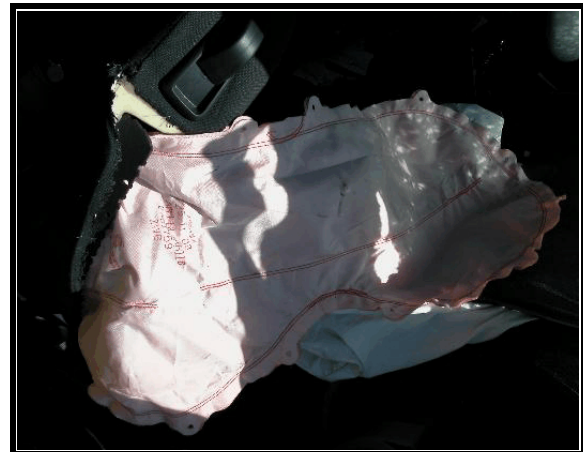
The Beetle was also equipped with seat back mounted side air bags. The front right passenger side air bag deployed during the crash. The air bag has a bow-tie shape. The width was 64.0 cm (25.2 in). The height at both ends was 31.0 cm (12.2 in) and narrows to 24.0 cm (9.5 in) in the middle. There is a single horizontal seam. There were no tethers. There was no contacts or damage to the air bag or the module cover.

Figure 15. Right, seat back mounted side air bag

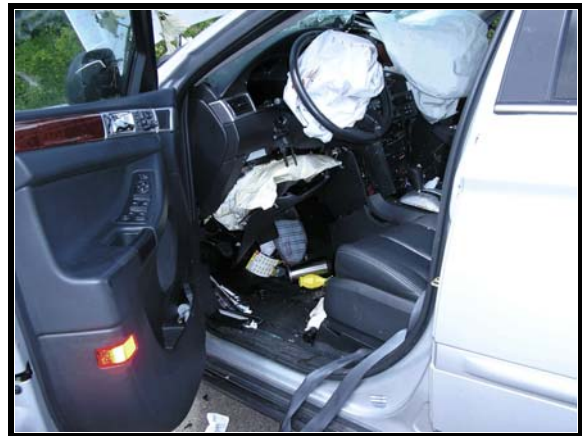
The driver's air bag was housed in the steering wheel hub with a U configuration module cover. The driver's air bag was circular in shape and measured 60.0 cm (23.6 in) in diameter in its deflated state. The air bag was vented by two circular vent ports at the 1 and 11 o'clock positions. There air bag was tethered by a single internal strap. There were no visible contacts or damage to the module cover. There was post-crash blood found on the face of the air bag.

The front right passenger's air bag was housed in the top of the instrument panel. The front right passenger's air bag was rectangular in shape and measured 44.0 cm (17.3 in) wide by 58.0 cm (22.8 in) high in its deflated state. There was a single circular vent port on the right side and no tethers.

Figure 25. Overview of driver air bag, knee air bag, and passenger frontal air bag

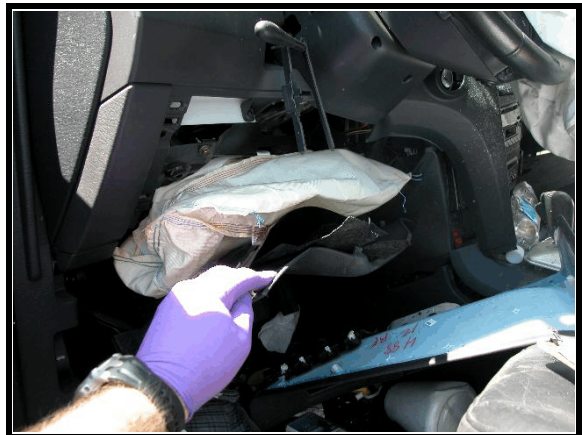
The driver's knee bag was housed in the lower instrument panel with a rectangular module cover. The cover measured 28.0 cm (11.0 in) high by 44.0 cm (17.3 in) wide. The air bag was roughly rectangular in shape and measured 34.0 cm (13.4 in) high by 44.0 cm (17.3 in) wide. There were no visible contacts or damage to the module cover. There was no damage to the air bag.

Figure 26. Close up view of knee air bag

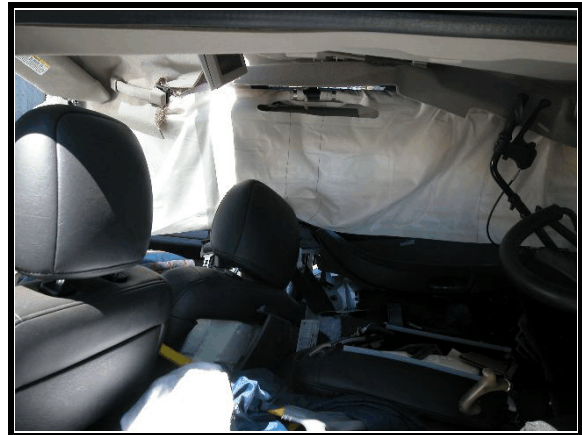
The right side air curtain was housed in the roof rail cladding. It was essentially rectangular in shape. It measured 201.0 cm (79.1in) long by 48.0 cm (18.9 in) high. The curtain covered all three seating positions in the right side. The front bottom of the curtain was tethered to the A pillar, the rear bottom was tethered just rear of the D pillar.

Figure 27. View of air curtain covering front right and second seat right positions

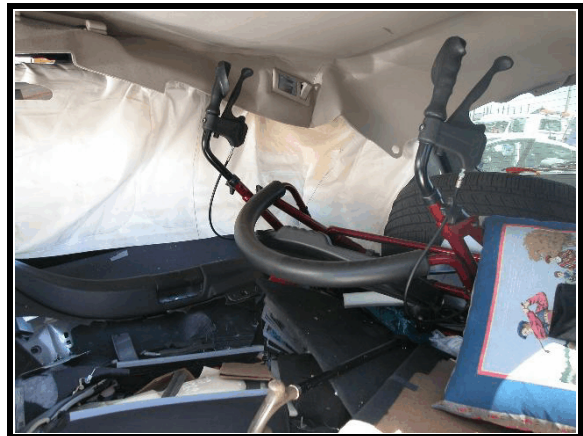
Figure 28. View of air curtain covering third row seat
