**CALSPAN ON-SITE CERTIFIED ADVANCED 208-COMPLIANT
VEHICLE CRASH INVESTIGATION**

SCI CASE NO: CA04-017

**VEHICLE: 2004 HONDA ACCORD
LOCATION: NORTH CAROLINA
CRASH DATE: MARCH 2004**

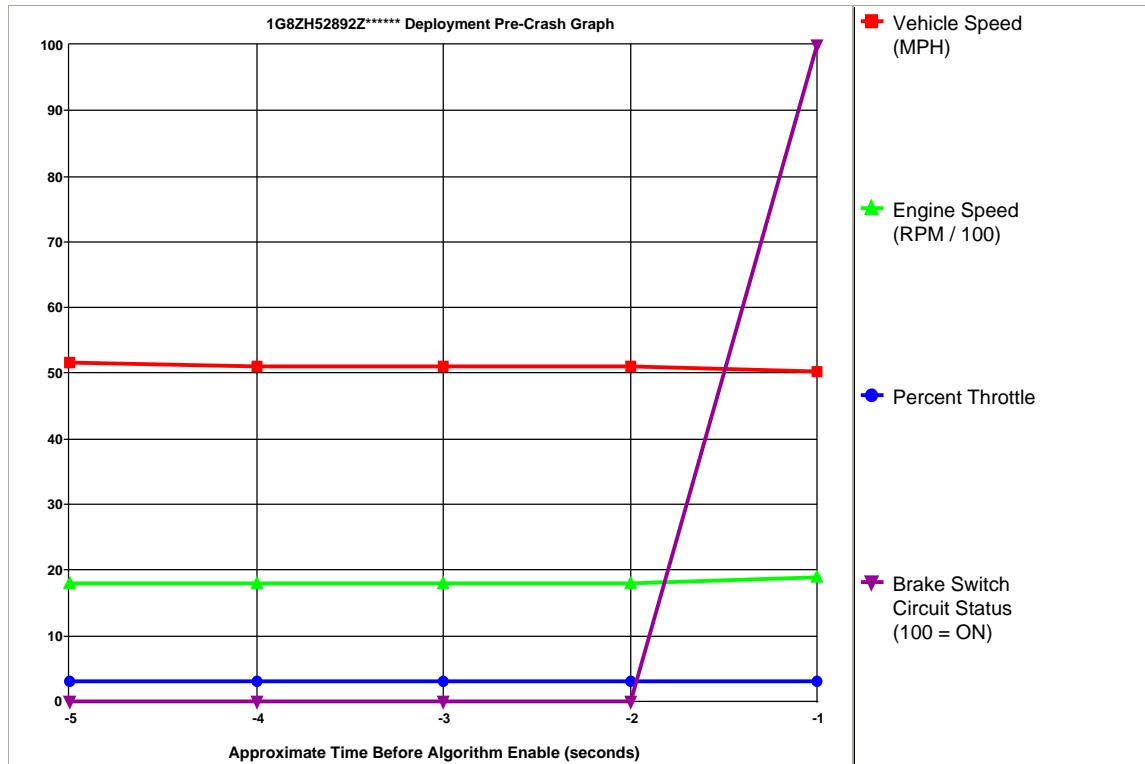
SIR Warning Lamp Status	OFF
Driver's Belt Switch Circuit Status	BUCKLED
Passenger Front Air Bag Suppression Switch Circuit Status	Air Bag Not Suppressed
Ignition Cycles At Deployment	3735
Ignition Cycles At Investigation	3737
Maximum SDM Algorithm Forward Velocity Change (MPH)	-20.54
Algorithm Enable to Maximum SDM Recorded Velocity Change (msec)	110
Time Between Non-Deployment And Deployment Events (sec)	N/A
Time From Algorithm Enable to Deployment Command Criteria Met (msec)	20

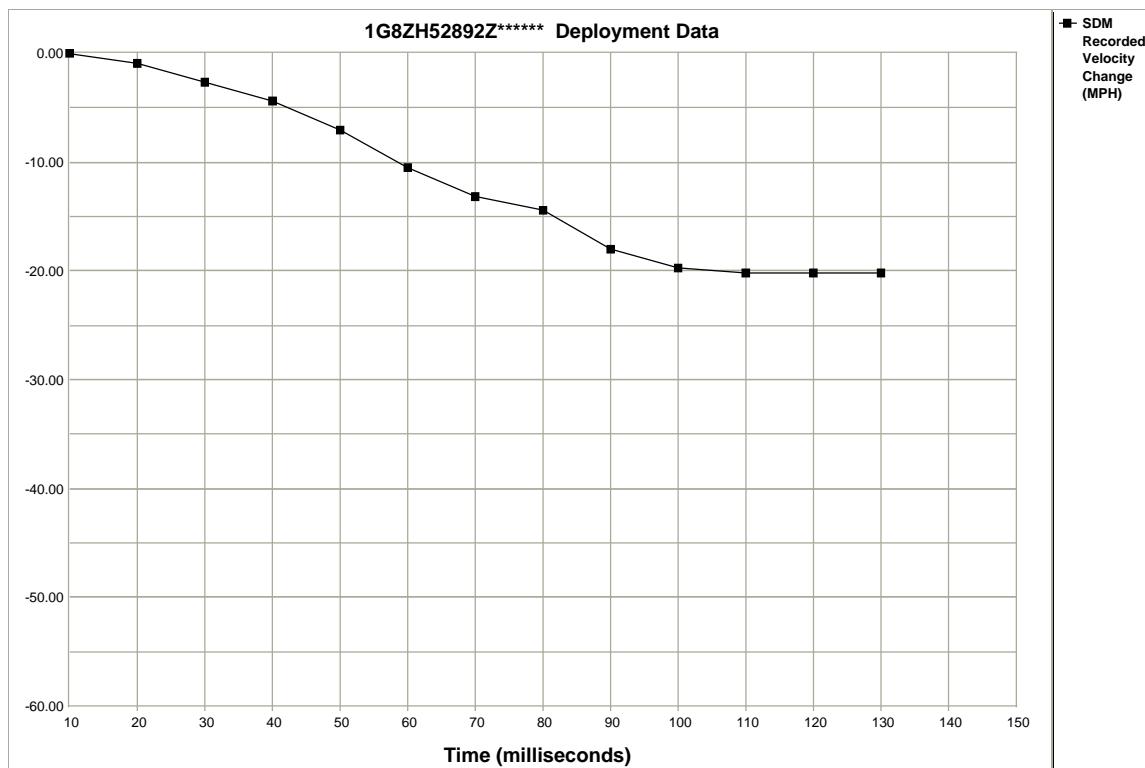
Seconds Before AE	Vehicle Speed (MPH)	Engine Speed (RPM)	Percent Throttle	Brake Switch Circuit Status
-5	52	1792	3	OFF
-4	51	1792	3	OFF
-3	51	1792	3	OFF
-2	51	1792	3	OFF
-1	50	1856	3	ON

Time (milliseconds)	10	20	30	40	50	60	70	80	90	100	110	120	130	140	150
SDM Recorded Velocity Change	0.00	-0.88	-2.63	-4.39	-7.02	-10.53	-13.16	-14.48	-17.99	-19.75	-20.18	-20.18	-20.18	N/A	N/A
