On scene Investigation / Vehicle to Vehicle
Dynamic Science, Inc. / Case Number: DS04018
1996 Dodge Grand Caravan
California
May, 2004

1. Report No. DS04018	2. Government Accession No.		3. Recipient Catalog No.	
4. Title and Subtitle On Scene Passenger Air Bag Serious Injury Investigation			5. Report Date March 18, 2005

Description: This on-scene investigation focused on the performance of the front right passenger air bag in a 1996 Dodge Grand Caravan and its interaction with a 9-year-old male seated in the front right seating position. This was a four-vehicle chain reaction type crash with this vehicle being involved in the first impact. At impact, the front right passenger bag deployed and came into contact with the front right occupant's face. He sustained a concussive head injury with loss of consciousness, a small left subdural hematoma, and a right ethmoid sinus fracture. He was transported by air ambulance to an area children's trauma center where he arrived with a Glasgow Coma Scale (GCS) score of 5 and was hospitalized for a total of 62 days.

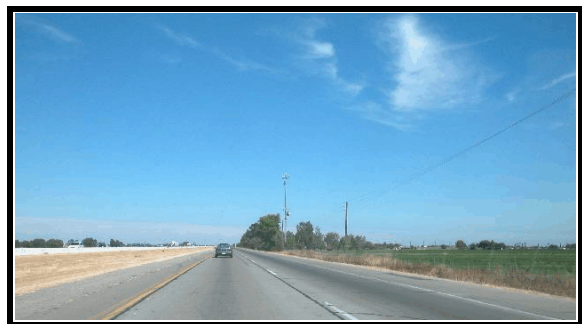
Figure 1. Path of travel (east)

This four vehicle, chain reaction crash occurred in northern California in May, 2004 at 1420 hours. The crash occurred in the eastbound lanes of a four-lane divided interstate roadway. The roadway consists of two eastbound and two westbound travel lanes separated by a 18 m (58 ft) median. Parallel to the westbound travel lanes is a concrete barrier. The weather was clear and dry. The asphalt roadway was straight and level. Traffic was heavy at the time of the crash. The speed limit is 105 km/h (65 mph).

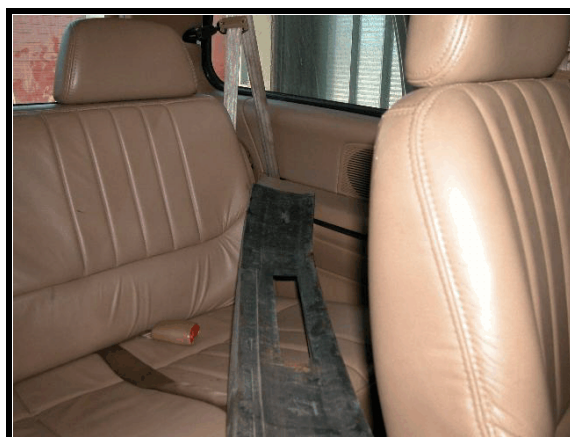
Figure 16. Third row left seating position

The 4-year-old male third row left seat occupant was seated in a normal, upright fashion in the leather covered bench seat. He was wearing the available 3-point manual lap and shoulder belt. Prior to impact, the driver began braking. This occupant pitched forward and likely began to load the shoulder harness. At impact, this occupant loaded the lap and shoulder belt. He was held in place by the belt system and did not sustain any injuries.
