**CALSPAN ON-SITE CERTIFIED ADVANCED 208-COMPLIANT  
VEHICLE CRASH INVESTIGATION**

**CASE NO: CA04-018**

**VEHICLE: 2003 ACURA MDX**

**CRASH DATE: MARCH 2004**

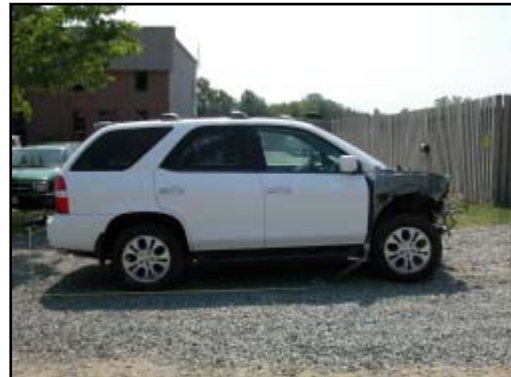
This on-site investigation focused on the performance of the Certified Advanced 208-Compliant (CAC) safety system in a 2003 Acura MDX (**Figure 1**). The manufacturer of this vehicle has certified that this 2003 Acura MDX meets the advanced air bag requirements of the Federal Motor Vehicle Safety Standard (FMVSS) No. 208. The safety system included dual stage frontal air bags, seat track position sensors, safety belt retractor pretensioners and an occupant detection sensor for the front right seat. In addition, the Acura was equipped with seatback-mounted side impact air bags for the front seating positions. The Acura also

**Figure 1. Subject 2003 Acura MDX.**

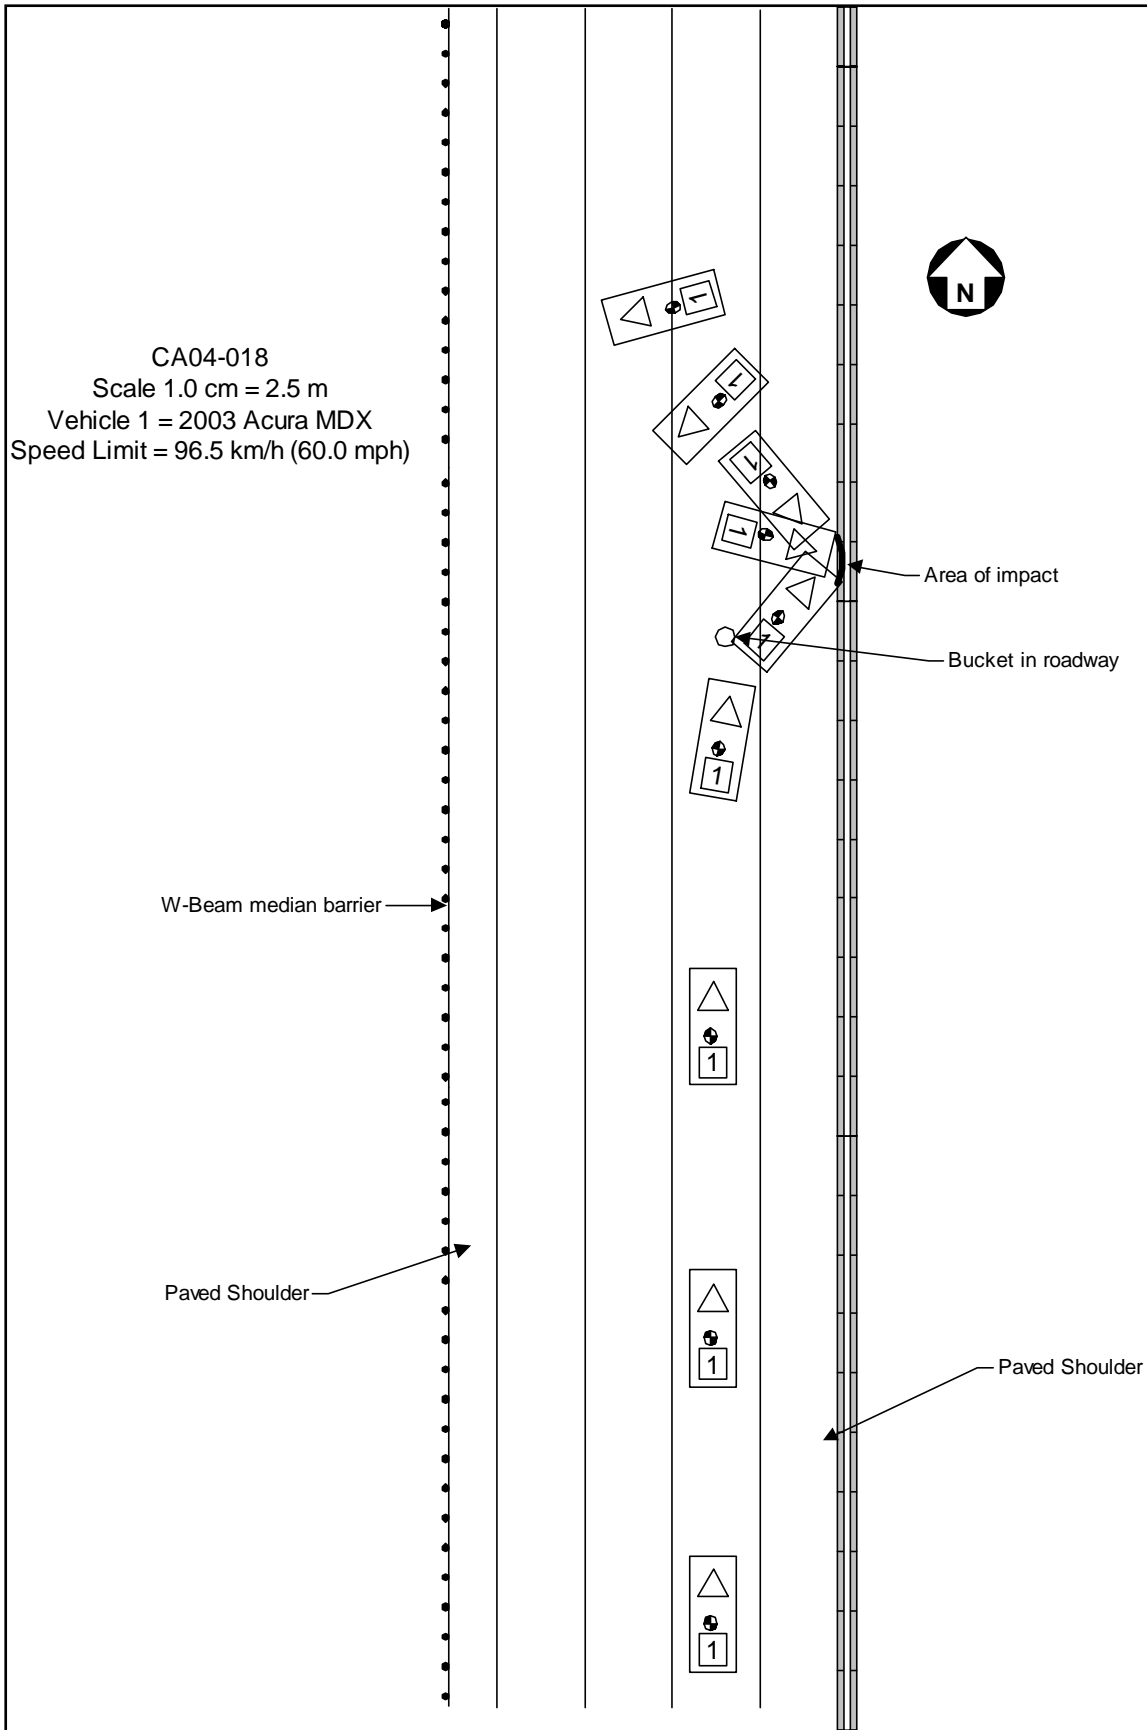
Figure 10. Scene schematic

This single vehicle crash occurred during the morning hours of March 2004. At the time of the crash, the weather was clear with no adverse conditions. The crash occurred on the outboard shoulder of a three-lane northbound interstate roadway. The northbound travel lanes were surfaced with worn asphalt and were separated from the opposing lanes by a W-beam median barrier. The west roadside consisted of an asphalt shoulder and a concrete Jersey barrier that extended beyond the shoulder. The posted speed limit for northbound traffic was 97 km/h (60 mph). The scene schematic is included as **(Figure 10)** of this report.
