ON-SITE POTENTIAL SAFETY RELATED DEFECT INVESTIGATION

CASE NUMBER - IN-04-022

VEHICLE - 2003 SATURN VUE

CRASH DATE - April 2004

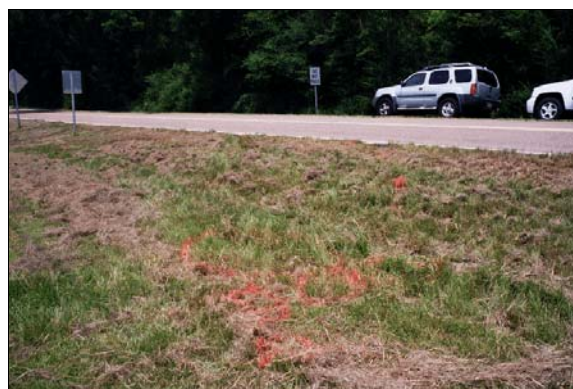
Post-Crash: The case vehicle came to rest on its wheels on the south side of the roadway facing northwest (**Figure 14**). The driver stated she exited the case vehicle under her own power through the driver's door. The witness stated she went to the case vehicle immediately after the crash and found the case vehicle driver out of the vehicle looking for her cat.

Figure 14: View back to roadway from area of case vehicle's final rest

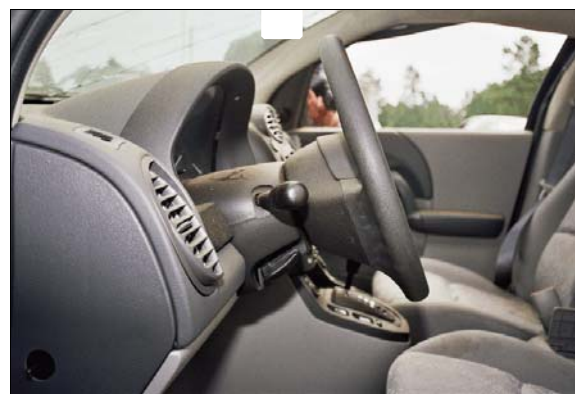
Vehicle Interior: Inspection of the case vehicle’s interior revealed no evidence of occupant contact to any interior surfaces or components. Numerous passenger compartment intrusions were observed and documented involving primarily the front right and back right seat positions. The most severe intrusions into these seat areas involved vertical intrusion of the roof of approximately 19 centimeters (7.5 inches), and approximately 9 centimeters (3.5 inches) of vertical and lateral intrusion of the roof side rail (**Figure 18**). In addition, there was lateral intrusion of the C-pillar and D-pillar of about 4 centimeters (1.6 inches). Lastly, there was no evidence of compression of the energy absorbing steering column, and no deformation of the steering wheel rim was observed (**Figure 19**).

Figure 19: Overview of case vehicle’s steering wheel and steering column

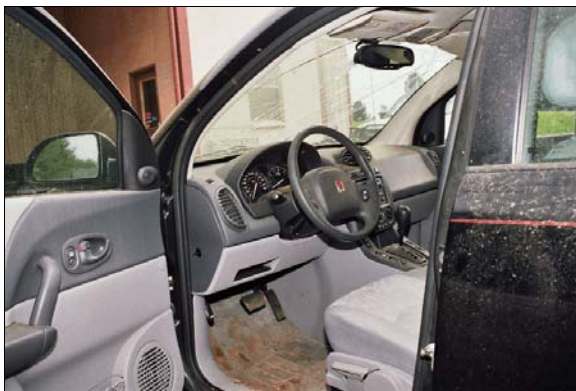
The case vehicle was equipped with de-powered air bags in the driver and front right passenger positions. The driver's air bag was located in the steering wheel hub (**Figure 24**) and the front right passenger's air bag was located in the middle instrument panel above the glove box (**Figure 25**). The driver and front right air bags did not deploy because no frontal impact occurred during the crash sequence.

Figure 24: Overview on steering wheel and instrument panel

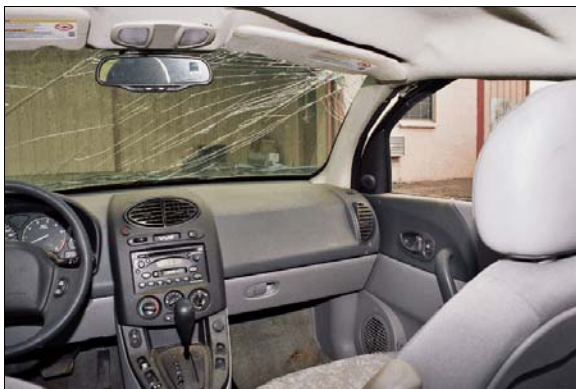
Figure 25: Overview of case vehicle's instrument panel, front right air bag located above glove box door

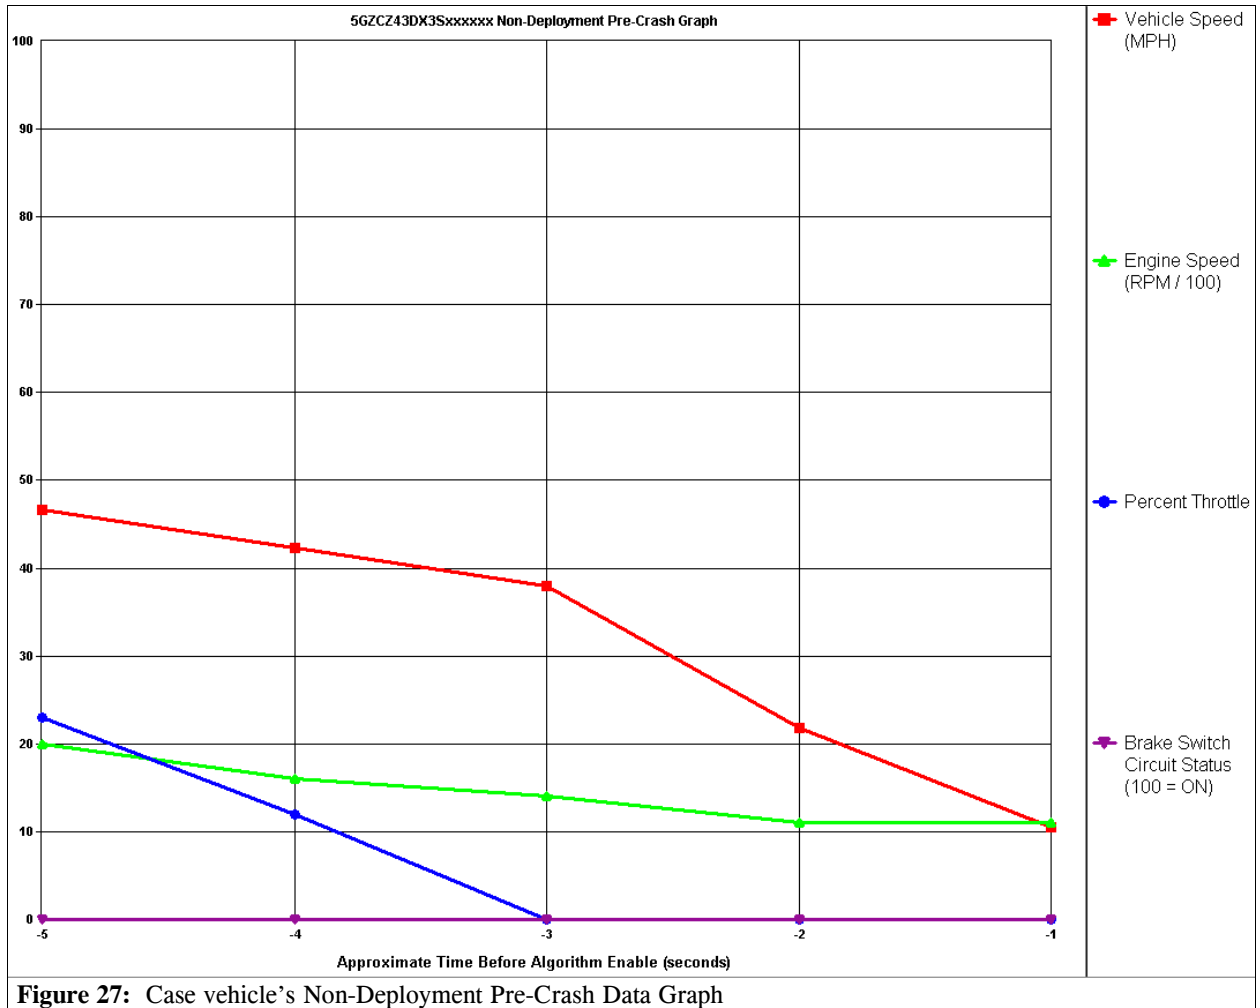
The download of the case vehicle's EDR was done during the vehicle inspection via connection to the case vehicle's diagnostic link connector. The EDR recorded a non-deployment event. The case vehicle's system status report and pre-crash data graph are presented at the end of this report (**Figures 26** and **27**). It is this contractor's opinion that the crash sensing algorithm was activated during the rollover event. It appears the vehicle sustained a longitudinal acceleration just severe enough to wake up the crash sensing algorithm as indicated by the maximum SDM recorded velocity change of 0.00 km.p.h. (0.00 m.p.h) shown on the system status report. The system status report also recorded the

Figure 27: Case vehicle's Non-Deployment Pre-Crash Data Graph
