**GENERAL DYNAMICS ON-SITE CHILD SAFETY SEAT FATALITY
INVESTIGATION
SCI TECHNICAL SUMMARY REPORT**

CASE NO: CA04-022

VEHICLE: 1991 CHEVROLET LUMINA APV

CRASH DATE: NOVEMBER 2003

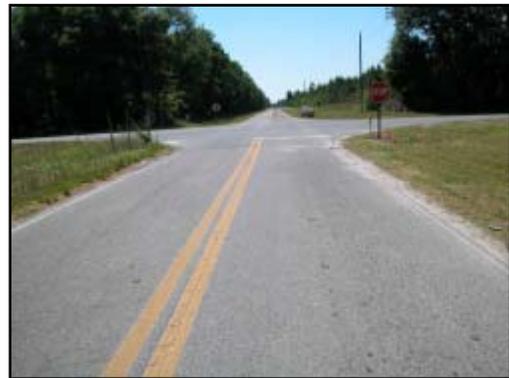
The 53-year-old driver of the Chevrolet Lumina was operating the vehicle westbound on approach to the four-leg intersection (**Figure 2**). Although all of the child occupants were initially restrained in the vehicle, the 7-year-old female seated in the third row right position removed the safety belt prior to the crash. The driver of the Lumina brought the vehicle to a controlled stop at the intersection. According to one of the child occupants, the driver's attention may have been focused on a non-contact vehicle that was stopped on the opposing leg of the intersection waiting to continue in an eastbound direction. The driver was also attempting to find a nearby address, and may have been distracted. The driver of the Toyota Tundra pickup truck was operating the vehicle with the trailer in tow, in a northbound direction on the north/south roadway (**Figure 3**) at a police-reported speed of 72 km/h (45 mph). According to witnesses to the crash, the driver of the Lumina proceeded slowly into the intersection across the path of the oncoming Toyota pickup truck. Her pre-crash speed was unknown, however, the speedometer was fixed at 16 km/h (10 mph) at the time of the vehicle inspection.

Figure 2. Westbound approach for the 1991 Chevrolet Lumina

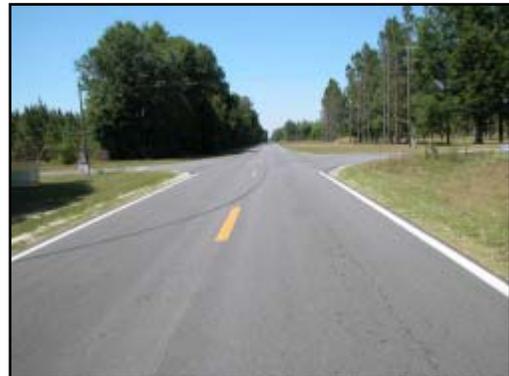
Figure 3. Northbound approach for the 2000 Toyota Tundra

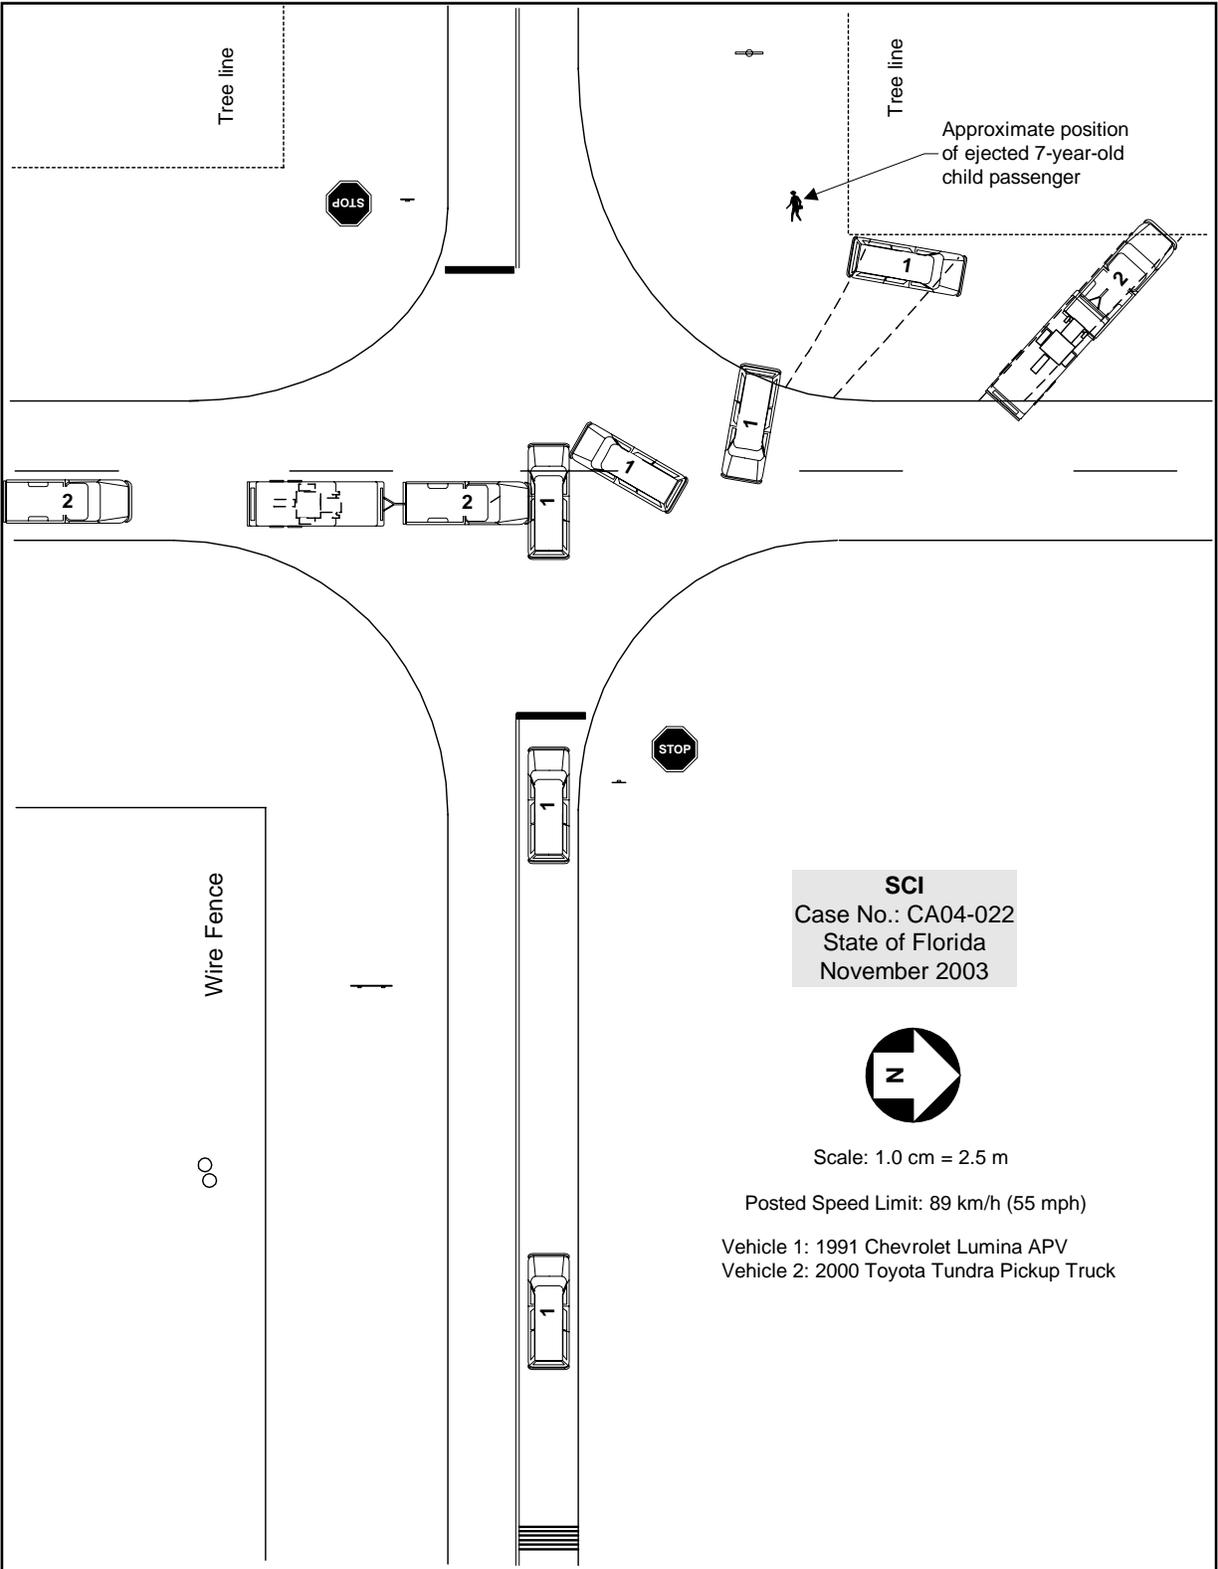
painted stop lines were also present on the road surface, 3 m (10') forward of each stop sign. Three series of raised asphalt rumble strips that were perpendicular to the travel lanes were present on the roadway as advanced warning devices on approach to each stop sign. The roadside environment included fields and wooded areas. The state speed limit for both roadways was 89 km/h (55 mph), although there were no speed limit signs posted on either roadway in the vicinity of the crash site. The scene schematic is included as **Figure 14** of this narrative report.

Figure 14. Scene schematic
