**CALSPAN ON-SITE CERTIFIED ADVANCED 208-COMPLIANT VEHICLE
CRASH INVESTIGATION**

SCI CASE NO. – CA04-025

SUBJECT VEHICLE – 2004 HONDA ACCORD EX

CRASH DATE – APRIL 2004

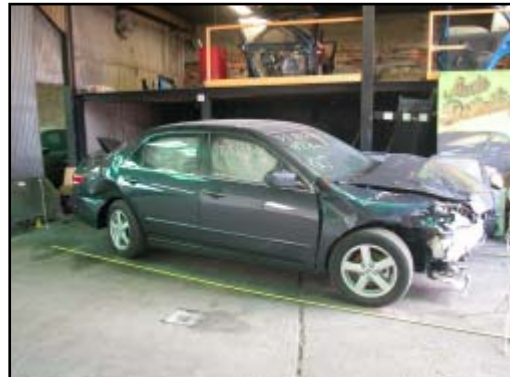
Figure 1. Subject 2004 Honda Accord.

This on-site investigation focused on the performance of the Certified Advanced 208-Compliant (CAC) safety system in a 2004 Honda Accord EX (**Figure 1**). The manufacturer of this vehicle has certified that this 2004 Honda Accord meets the advanced air bag requirements of the Federal Motor Vehicle Safety Standard (FMVSS) No. 208. The safety system included dual stage frontal air bags, safety belt pretensioners, and an occupant detection sensor for the front right seat. In addition, the Honda was equipped with seatback-mounted side impact air bags for the front seating positions and Inflatable Curtains

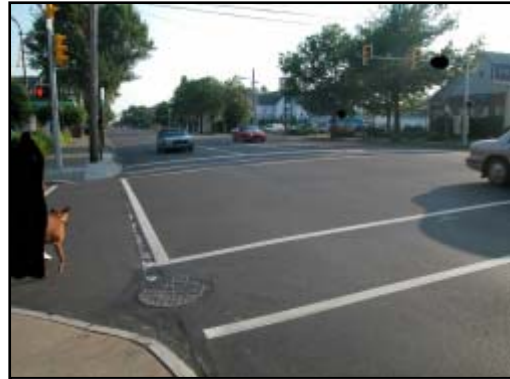
Figure 2. Southwest view of the crash site.

This intersection crash occurred during the daylight hours of April 2004. At the time of the crash, the weather was clear with no adverse conditions. The crash occurred at a four-leg intersection of two local roadways (**Figure 2**). The north and south legs of the intersection were configured with two through traffic lanes and a center left turn lane. The travel lanes of the north/south legs were separated by double yellow centerlines. The east leg of the intersection was configured with one through/left-turn lane and a right turn only lane and was separated by double yellow centerlines. The west leg was configured with one lane in

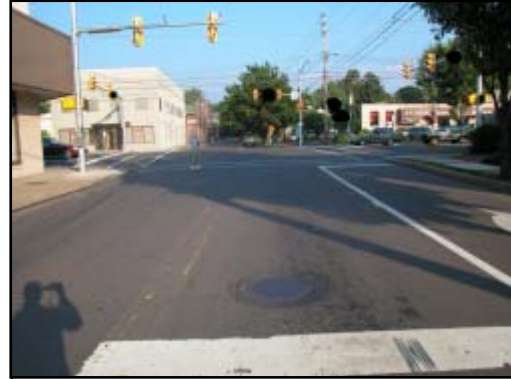
Figure 3. Eastbound approach to the intersection from the path of the 2004 Honda Accord.

The restrained 39-year-old female driver of the 2004 Honda Accord was operating the vehicle eastbound on the three-lane roadway approaching the intersection (**Figure 3**). A 34-year-old male driver was operating the 1999 Dodge Ram northbound on the intersecting roadway. The 1998 Ford F-150 was occupied by a 64-year-old male driver that was operating the vehicle southbound on the intersecting roadway. The Ford was stopped at the intersection due to the red traffic signal phase. The driver of the Honda proceeded into the intersection on a green light phase. The driver of the Dodge failed to stop for the red traffic signal and entered the intersection.

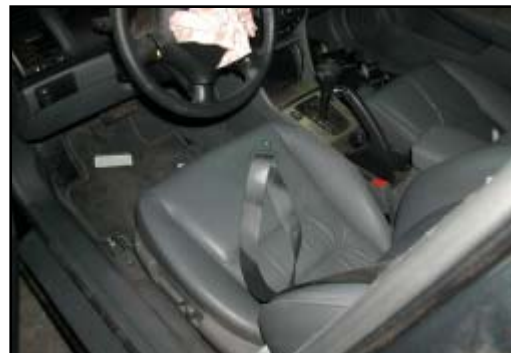
Figure 16. Driver's safety belt.

The 2004 Honda Accord was equipped with continuous loop manual 3-point lap and shoulder safety belts for the five seating positions. The driver safety belt was configured with a sliding latch plate, Emergency Locking Retractor (ELR), height adjustable D-ring, and a retractor pretensioner (**Figure 16**). The driver utilized her safety belt in the crash; however, no crash related evidence such as stretching or transfers were present on the belt system. Additionally, the safety belt was located in the used position, which was restricted by the fired pretensioner. The front right safety belt was configured with a sliding latch plate, switchable ELR/Automatic Locking Retractor (ALR), height adjustable D-ring, and a retractor pretensioner. The front right seat was not occupied, therefore the pretensioner did not deploy in the subject crash. The rear safety belts were configured with sliding latch plates and switchable ELR/ALR retractors.

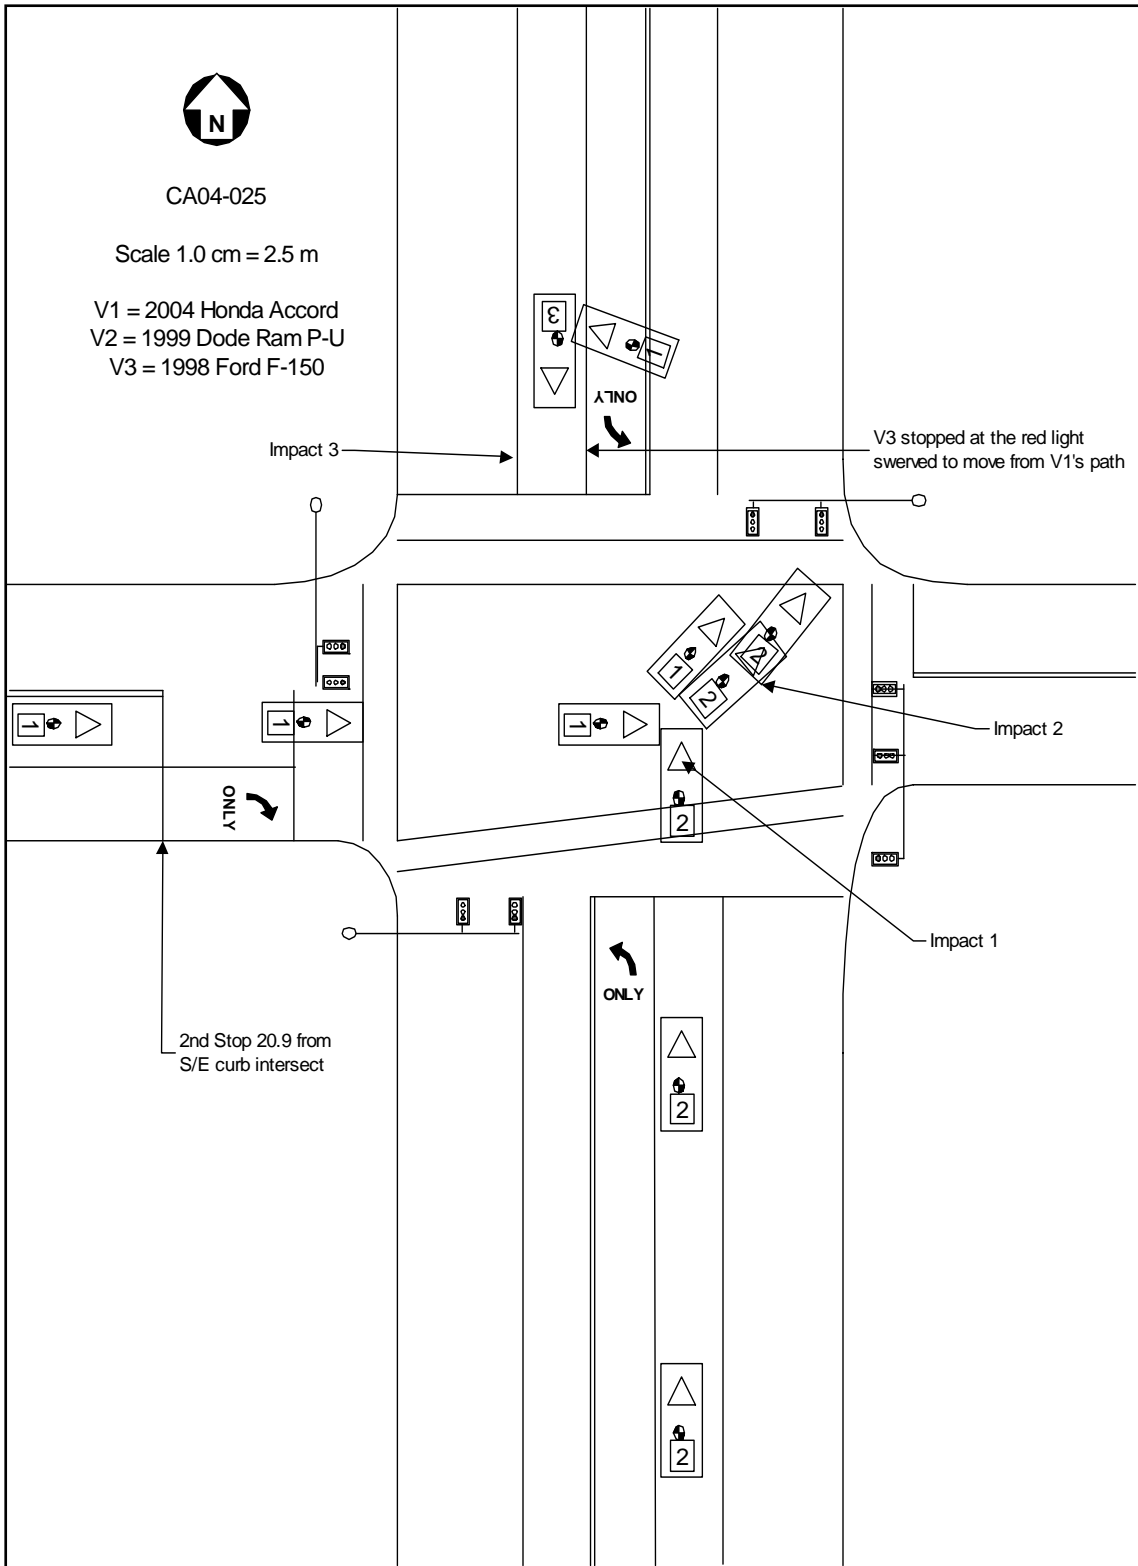
Figure 17. Scene schematic

each direction and was delineated by double yellow centerlines. The roadways were constructed of asphalt and were bordered by concrete barrier curbs. Traffic flow through the intersection was controlled by overhead three-phase traffic signals. There were no speed limits posted in the vicinity of the crash site. The scene schematic is included as (**Figure 17**) of this report.
