ON-SITE POTENTIAL SAFETY-RELATED DEFECT INVESTIGATION

CASE NUMBER - IN-04-025

LOCATION - Missouri

VEHICLE - 2004 SATURN VUE

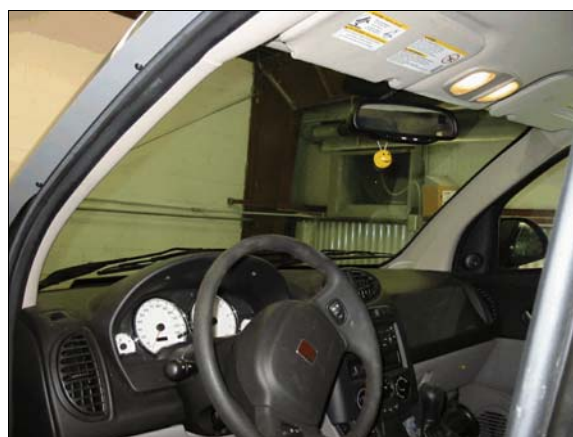
Vehicle Interior: Inspection of the case vehicle's interior revealed occupant contacts on the center console trim, front right roof, glove box door and right front door and window (**Figure 14** and **Figure 15** below). Some of these contacts could have occurred as the occupants were exiting the vehicle. There was an obvious shoe print on the right roof side rail that apparently occurred as the occupants were climbing out of the vehicle. There were no intrusions of the passenger compartment and no evidence of compression to the energy absorbing steering column or deformation of the steering wheel rim was observed (**Figure 16** below).

Figure 14: Overview of windshield, steering wheel and instrument panel

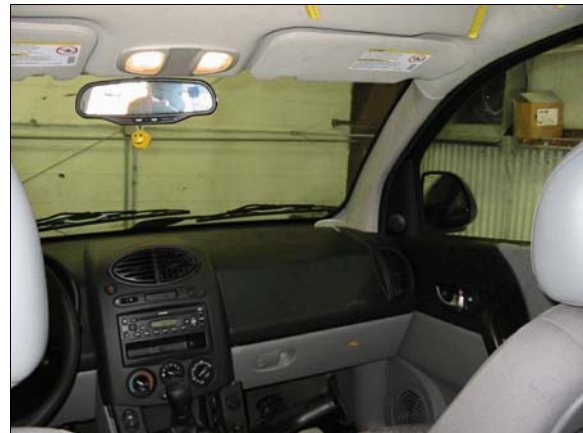
The case vehicle was equipped with dual stage air bags at the driver and front right passenger positions. The case vehicle’s driver air bag was located in the steering wheel hub and the front right passenger air bag was located in the middle instrument panel above the glove box door (Figure 20). Neither of these air bags deployed during the crash. The evidence and the EDR data indicate that the frontal impact was not severe enough to require their deployment.

Figure 20: Front right air bag located in middle of instrument panel above glove box door
