ON-SITE CERTIFIED ADVANCED 208- COMPLIANT VEHICLE INVESTIGATION

CASE NUMBER - IN-04-027

VEHICLE - 2004 CHEVROLET AVALANCHE

CRASH DATE - June 2004

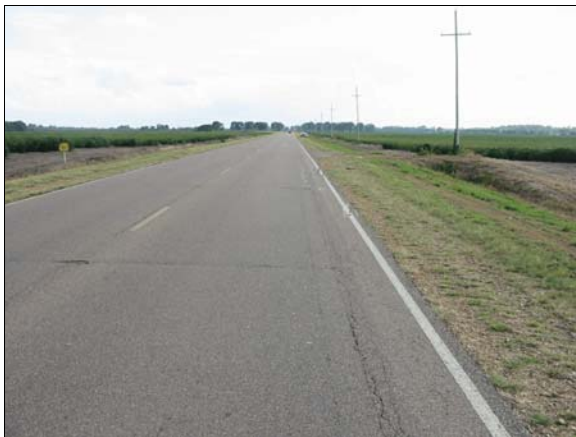
Pre-Crash: The case vehicle was traveling southwest in the southwest travel lane, and the driver was intending to proceed straight ahead (**Figure 1**). The EDR data indicated the case vehicle was traveling 98 km.p.h. (61 m.p.h.) approximately 1 second prior to the crash. The Chevrolet Silverado was in front of the case vehicle in the same lane traveling in the same direction at a police estimated speed of 48 km.p.h. (30 m.p.h.), and the driver was also intending to proceed straight ahead. Based on the interview with the driver of the Silverado and supporting evidence by the damage offset on the front of the case vehicle, the case vehicle's driver steered left just prior to the crash. The EDR data for the deployment event indicated the case vehicle's driver did not apply the brakes prior to the crash. The crash occurred in the southwest travel lane of the roadway.

Figure 1: Approach of case vehicle and Chevrolet Silverado in the southwest travel lane

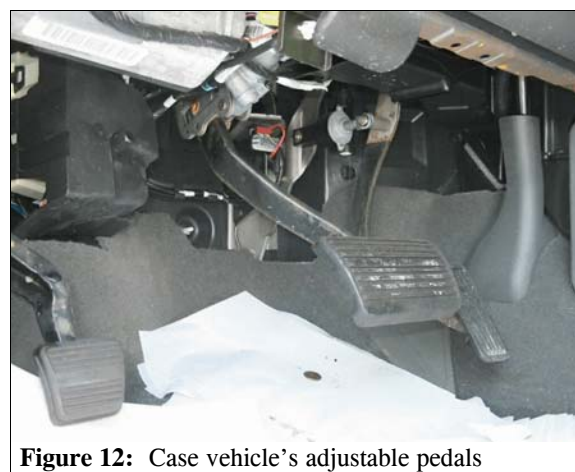
Figure 12: Case vehicle’s adjustable pedals

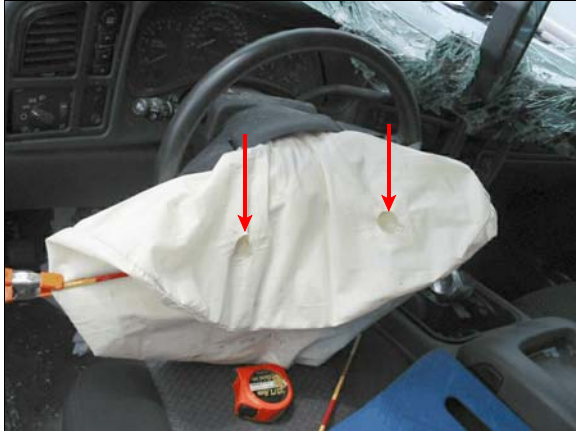
The case vehicle's driver air bag was located in the steering wheel hub. An inspection of the air bag module cover flaps and the air bag fabric revealed that the cover flaps opened at the designated tear points (**Figure 13**). There was no evidence of damage during the deployment to the air bag or the cover flaps. The air bag module cover consisted of symmetrical "I" configuration cover flaps. The two cover flaps were each constructed of pliable vinyl, and each flap was approximately 7 centimeters (2.8 inches) in width at the top and approximately 6.0 centimeters (2.4 inches) in width at the bottom. The vertical tear seam between the two cover flaps was 12 centimeters (4.7 inches) in height. The deployed driver's air bag (**Figure 14**) was round with a diameter of approximately 63 centimeters (24.8 inches) and was designed with two tethers, each approximately 11 centimeters (4.3 inches) in width. The driver's air bag had two vent ports, each approximately 3 centimeters (1.2 inches) in diameter, located at the 10 and 2 o'clock positions (**Figure 15** below). An inspection of the driver's air bag fabric revealed no evidence of occupant contact. The distance between the mid-center of the driver's seat back, as positioned at the time of the inspection (i.e., approximately at the rear track position), and the front surface of the air bag's fabric at full excursion was 34 centimeters (13.4 inches).

Figure 15: Case vehicle's driver air bag vent ports and steering wheel

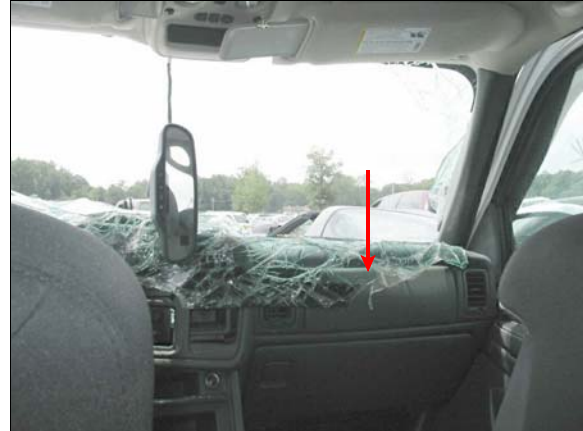
The front right passenger's air bag was located in the middle of the instrument panel above the glove box door (**Figure 16** below). The front right air bag did not deploy during the crash. The case vehicle's occupant detection and automatic air bag suppression system properly determined that no passenger was in the front right seat and suppressed deployment of the front right air bag.

Figure 16: Case vehicle's front right air bag is located in the middle of the instrument panel above the glove box door.

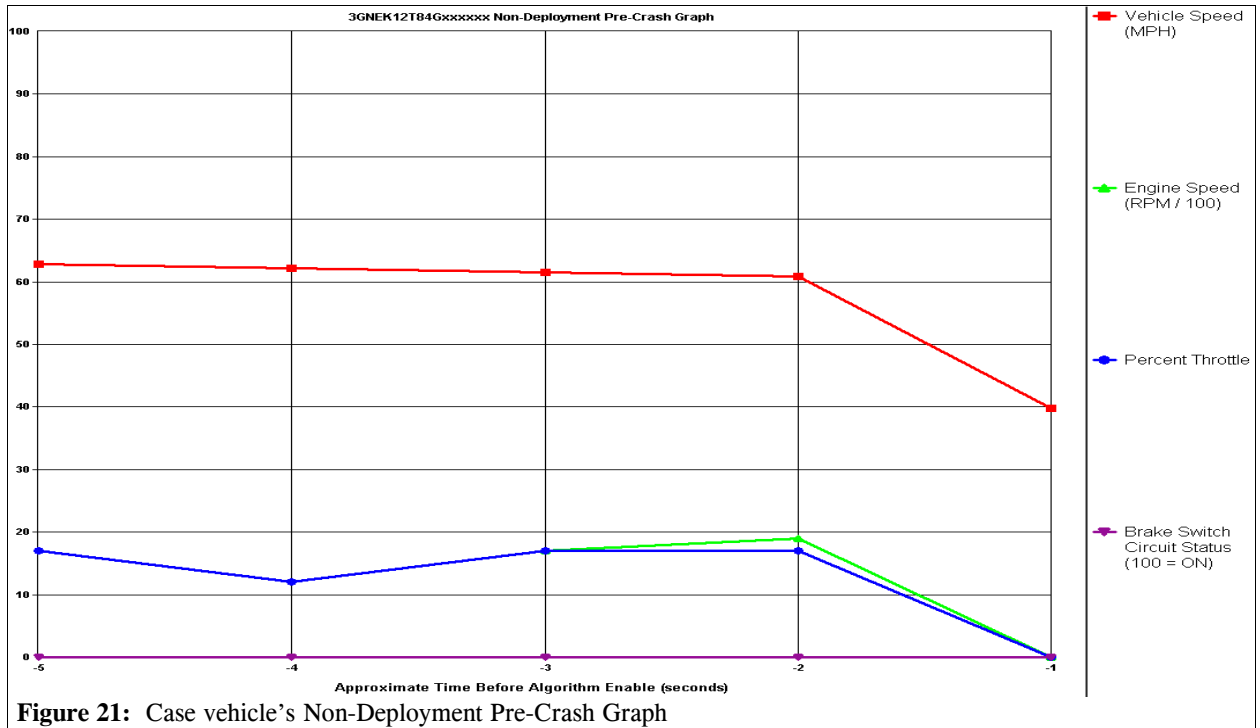
Figure 21: Case vehicle's Non-Deployment Pre-Crash Graph

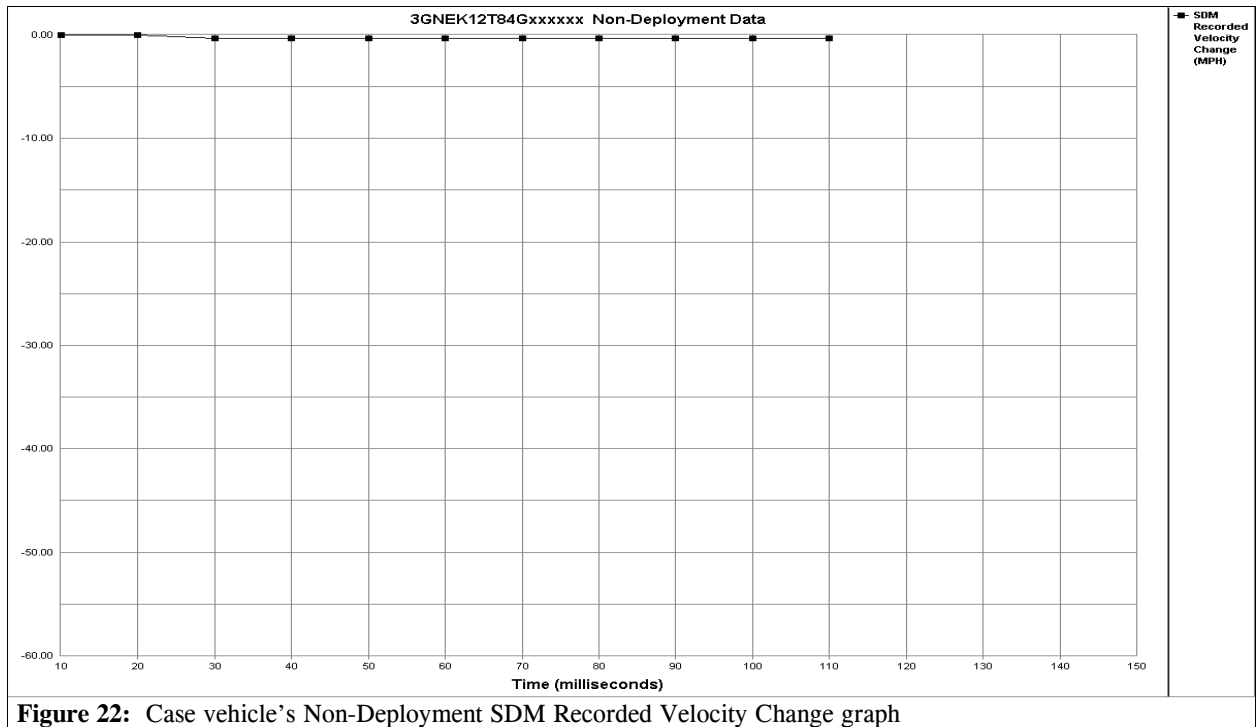
Figure 22: Case vehicle's Non-Deployment SDM Recorded Velocity Change graph
