TRANSPORTATION RESEARCH CENTER

ON-SITE CERTIFIED ADVANCED 208- COMPLIANT VEHICLE INVESTIGATION

CASE NUMBER - IN-04-030
LOCATION - MISSOURI
VEHICLE - 2004 CHEVROLET SILVERADO Z-71
CRASH DATE - September 2004

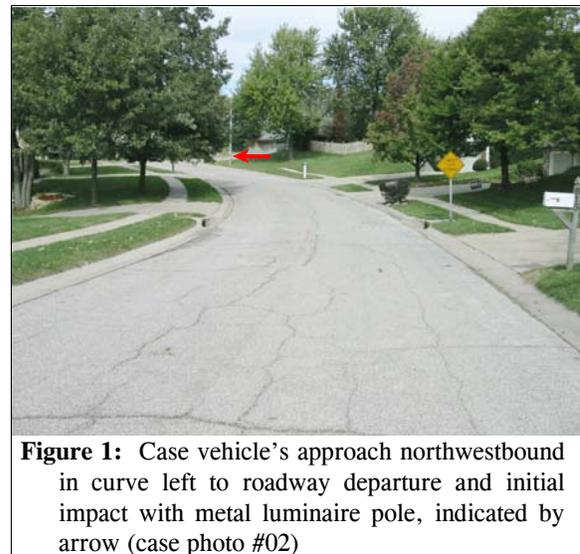
Pre-Crash: The case vehicle was traveling northwest in the middle of the roadway (**Figure 1**) in a left curve and was accelerating to a speed of 146 km.p.h. to 159 km.p.h. (91 to 99 m.p.h.), and the driver apparently intended to negotiate the curve and continue northwestbound. The police crash report indicated that the speed of the case vehicle prior to leaving the roadway was 159 km.p.h. (99 m.p.h.). The police reconstructionist used a critical speed analysis based on a yaw mark (i.e., a mark left by a tire that is rotating and slipping sideways) left by the case vehicle as the driver attempted to negotiate the curve. The police calculated the radius of the yaw mark by using a chord 21.3 meters (70 feet) long and measured a middle ordinate of 20.3 centimeters (8 inches). They conducted a series of three skid tests on the roadway using a Vericom VC 200 brake test computer and determined a roadway coefficient of friction of 0.72. These data were used in the critical speed equation to calculate the speed of the case vehicle at the onset of the yaw

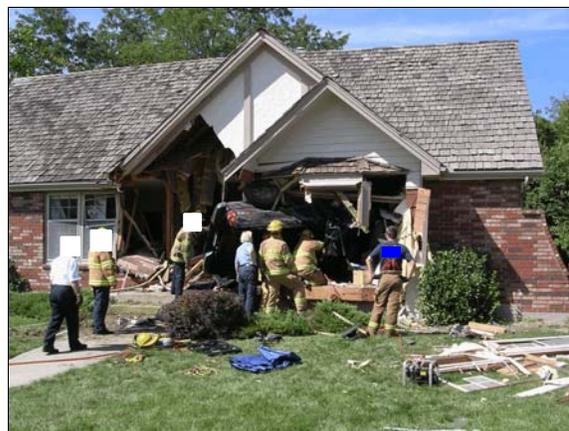
the driver moved left then forward, and his chest impacted the steering wheel (which was now unprotected due to prior deployment of the air bag) resulting in lacerations to numerous internal organs including the aorta, left ventricle, both lungs, pericardium, left kidney, liver and mesentery, and multiple bilateral rib fractures. In addition, as the case vehicle's roof shifted left during the house impact, the driver's head impacted the right roof side rail probably resulting in a cerebral edema. Based on the on-scene photographs, damage to the case vehicle and evidence found in the case vehicle, it appears likely that the driver was removed from the case vehicle through the backlite by rescue personnel.

Figure 21: Rescue personnel in process of removing driver from the case vehicle (case photo #115)

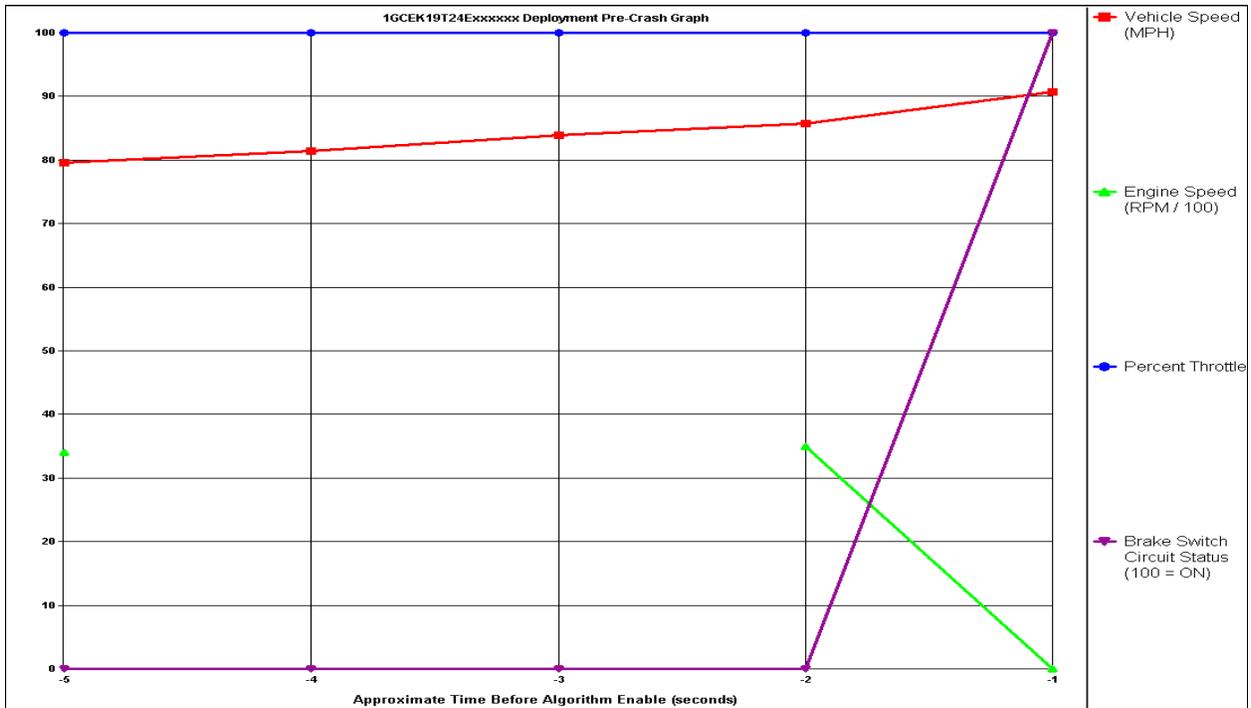
mark. The police reconstruction is supported by the case vehicle's EDR pre-crash data, which indicated that the vehicle's speed was 146 km.p.h. (91 m.p.h.) one second prior to AE for the deployment event (i.e., impact with the concrete steps). The EDR data also indicated that the driver applied the brakes just prior to the crash. The driver did not negotiate the left curve and the case vehicle departed the right side of the roadway. The crash occurred in a residential yard.

Figure 23: Case vehicle's Deployment Pre-Crash Graph

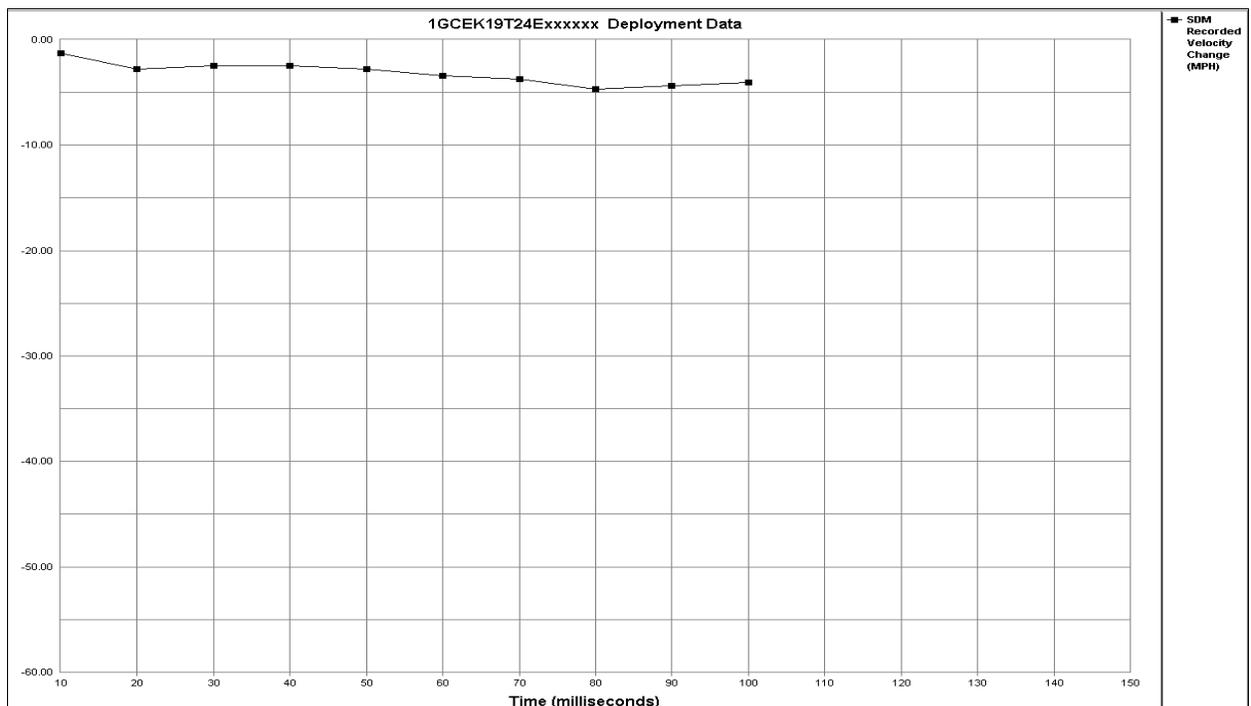
Figure 24: Case vehicle's deployment SDM Recorded Velocity Change graph

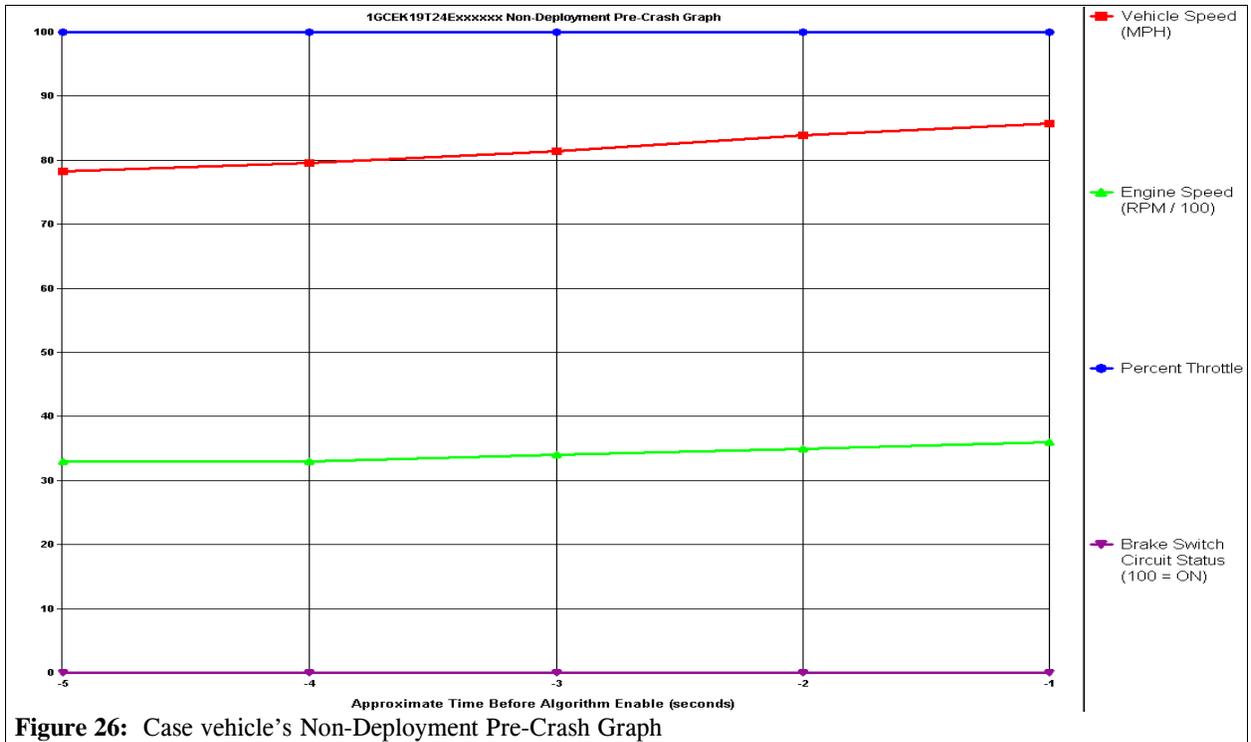
Figure 26: Case vehicle's Non-Deployment Pre-Crash Graph

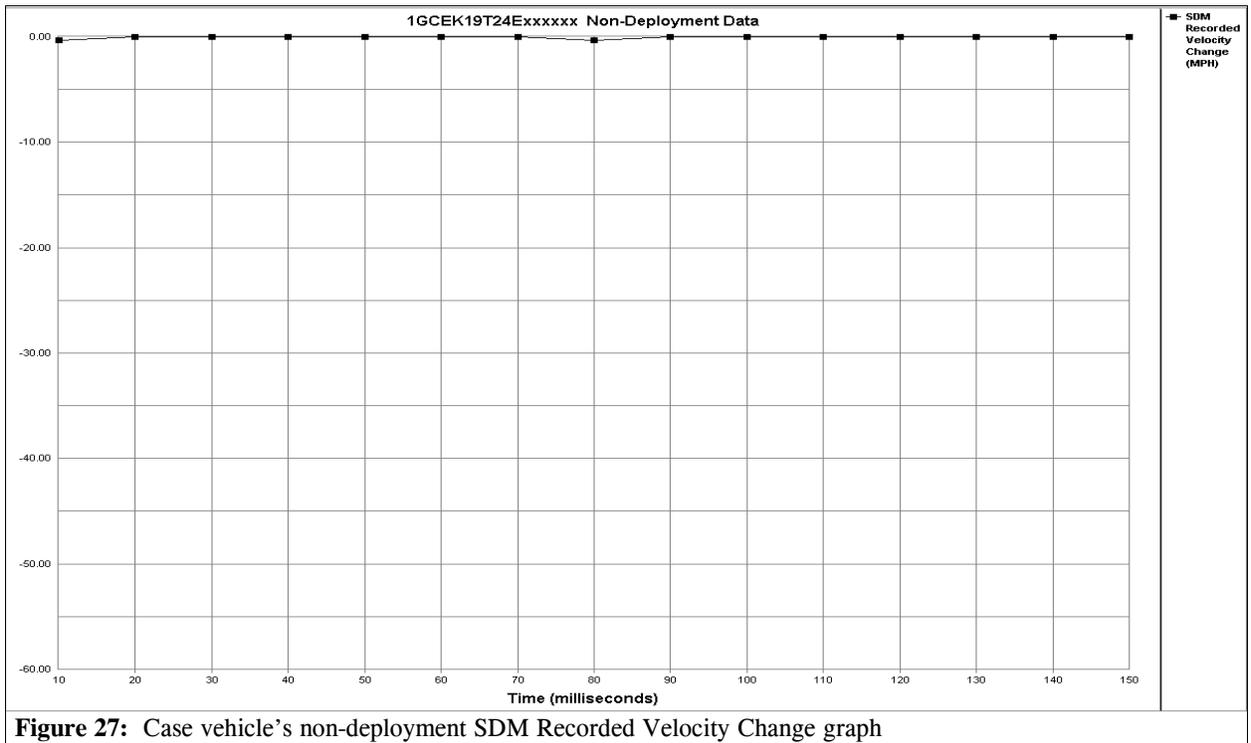
Figure 27: Case vehicle's non-deployment SDM Recorded Velocity Change graph
