**GENERAL DYNAMICS ON-SITE CERTIFIED ADVANCED-208 COMPLIANT
VEHICLE CRASH INVESTIGATION**

SCI CASE NO. – CA04-033

SUBJECT VEHICLE – 2004 GMC YUKON

CRASH DATE – JUNE 2004

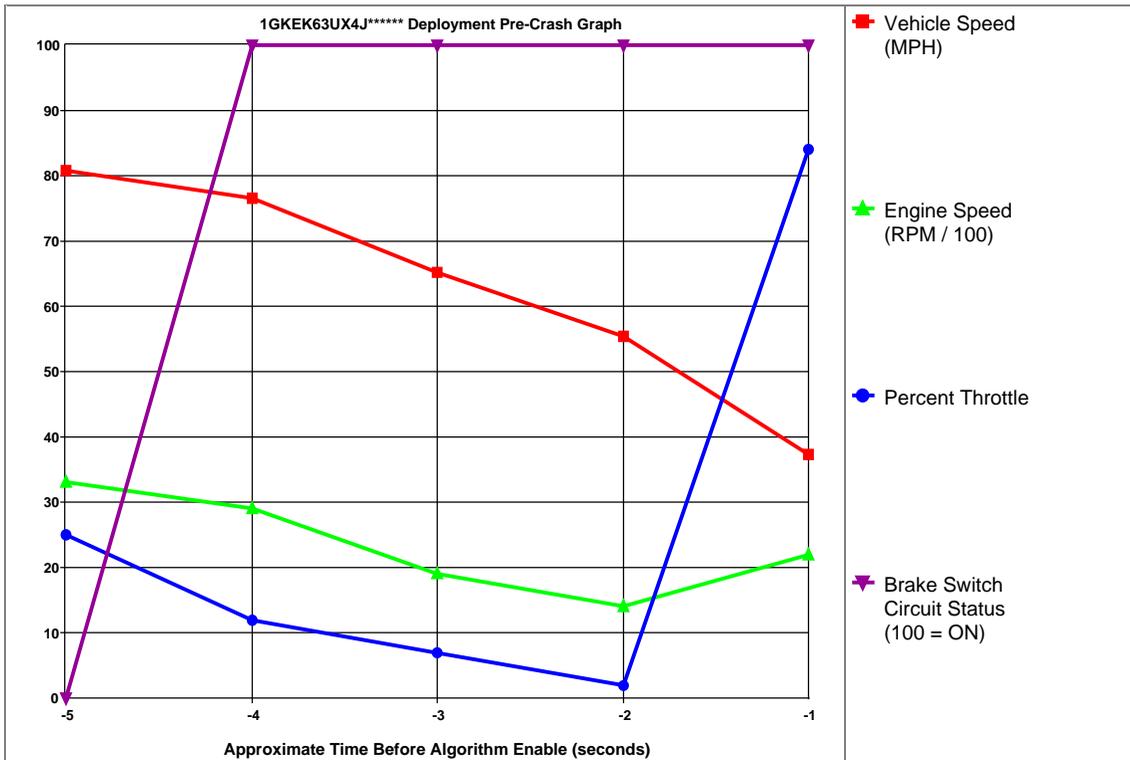
Seconds Before AE	Vehicle Speed (MPH)	Engine Speed (RPM)	Percent Throttle	Brake Switch Circuit Status
-5	81	3264	25	OFF
-4	76	2944	12	ON
-3	65	1856	7	ON
-2	55	1408	2	ON
-1	37	2240	84	ON

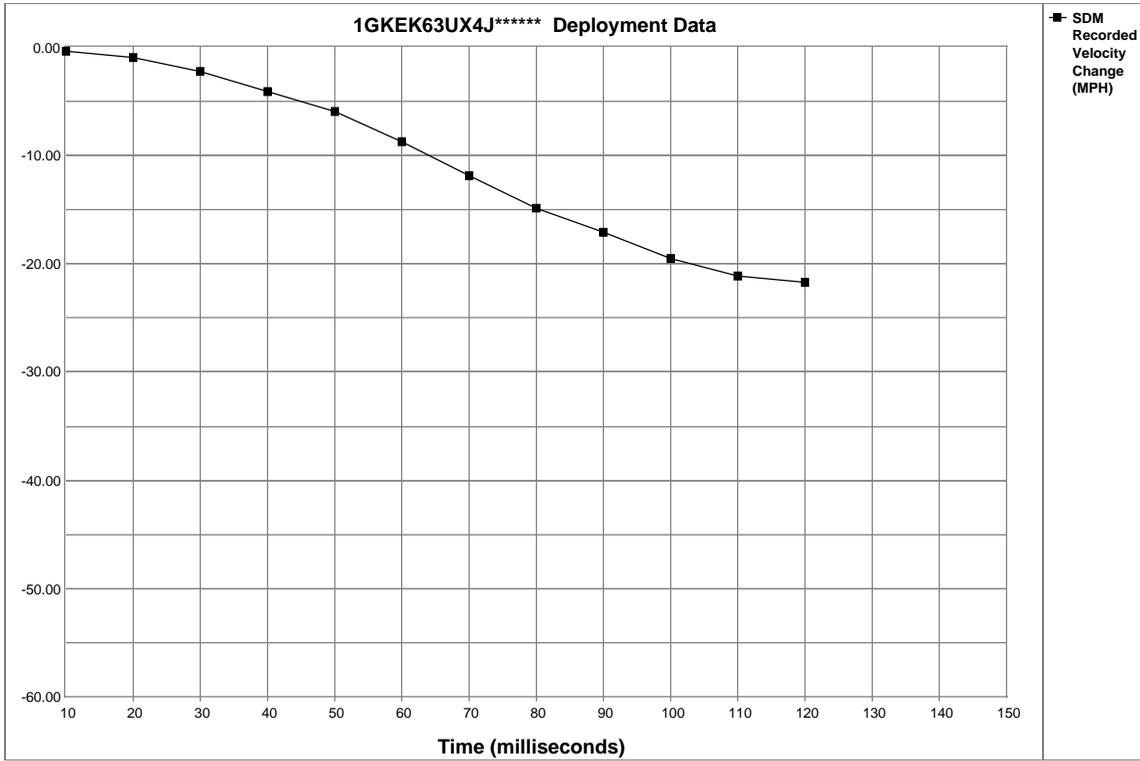
Time (milliseconds)	10	20	30	40	50	60	70	80	90	100	110	120	130	140	150
Recorded Velocity Change (MPH)	-0.31	-0.93	-2.17	-4.03	-5.89	-8.68	-11.78	-14.88	-17.05	-19.53	-21.08	-21.70	N/A	N/A	N/A

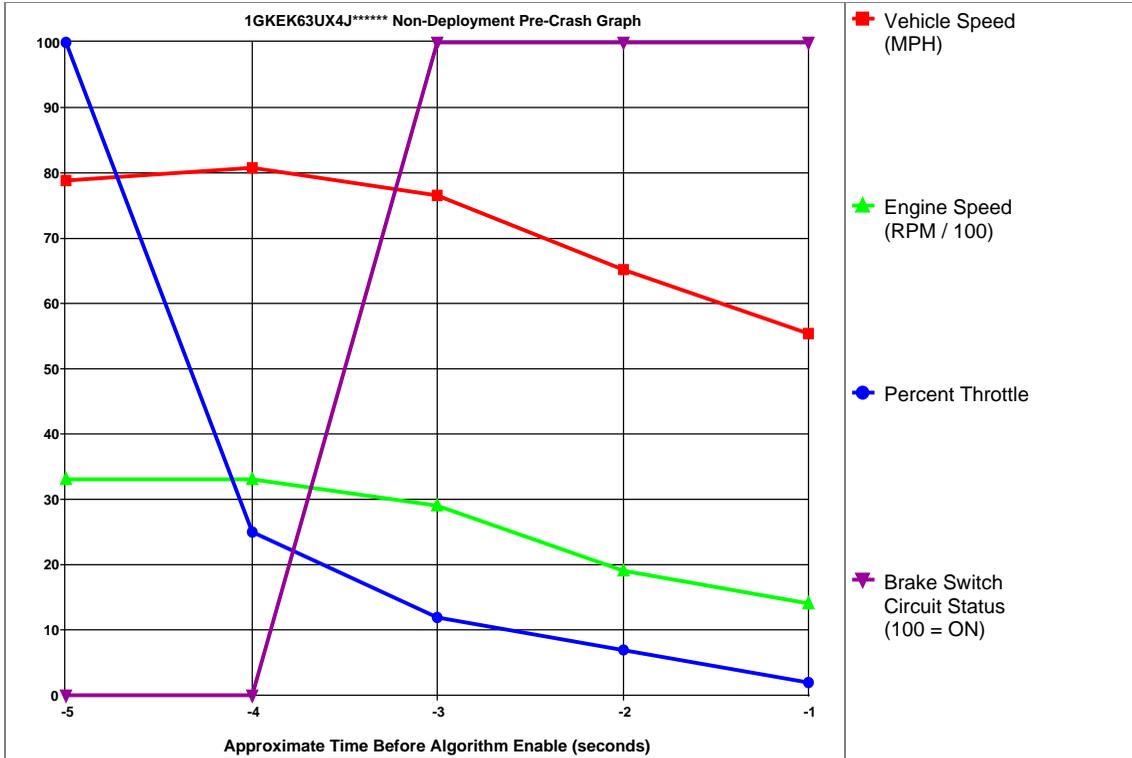
Seconds Before AE	Vehicle Speed (MPH)	Engine Speed (RPM)	Percent Throttle	Brake Switch Circuit Status
-5	79	3328	100	OFF
-4	81	3264	25	OFF
-3	76	2944	12	ON
-2	65	1856	7	ON
-1	55	1408	2	ON

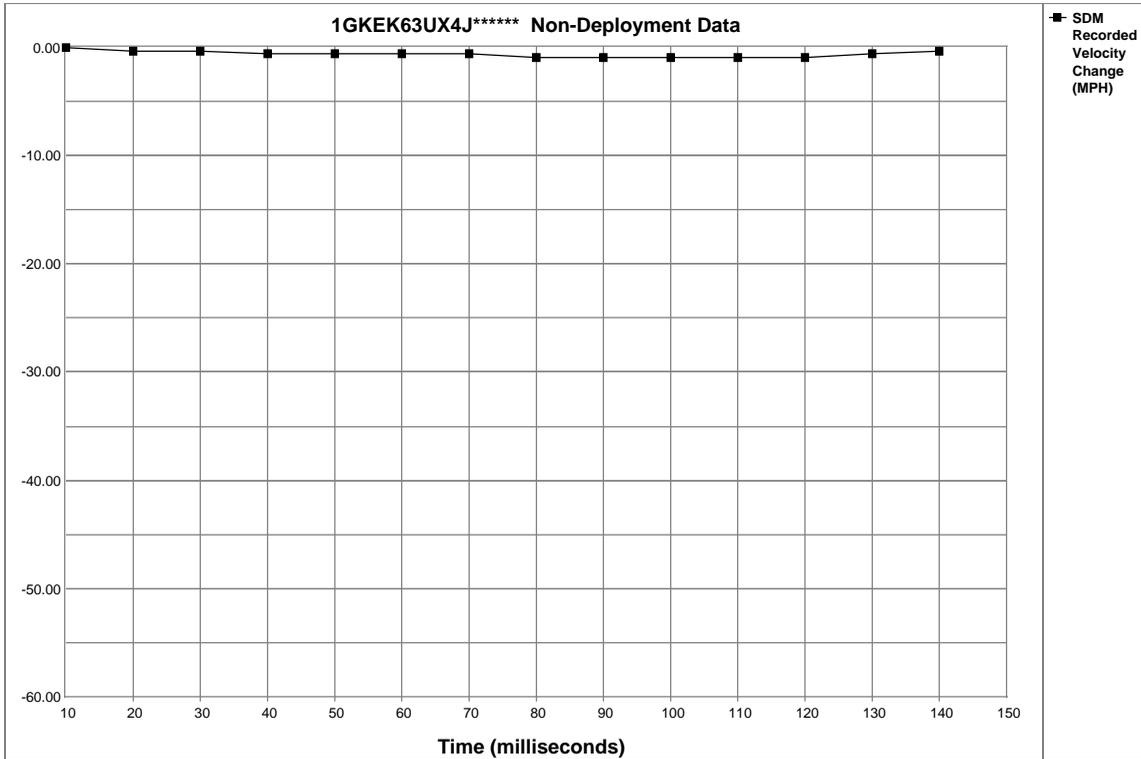
Time (milliseconds)	10	20	30	40	50	60	70	80	90	100	110	120	130	140	150
Recorded Velocity Change (MPH)	0.00	-0.31	-0.31	-0.62	-0.62	-0.62	-0.62	-0.93	-0.93	-0.93	-0.93	-0.93	-0.62	-0.31	N/A
