## ON-SITE CERTIFIED ADVANCED 208- COMPLIANT VEHICLE INVESTIGATION

CASE NUMBER - IN-04-041  
LOCATION - TEXAS  
VEHICLE - 2005 Ford F-150  
CRASH DATE - October 2004

September 29, 2005  
Revised August 31, 2007

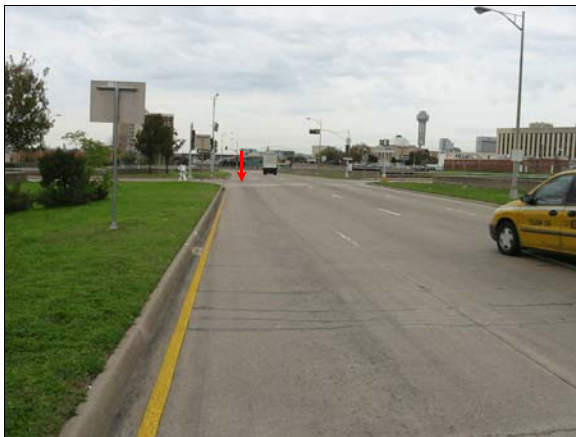
**Figure 1:** Approach of case vehicle south-southwest bound to the intersection in the left lane, arrow shows area of impact

**Pre-Crash:** The case vehicle was traveling south-southwest in the left through lane (**Figure 1**) at a driver estimated speed of 64 - 72 km.p.h. (40 -45 m.p.h.), and the driver was intending to continue straight ahead through the intersection. The Oldsmobile was traveling southeast in the center through lane (**Figure 2**), and the driver was also intending to continue straight ahead through the intersection. As both vehicles entered the intersection, the case vehicle’s driver

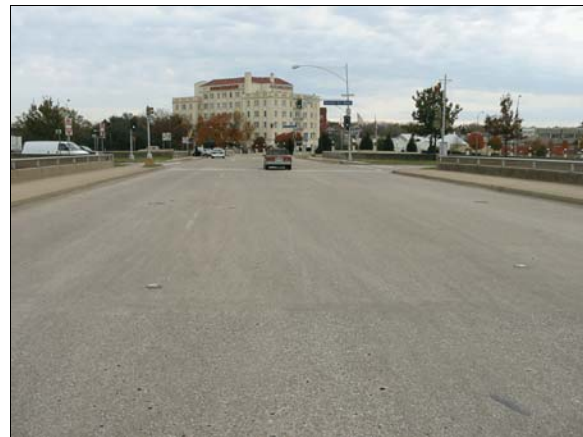
**Figure 2:** Approach of Oldsmobile southeast bound to the intersection in the center lane.

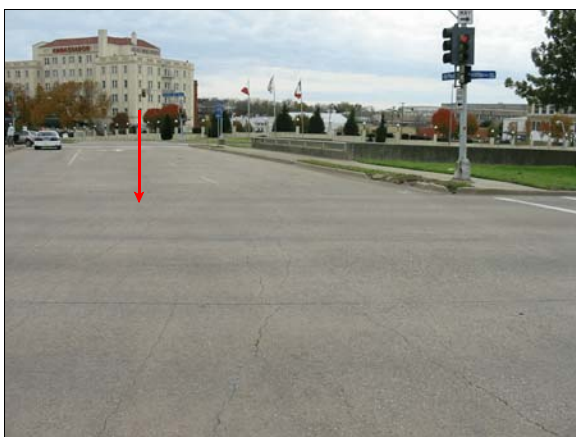
**Figure 3:** View southeast to area of impact, indicated by arrow

perceived the impending crash and steered left in an attempt to avoid the impact. The crash occurred in the four-leg intersection of the two roadways (**Figure 3** above).

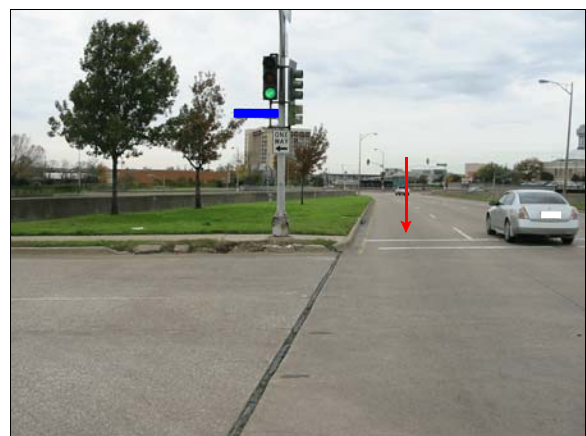
**Post-Crash:** The case vehicle came to rest against the steel traffic signal pole facing south (**Figure 7**). It is estimated that the Oldsmobile traveled through the intersection and came to rest partially in the south leg of the intersection facing south (**Figure 7**). The police crash sketch did not show a final rest position for the Oldsmobile.

**Figure 7:** Overview of area of final rest of case vehicle against traffic signal pole and Oldsmobile, indicated by arrow

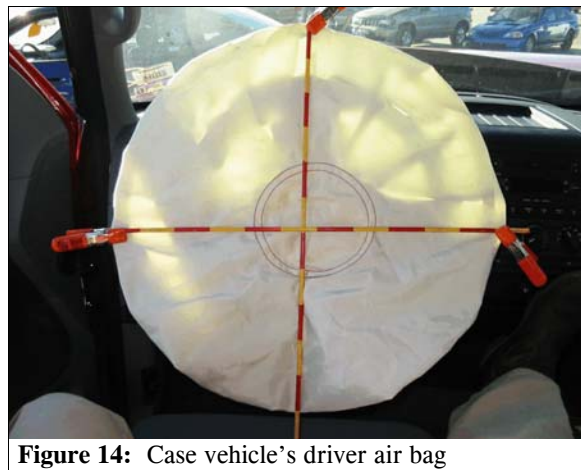
The case vehicle's driver air bag was located in the steering wheel hub. An inspection of the air bag module's cover flaps and the air bag's fabric revealed that the cover flaps opened at the designated tear points (**Figure 13**), and there was no evidence of damage during the deployment to the air bag or the cover flaps. The module cover consisted of symmetrical "H" configuration cover flaps constructed of thick vinyl. There was a rounded contour in the center of each cover flap at the tear seam to accommodate the Ford emblem. The top module cover flap was 11 centimeters wide (4.3 inches) and 8 centimeters (3.1 inches) high. The bottom module flap was 11 centimeters (4.3 inches) wide and 11.5 centimeters (4.5 inches) high. The deployed driver's air bag (**Figure 14** below) was round with a diameter of approximately 59 centimeters (23 inches), and was designed with two tethers, each approximately 14 centimeters (5.5 inches) in width. The driver's air bag had two vent ports (**Figure 15**), each approximately 2.5 centimeters (1 inch) in diameter, located at the 11 and 1 o'clock positions. The distance between the mid-center of the driver's seat back, as positioned at the time of the vehicle inspection, and the front surface of the air bag at full excursion was 29 centimeters (11.4 inches). An inspection of the driver's air bag fabric revealed no evidence of occupant contact. The front right passenger's air bag was located in the middle of the right instrument panel. This air bag did not deploy because there was no occupant seated in the front right seat.

**Figure 14:** Case vehicle's driver air bag

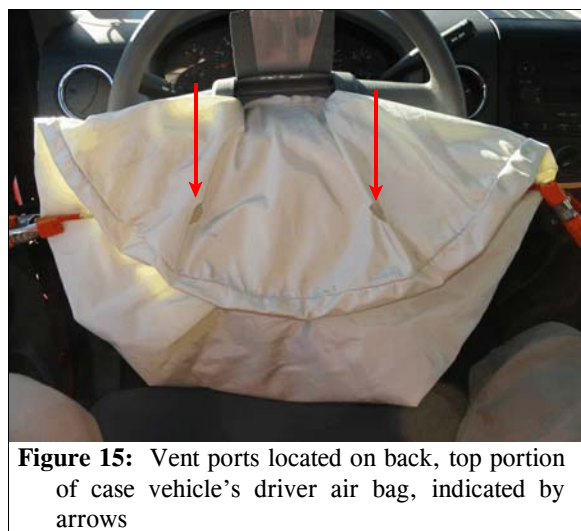
**Figure 15:** Vent ports located on back, top portion of case vehicle's driver air bag, indicated by arrows
