ON-SITE REDESIGNED AIR BAG INVESTIGATION

CASE NUMBER - IN-04-042

VEHICLE - 2004 MAZDA 6

CRASH DATE - October 2004

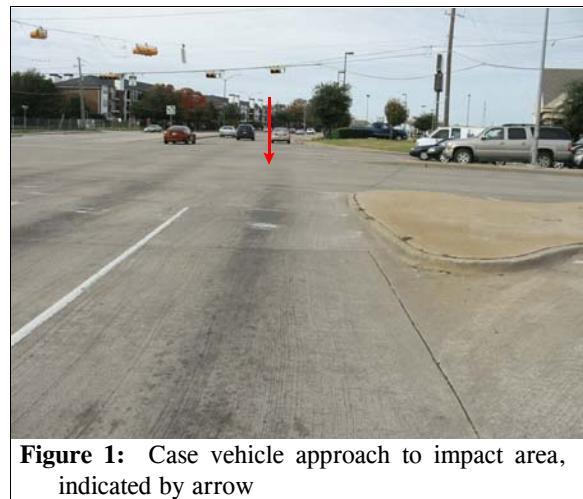
Pre-Crash: The case vehicle was traveling west in the outside through lane (**Figure 1**), and the driver was intending to continue straight through the intersection. The Ford was traveling east in the left turn lane (**Figure 2** below), and the driver was in the process of making a left turn to travel north. The Toyota was southbound in the left through lane and was stopped at the traffic signal, and the driver was intending to continue southbound. It is unknown if the case vehicle's driver made any avoidance maneuvers prior to the crash. The crash occurred in the four-leg intersection of the two trafficways.

Figure 1: Case vehicle approach to impact area, indicated by arrow

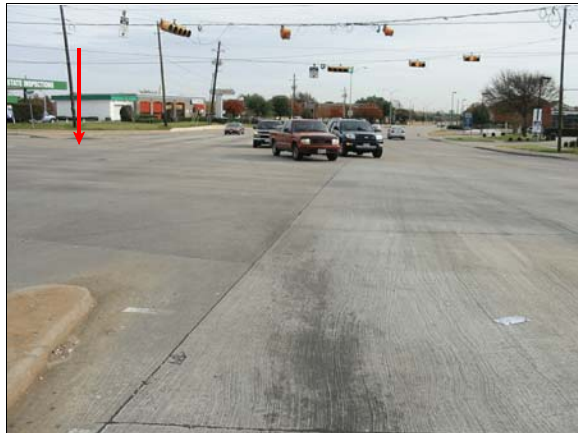
Figure 2: Approach of Ford in left turn lane to impact area, indicated by arrow

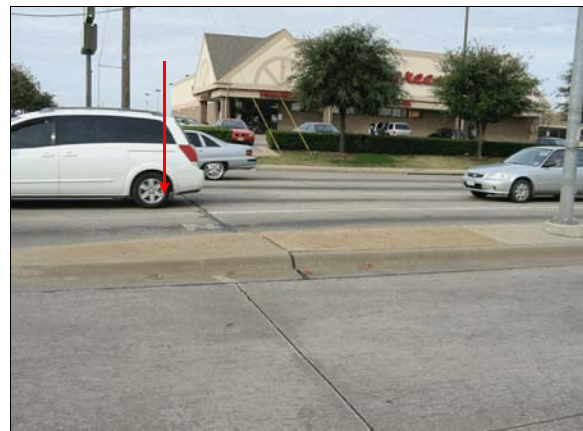
Figure 5: Arrow shows area of impact and final rest of case vehicle and Toyota

Post-Crash: The case vehicle came to rest in the mouth of the intersection in the Toyota's travel lane (**Figure 5**) facing northwest with the front of the vehicle against the front of the Toyota. As a result of the impact with the case vehicle, the Ford rotated counterclockwise and came to rest in the intersection near the case vehicle facing northwest (**Figure 6** below).

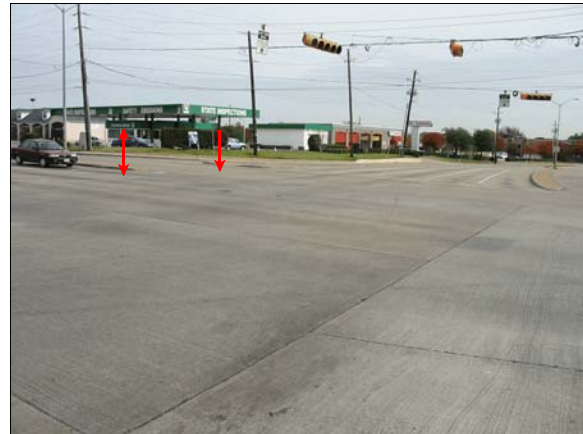
Figure 6: View northeast along Ford’s approach to impact area with case vehicle (single head arrow) and area of final rest of Ford (double head arrow)

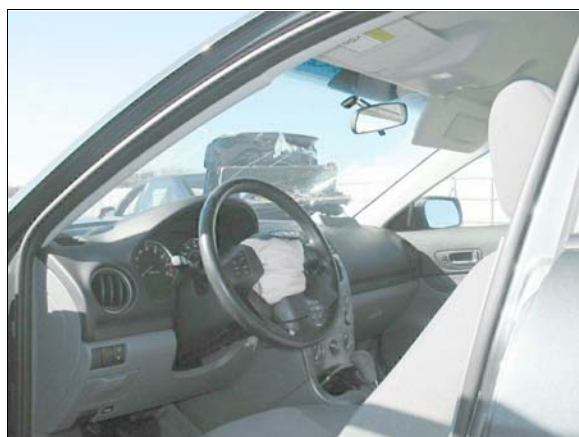
Vehicle Interior: Inspection of the case vehicle’s interior (**Figures 8 and 9**) revealed no evidence of occupant contact. There were also no occupant compartment intrusions, no compression of the energy absorbing steering column and no deformation of the steering wheel (**Figure 10** below).

Figure 8: Overview of steering wheel and instrument panel from case vehicle’s driver door

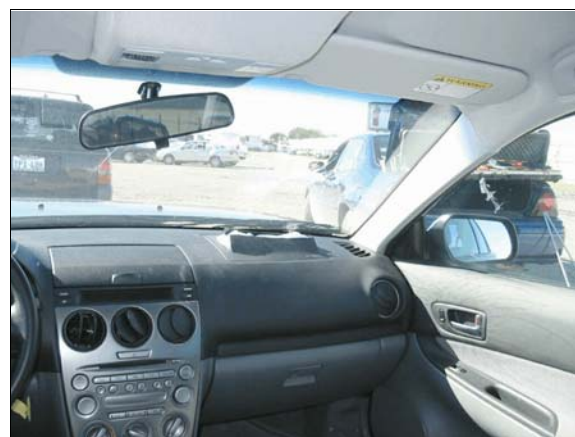
Figure 9: Overview of front right instrument panel, front right air bag in top of instrument panel

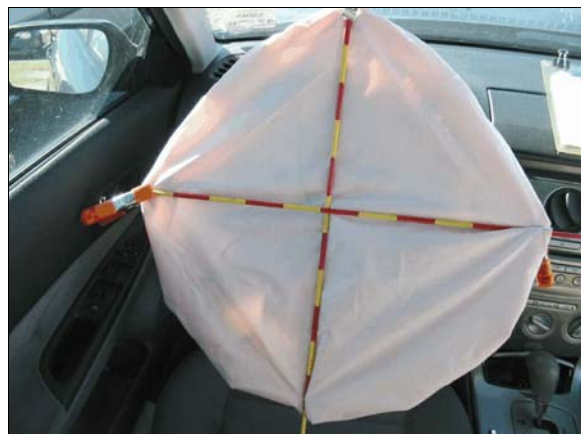
The case vehicle's driver air bag was located in the steering wheel hub. An inspection of the air bag module's cover flaps and the air bag's fabric revealed that the cover flaps opened at the designated tear points (**Figure 11**). There was no evidence of damage during the deployment to the air bag or the cover flaps. The module cover consisted of three flaps made of pliable vinyl. The top flap was 17 centimeters in width and had a rounded contour in the center of the flap to accommodate the Mazda emblem. The height of the top flap, measured at the center of the flap, was 7 centimeters (2.8 inches). Each of the two bottom flaps were irregularly shaped. Each flap was constructed with a concave contour in the center that mated to the top flap's Mazda emblem. The outer edge of each flap was 6 centimeters (2.4 inches) in length. The top of each flap was approximately 5.5 centimeters (2.2 inches) in length, the bottom was approximately 4.5 centimeters (1.8 inches) in length, and the distance across each concave contour was approximately 4 centimeters (1.6 inches). The deployed driver's air bag (**Figure 12** below) was round with a diameter of approximately 57 centimeters (22.4 inches), and was designed without any tethers. The driver's air bag had two vent ports (**Figure 13** below), each approximately 3 centimeters (1.2 inches) in diameter, located at the 11 and 1 o'clock positions. An inspection of the driver's air bag fabric revealed no evidence of occupant

Figure 12: Case vehicle's driver air bag

contact. In addition, a few scuffs were noted on the air bag that appeared related to the deployment. The front surface of the driver's air bag at full excursion touched the mid-center of driver's seat back. The driver's seat adjustment was electric and the seat was found positioned to its full forward position at the vehicle inspection, and the seat back was slightly reclined.

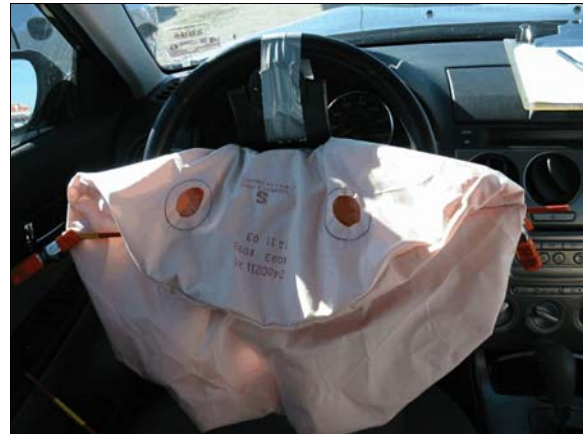
Figure 13: Top back portion of case vehicle's driver air bag showing vent ports

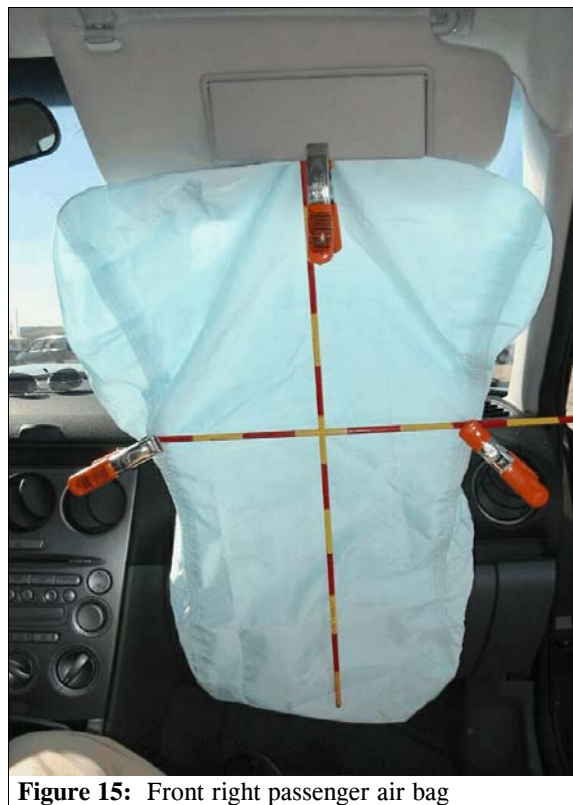
The front right passenger's air bag was located in the top of the instrument panel (**Figure 14**). An inspection of the air bag module's cover flaps and the air bag's fabric revealed that the cover flaps opened at the designated tear points. There was no evidence of damage during the deployment to the air bag or the cover flaps. The two cover flaps were rectangular in shape, and each flap was 27.5 centimeters (10.8 inches) in width and 4.5 centimeters in height (1.8 inches). The deployed front right air bag (**Figure 15** below) was trapezoidal in shape with a top width of approximately 44 centimeters (17.3 inches), a center width of approximately 34 centimeters (13.3 inches), a bottom width of approximately 30 centimeters (11.8 inches), and a height of approximately 66 centimeters (26 inches). The front right passenger's air bag was designed without any tethers. The front right air bag had two vent ports, each approximately 6 centimeters

(2.4 inches) in diameter, located at the 9:30 and 2:30 o'clock positions. The distance between the face of the instrument panel and the first module flap was approximately 19 centimeters (7.5 inches). The distance between the mid-center of the front right passenger's seat back, as positioned at the time of the inspection (i.e., the rear most track position), and the front surface of the passenger air bag at full excursion was 44 centimeters (17.3 inches). An inspection of the front right passenger's air bag fabric revealed no evidence of occupant contact. The air bag contacted and cracked the windshield during deployment (**Figure 14**).

Figure 15: Front right passenger air bag
