**CALSPAN ON-SITE ADULT AIR BAG RELATED FATALITY CRASH  
INVESTIGATION**

**CASE NO: CA04-053**

**VEHICLE: 1993 CHEVROLET CORSICA**

**CRASH DATE: JULY 2004**

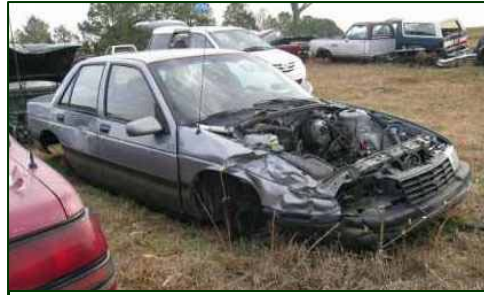
**Figure 1. Front right three-quarter view of the involved 1993 Chevrolet Corsica.**

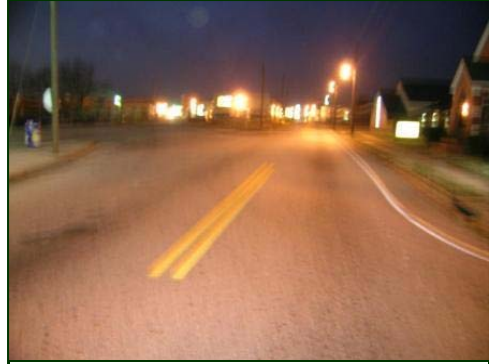
The crash occurred at an offset, oblique four-leg intersection (**Figure 2**) of two local streets during daylight conditions. At the time of the crash, the weather was clear and the road surfaces were dry. The Corsica approached the intersection on a two lane street that was 6.2 m (20.3') in width and delineated by double yellow center lines. A regulatory stop sign controlled westbound traffic entering the intersection. The Dodge Caravan was southbound traveling on a straight and level road that was 6.9 m (22.6') in width. This north/south road was delineated by double yellow centerlines and traffic flow was not regulated through the intersection. The posted speed limit for the urban area was 48 km/h (30 mph). The Crash Schematic is attached as **Figure 10** of this report.

**Figure 2. Overall view of the crash site and trajectory of the Chevrolet Corsica.**

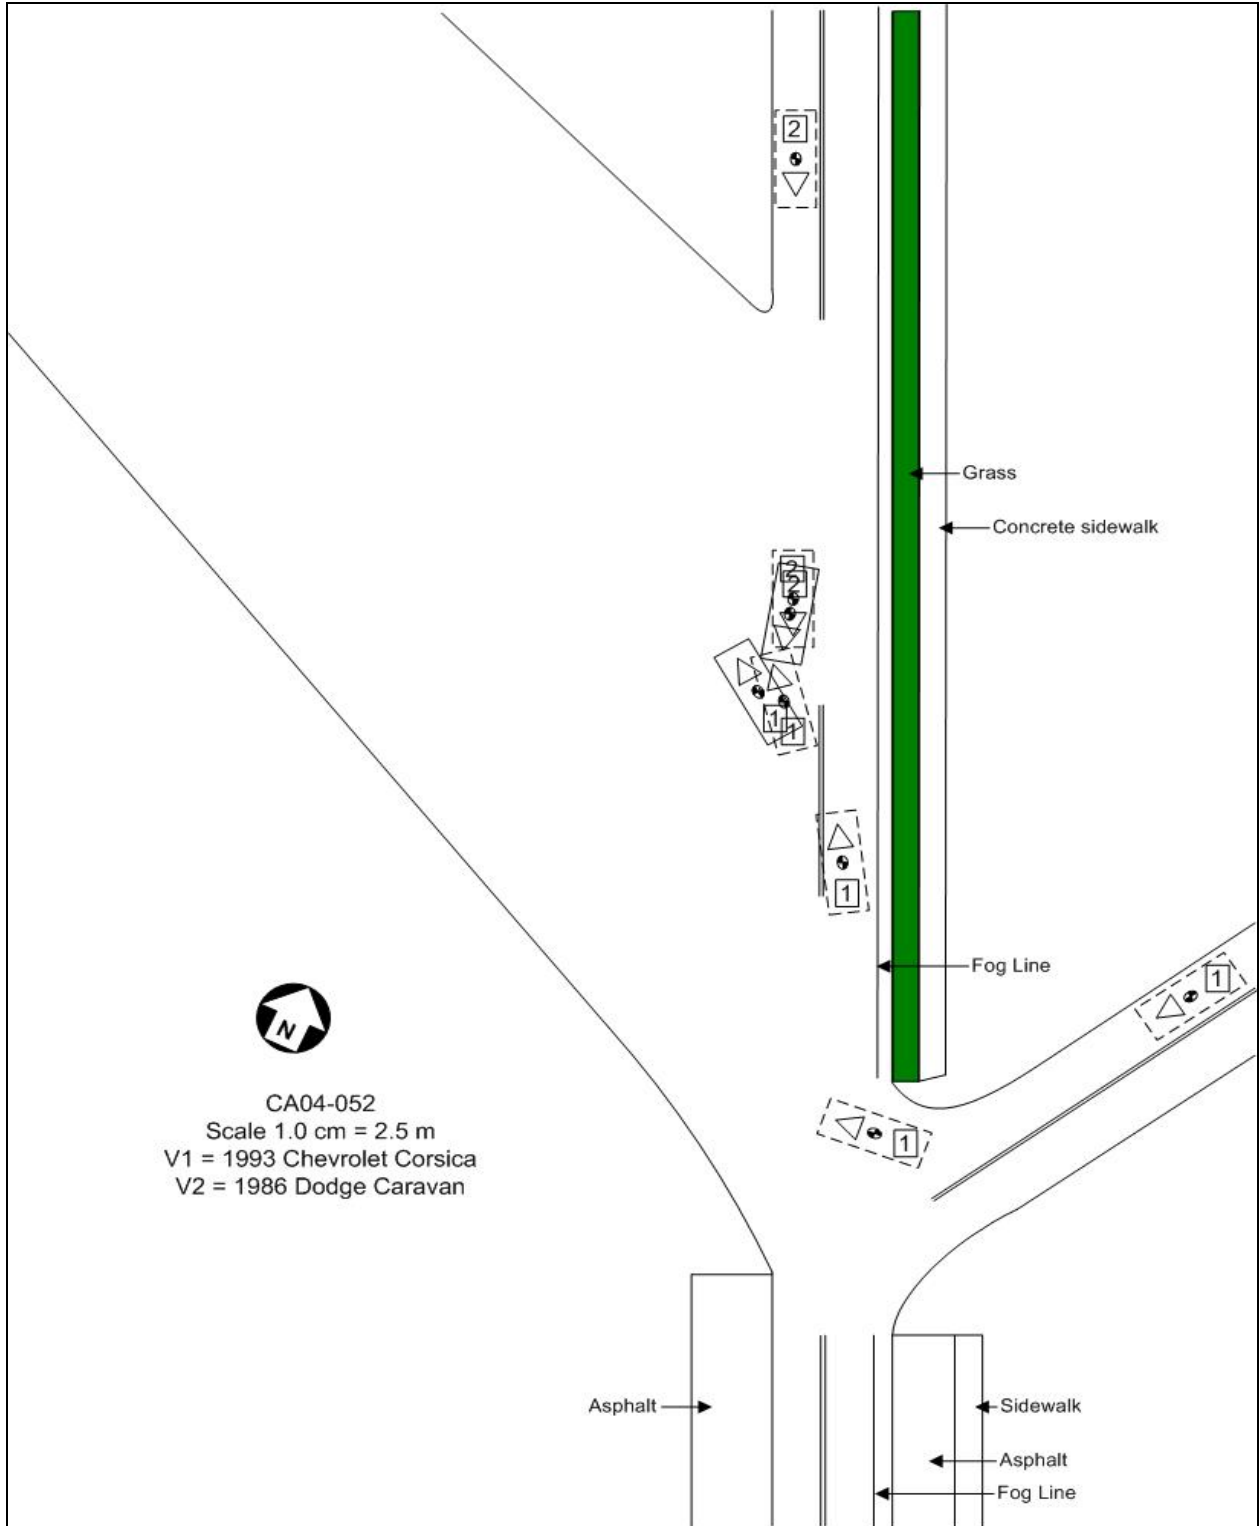
Figure 10 – Scene Schematic

The vehicles impacted in an off-set, head-on configuration in the southbound travel lane within the boundaries of the intersection. The front right area of the Caravan impacted the front right corner area of the Corsica. Although the Caravan was not inspected, both vehicles experienced impact forces that were within the 12 o'clock sector. The direct contact damage to the Corsica began at the front corner of the bumper fascia and extended onto the right front fender as both vehicles continued forward trajectories. The engagement continued 58 cm (23") onto the right front fender prior to separation of the vehicles. Due to the corner impact and the multiple plane engagement, the vehicles did not reach a common velocity; therefore, the impact and resultant damage was outside the scope of the WINSMASH reconstruction program. The SCI estimated velocity change for the Corsica was in the 19-24 km/h (12-15 mph) range. As a result of the crash, the driver air bag system in the Corsica deployed.
