CALSPAN ON-SITE CHILD SAFETY SEAT CRASH INVESTIGATION

CASE NO: CA04-055

VEHICLE: 2003 DODGE RAM 2500 PICKUP TRUCK

CRASH DATE: NOVEMBER 2004

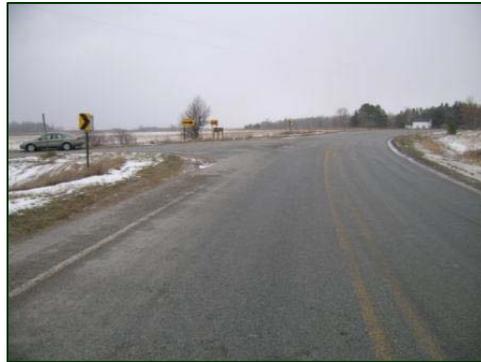
crash was traveling northbound; therefore all references for this segment of road will be considered northbound. At the crash site, the roadway curved to the right for northbound traffic with a radius of curvature of 115 m (376'). The roadway had a positive grade of one percent to the north and a super-elevation of two percent. At the apex of the curve, a two lane local road intersected the roadway at the west road edge. An accumulation of loose gravel was present on the west shoulder of the roadway and at the mouth of the intersection. The area to the northwest of the intersection was a field with a gradual down slope that transitioned to a shallow drainage ditch. This area contained tall grass and the ground was soft due to the above freezing temperatures and frequent precipitation. At the time of the crash, the environmental surfaces were wet due to a moderate snowfall with a temperature of approximately 1 degree C (mid 30 degrees F). Curve warning signs were posted along the west road edge on both sides of the intersection with an advisory speed warning of 56 km/h (35 mph). The posted speed limit for the U.S. route was 89 km/h (55 mph). **Figure 2** is a northbound view of the crash site. The Scene Schematic is included as **Figure 14** of this narrative report.

Figure 2. Northbound view of the crash site.

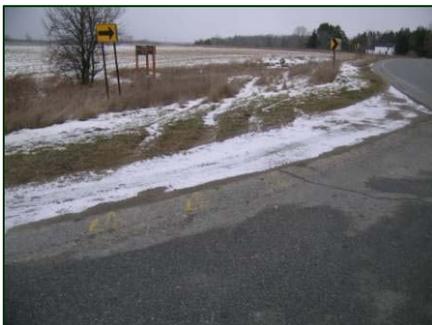
Figure 3. Intersection departure of the Dodge Ram pickup truck.

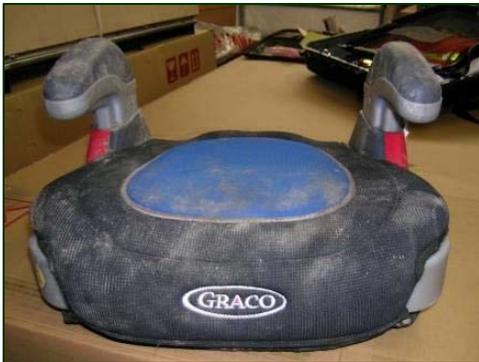
The 5-year old male child passenger was seated in a backless booster seat (**Figure 9**) and was restrained by the vehicle's manual safety belt system. The booster seat was a Graco, Model No. 8491RGB with a Serial No. of JJ0720031194164. It was manufactured on 7/20/03 and was purchased new by the parents of the child. The booster seat was labeled for use by children 4-10 years of age with height and weight limits of 102-145 cm (40-57") and 18-45 kg (40-100 lb). The molded base of the unit had two retractable cup holders built into the forward sides. Two adjustable armrests were present with two sets of adjustment slots. Both armrests were adjusted to the upper adjustment points. The vertical distance between the seat cushion of the booster seat and the top of the armrest was 13 cm (5"). The vehicle safety belt path was located below the armrests indicated by red plastic guides (**Figure 10**). There was no damage to the booster seat or loading evidence from the manual safety belt system. The booster seat was muddy; however, the area of the cushion where the child was positioned remained relatively clean.

Figure 9. Graco backless booster seat.

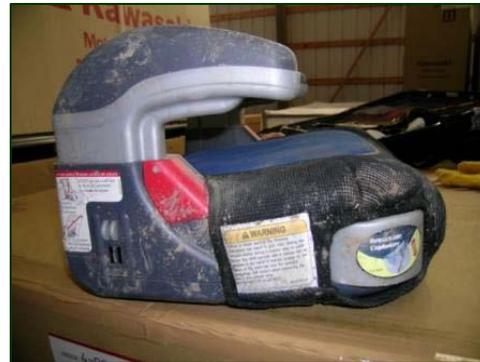
Figure 10. Right side belt path of the booster seat.

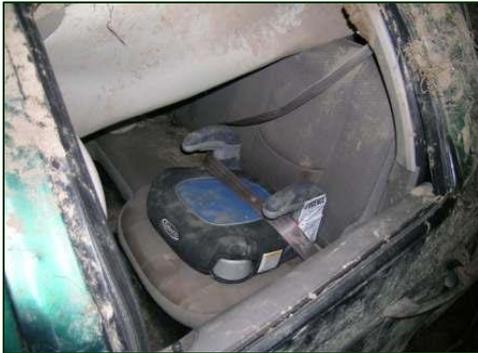
The 5-year old child passenger was seated in a Graco backless booster seat and restrained by the vehicle's manual 3-point lap and shoulder belt system in the rear left position of the Dodge Ram pickup truck (**Figure 12**). Safety belt usage was determined by mud and debris that was present on the safety belt webbing and the lack of injury or ejection of the child passenger.

At the on-set of the rollover, the ELR retractor locked. The child passenger would have initiated a lateral trajectory to his left in response to the lateral forces exerted on the vehicle. There was no contact evidence to the left rear door panel. As the vehicle continued to rollover, the child loaded the manual belt system which held the child in position and prevented him from ejection. The booster seat elevated the child to provide a better fit of the manual belt system. The severe roof intrusion was located immediately above the child passenger's position (**Figure 13**). He did have sufficient occupant space left of his seated position. The vertical distance between the leading edge of the booster seat cushion and the intruding roof measure d 27 cm (10.5"). The aft edge of the booster seat cushion to the roof measured 38 cm (15.1").

Figure 12. Left side view of the booster seat.
