Combination Hybrid Vehicle Investigation/ Vehicle to Vehicle
Dynamic Science, Inc. / Case Number: 2005-082-083A
2004 Honda Civic
Washington
September, 2005

1. Report No. 2005-082-083A	2. Government Accession No.	3. Recipient Catalog No.	
4. Title and Subtitle Combination Hybrid Vehicle Investigation		5. Report Date March 24, 2006

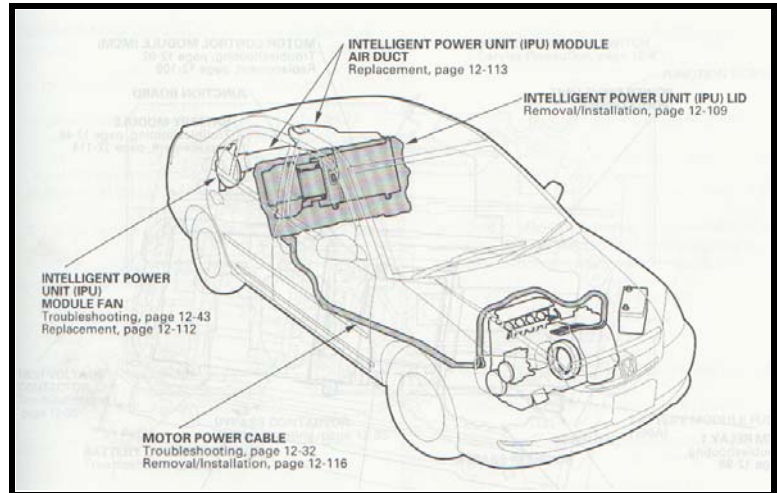
Figure 11. Overview, IMA system

This contractor reviewed publicly available manufacturer information regarding the electrical system of the Civic Hybrid to determine likely points to assess vehicle electrical isolation. The system basically consists of the intelligent power unit (IPU) which is located behind the rear seat, the electric motor which is located in the engine compartment, and the motor power cable which is the cable that connects the power unit to the drive unit. The system uses high voltage (144 V) circuits. The high voltage cables and their covers are identified by orange coloring. There are two likely points of electrical exposure: the cable connection to the IPU and the cable connection to the electric motor.

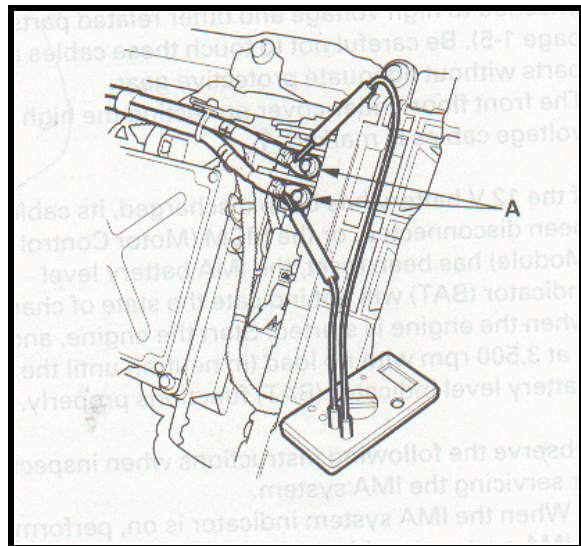
- Ignition switch off.
- Remove back seat back.
- Access battery module switch and turn to off.
- Remove IPU lid.
- Measure voltage at the junction board terminals. There should be 30 V or less. If more than 30 V is present, there is a problem in the circuit.

Figure 12. IPU circuit test at battery end of high voltage line

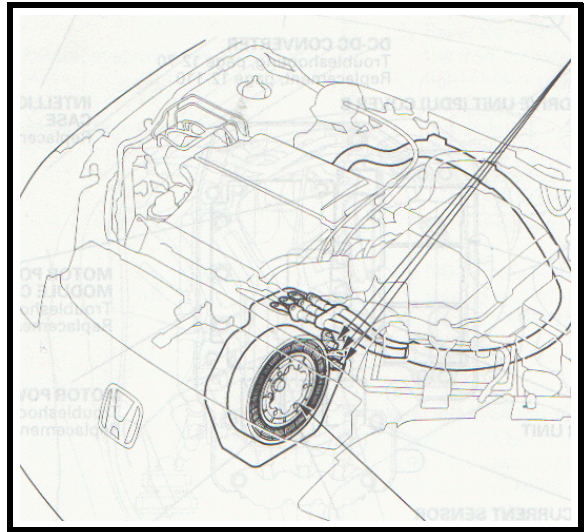
- Disconnect the high voltage cables from the output terminals on the junction board.
- Measure resistance between high-voltage cables and body ground individually.
- If the resistance is $350\text{ k}\Omega$ or lower, there is a short in the high voltage line.

Figure 13. Engine side of high voltage line
