**CALSPAN ON-SITE CHILD AIR BAG RELATED FATALITY
CRASH INVESTIGATION**

CASE NO: CA05-001

VEHICLE: 2000 CHEVROLET METRO LSi

CRASH DATE: NOVEMBER 2004

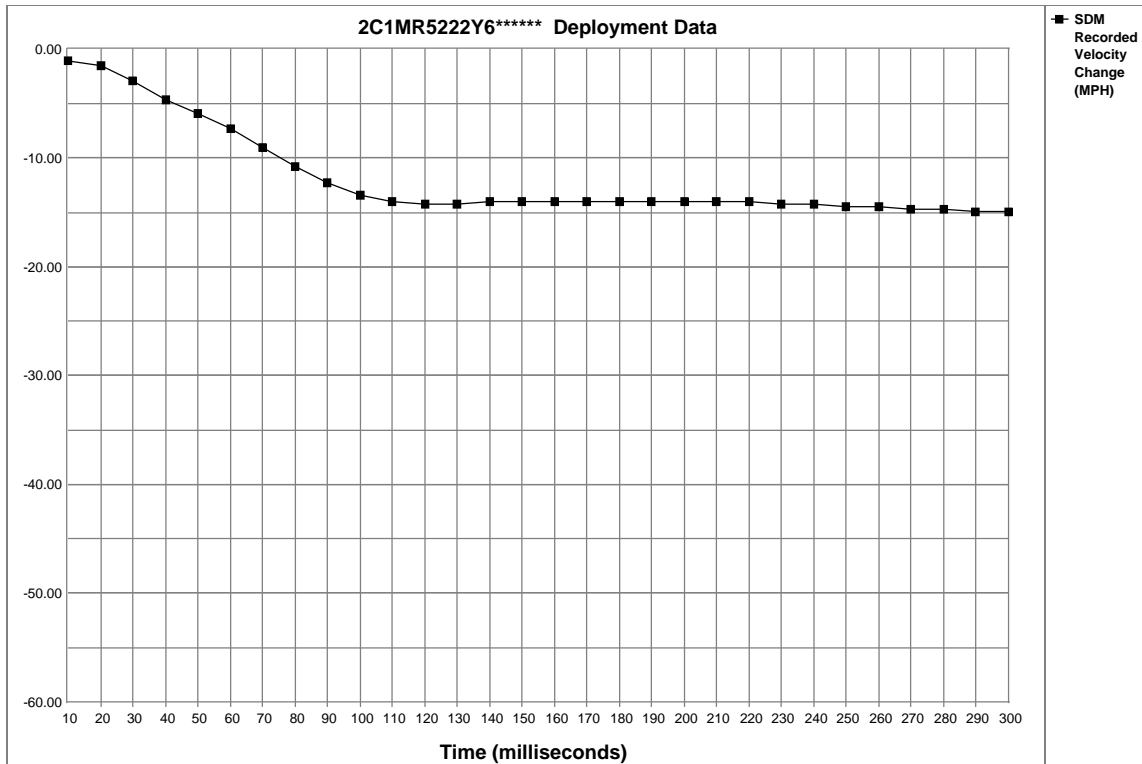
SIR Warning Lamp Status	ON
Driver's Belt Switch Circuit Status	UNBUCKLED
Ignition Cycles At Deployment	16965
Ignition Cycles At Investigation	16976
Time From Algorithm Enable To Deployment Command (msec)	35
Time Between Non-Deployment And Deployment Events (sec)	N/A

Time (milliseconds)	10	20	30	40	50	60	70	80	90	100	110	120	130	140	150
Recorded Velocity Change (MPH)	-1.10	-1.54	-2.85	-4.61	-5.92	-7.24	-9.00	-10.75	-12.29	-13.38	-14.04	-14.26	-14.26	-14.04	-14.04
Time (milliseconds)	160	170	180	190	200	210	220	230	240	250	260	270	280	290	300
Recorded Velocity Change (MPH)	-14.04	-14.04	-14.04	-14.04	-14.04	-14.04	-14.04	-14.26	-14.26	-14.48	-14.48	-14.70	-14.70	-14.92	-14.92
