**CALSPAN ON-SITE ADULT AIR BAG RELATED FATALITY
INVESTIGATION**

SCI CASE NO.: CA05-003

SUBJECT VEHICLE – 1996 MERCURY GRAND MARQUIS

CRASH DATE – DECEMBER 2004

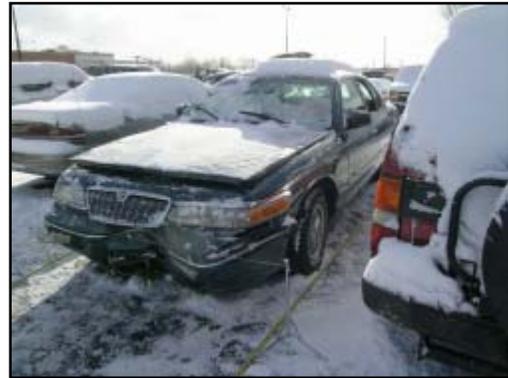
Figure 1. Subject vehicle 1996 Mercury Grand Marquis.

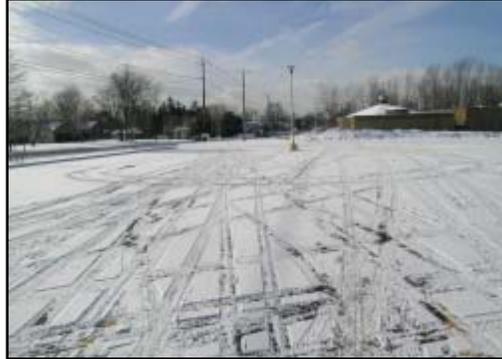
This single vehicle crash occurred during the daytime hours of December 2004. At the time of the crash, it was raining and the asphalt pavement was wet. The crash occurred at the eastern end of a large church parking lot. The parking lot consisted of multiple parking spaces and six light poles that were spaced 20.7 m (68') from north to south and 35.6 m (117') from east to west in a rectangular pattern. The struck concrete base support was 61 cm (24") in diameter and 51 cm (20") in height. A 12.7 (5") diameter metal light pole that was approximately 6.4 meters (21 ft) in height was mounted to the concrete base. A travel lane was located adjacent (south) to the concrete base support. The parking lot terminated 12.8 m (42.1') south of the concrete base support. The nearest exit was located 7.1 m (23.2') east of the area of impact. Traffic flow through the parking lot was not regulated by posted speed limits or traffic control devices. **Figure 2** is an overall view of the crash site. The scene schematic is included as (**Figure 11**) of this report.

Figure 2. Overall view of the crash site.

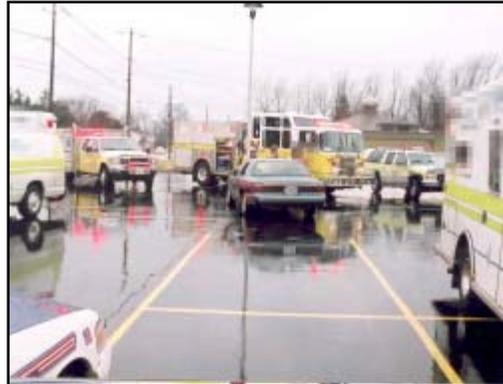
The 66-year-old male driver of the Mercury was traveling in an easterly direction in the church parking lot approaching the exit (**Figure 3**). A family member who witnessed the crash stated that the driver had traveled some distance through the parking lot prior to the crash. Furthermore, she stated she did not observe brake lights or avoidance maneuvers prior to the impact.

Figure 3. The Mercury's eastbound travel through the parking lot.
