School Bus Investigation/Vehicle to Vehicle
Dynamic Science, Inc./Case Number: DS05010
2003 Bluebird Micro-Bird - GMC Savana Cutaway Van
Utah
June 2006

1. Report No. DS05010	2. Government Accession No.	3. Recipient Catalog No.	
4. Title and Subtitle School Bus Investigation		5. Report Date August 25, 2006

The focus of this on-site investigation was the performance of a 2003 Bluebird Micro-Bird school bus that was involved in a head-on crash with a semi tractor-trailer. The crash occurred at 1511 hours on a two-lane, two way highway in a rural area of Utah. The school bus was being driven by a 22-year-old male. The bus had sixteen additional occupants, two adult counselors and fourteen children. The children were being transported back to a summer camp after a day of swimming. The driver of the bus was restrained with a 3-point manual lap and shoulder belt. This Bluebird Micro-Bird bus did not originally have seat belts in any of the passenger seats, but the owners of the bus had manual lap belts installed in all sixteen passenger seat locations. According to police investigators, some of the children and/or adults were wearing the lap belts, but the police report did not indicate

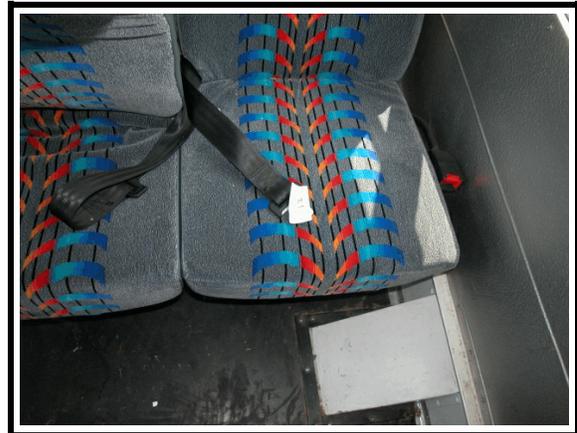
The 2003 Bluebird Micro-Bird was configured with a manual 3-point lap and shoulder belt for the driver's seat position. The driver's seat belt height adjuster was in the full up position. The passenger seats did not originally come equipped with safety belts, but the owners of the bus had manual lap belts installed in all 16 seats. The driver's safety belt was configured with a sliding latchplate and an emergency locking retractor (ELR). The sixteen lap belts were configured with sliding latchplates. It appears that only the driver of the bus was restrained at the time of the collision.

Figure 19. After-market lap belts - installed in all passenger positions

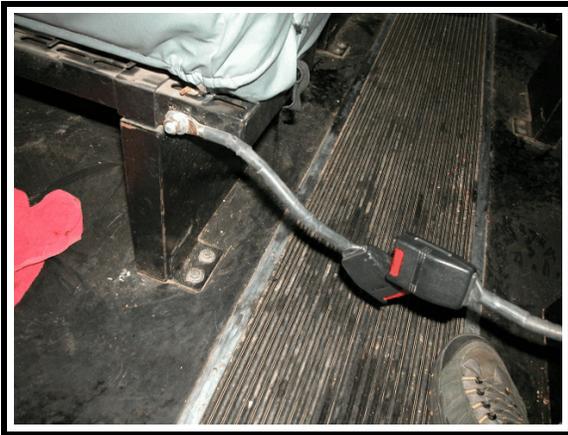
Figure 20. After-market seat belt buckles

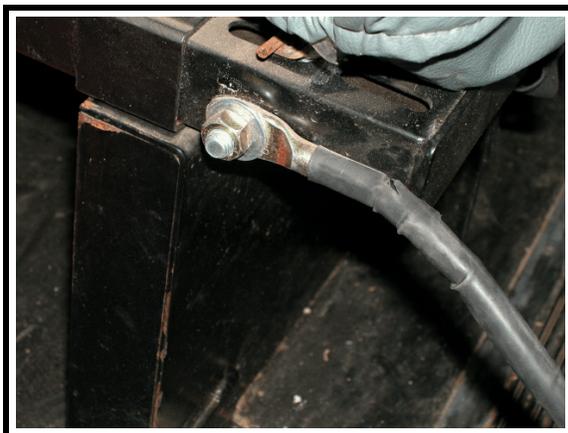
Figure 22. Closer view - After market seat belt buckle attachment point

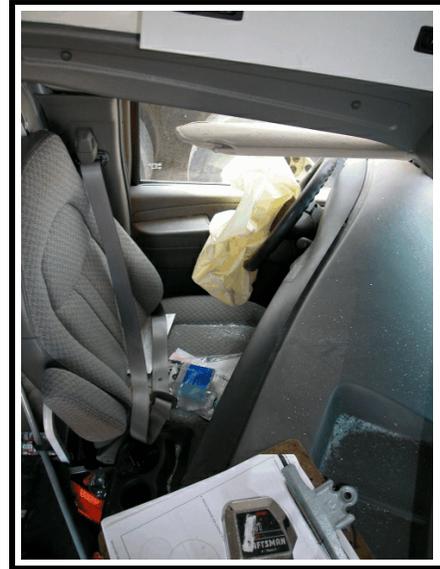
Figure 24. Driver's seating area

The force of the impact caused the driver to load his seat belt as he initiated a forward trajectory towards the 12 o'clock direction of force. The case vehicle continued a short distance forward as the tractor crushed the Bluebird's engine compartment. The bus came to final rest facing west in the eastbound lane, still in contact with the front of the Freightliner.

According to police, this occupant sustained "broken bones or bleeding wounds" to his legs. It is believed that he was transported to an area hospital where he was treated and released.

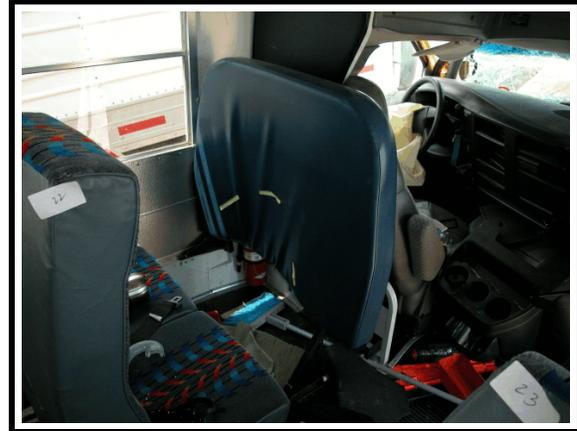
Figure 25. Padded divider separating driver and second row/left passengers

The force of the impact caused this passenger to initiate a forward trajectory towards the 12 o'clock direction of force, likely causing him to contact the padded divider located between the back of the driver's seat back and this occupant's seating area. The case vehicle continued a short distance forward as the tractor crushed the Bluebird's engine compartment. The bus came to final rest facing west in the eastbound lane, still in contact with the front of the Freightliner.

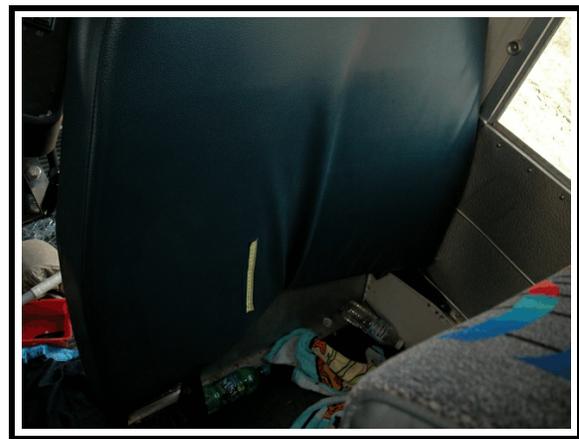
Figure 26. Padded divider separating second row/right seats from front entrance

The force of the impact caused this passenger to initiate a forward trajectory towards the 12 o'clock direction of force, likely causing him to contact the padded divider located between this occupant's seating area and the right front door entrance. The case vehicle continued a short distance forward as the tractor crushed the Bluebird's engine compartment. The bus came to final rest facing west in the eastbound lane, still in contact with the front of the Freightliner.

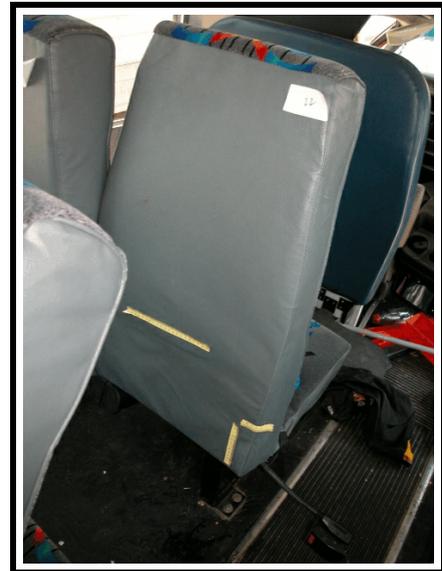
Figure 28. Back of Seat 22

The post-crash angle of this occupant's seat back was 45 degrees. He was assisted by the adult passengers and exited the vehicle through the rear emergency door. According to police, this occupant sustained facial "broken bones or bleeding wounds". Interview information confirmed this passenger was bleeding post-crash, but specific injury information could not be obtained. It is believed that he was transported to an area hospital where he was treated and released.

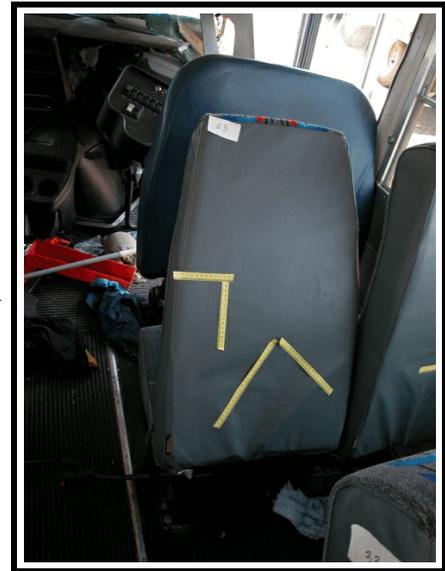
Figure 29. Back of Seat 23

The post-crash angle of this occupant's seat back was 38 degrees. He was assisted by the adult passengers and exited the vehicle through the rear emergency door. According to police, this occupant sustained facial "broken bones or bleeding wounds". Interviewees reported that this occupant had no visible injuries. It is not known if he was medically treated.

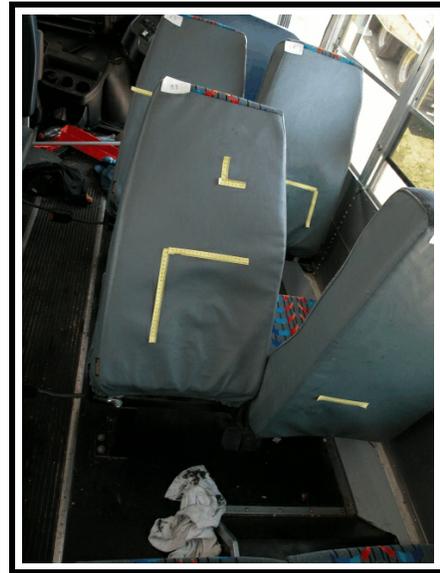
Figure 33. Back of Seat 33

The post-crash angle of this occupant's seat back was 88 degrees. It appears that the back of the seat back was struck by passengers in the row behind him, slightly deforming it.

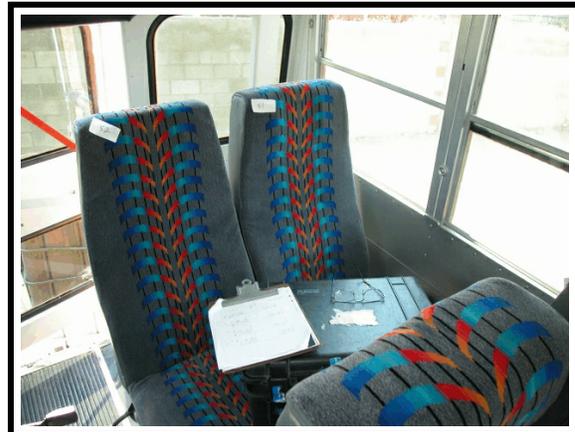
Figure 36. Seats 51 & 52

The post-crash angle of this occupant's seat back was 86 degrees. According to the interview sources, this occupant was still in his seat post-crash. He was assisted by the adult passengers and exited the vehicle through the rear emergency door. He sustained a visible facial injury (specifics unknown) and was transported to an area hospital where he was treated and released.

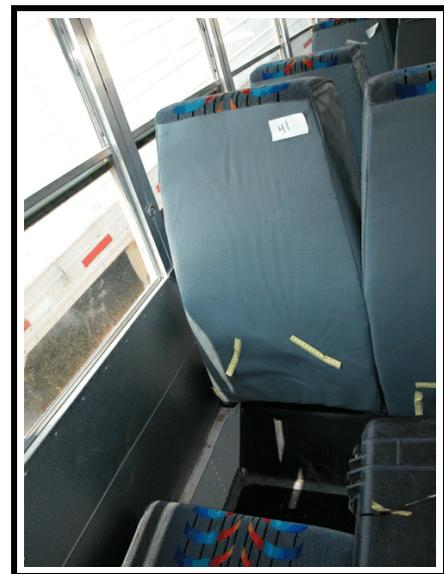
Figure 37. Back of Seat 41

The force of the impact caused this passenger to initiate a forward trajectory towards the 12 o'clock direction of force, likely causing him to contact the seat back in front of him. The case vehicle continued a short distance forward as the tractor crushed the Bluebird's engine compartment. The bus came to final rest facing west in the eastbound lane, still in contact with the front of the Freightliner.

The post-crash angle of this occupant's seat back was 90 degrees. According to the interview sources, this occupant flew forward and traveled up and over the seat back directly in front of him. He may have lost consciousness momentarily. When the crash was over, he was kneeling in the center aisle and his arms were draped over one or more of the seat cushions. He was assisted by the adult passengers and exited the vehicle through the rear emergency door. He sustained a right eyebrow contusion and lower leg abrasions and was transported to an area hospital where he was treated and released. He had been wearing glasses, which may have caused the eyebrow contusion.

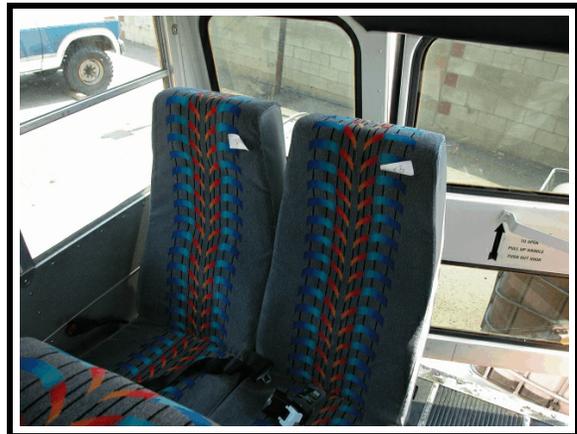
Figure 40. Seats 53 & 54

The post-crash angle of this occupant's seat back was 90 degrees. He was assisted by the adult passengers and exited the vehicle through the rear emergency door. According to police, this occupant sustained facial "broken bones or bleeding wounds". Interviewees reported that this occupant was not injured.

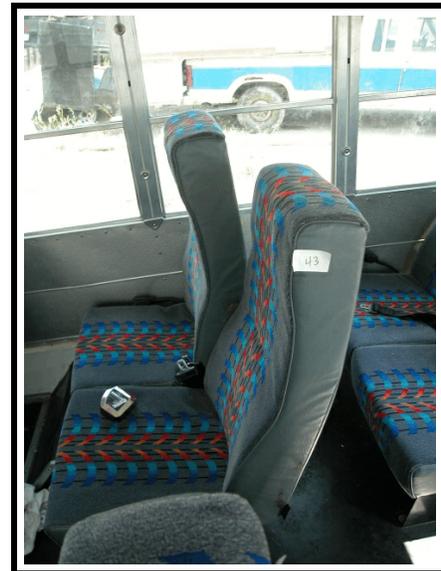
Figure 41. Seats 43 & 44

The force of the impact caused this passenger to initiate a forward trajectory towards the 12 o'clock direction of force, causing him to contact the seat back in front of him. The case vehicle continued a short distance forward as the tractor crushed the Bluebird's engine compartment. The bus came to final rest facing west in the eastbound lane, still in contact with the front of the Freightliner.

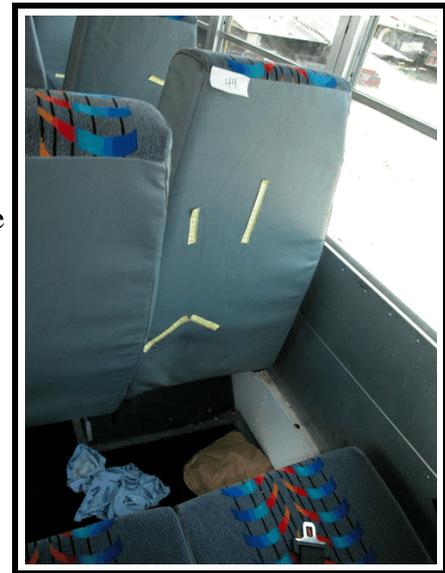
Figure 42. Back of Seat 44

The post-crash angle of this occupant's seat back was 90 degrees. He was assisted by the adult passengers and exited the vehicle through the rear emergency door. He sustained a fractured arm and was transported to an area hospital where he was treated and released.
