# INDIANA UNIVERSITY

## ON-SITE CHILD SAFETY SEAT INVESTIGATION

CASE NUMBER - IN-05-013  
LOCATION - MICHIGAN  
VEHICLE - 1994 FORD ESCORT LX STATION WAGON  
CRASH DATE - December 2004

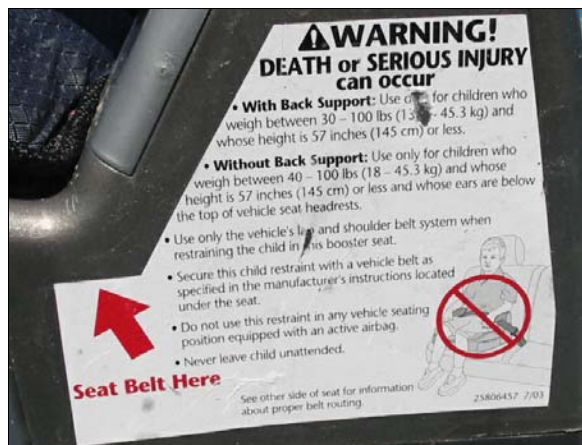
There were manufacturer’s information and warning labels affixed to both sides of the booster seat that specified the seat’s weight, height, and age limitations and the proper safety belt routing (**Figures 14 and 15**). The booster seat was specified for ages four through 10 years, the weight range was 18 to 45.3 kilograms (40 to 100 pounds) and the child’s height range was 101 to 145 centimeters (40 to 57 inches).

**Figure 14:** Warning label on left side of booster seat

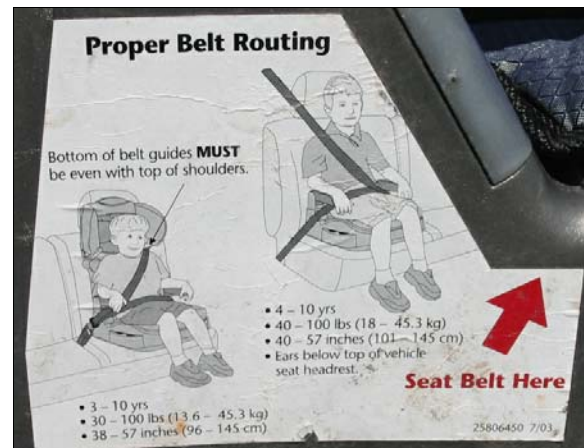
**Figure 15:** Information label showing proper belt routing and booster seat age, height and weight limits
