**CALSPAN ON-SITE CHILD SAFETY SEAT CRASH INVESTIGATION**  
**SCI CASE NO: CA05-017**

**VEHICLE: 2002 FORD TAURUS**  
**LOCATION: PENNSLYVANIA**  
**CRASH DATE: MARCH, 2005**

<i>15. Supplementary Note</i> An investigation of an Evenflo Rear Facing Child Safety Seat (RFCSS) in use during a two vehicle opposite direction crash.			
<i>16. Abstract</i> This investigation focused on the crash dynamics and injury sources that resulted in a double fatality in a 2002 Ford Taurus. The Ford was occupied by a 24 year old restrained male driver and a four month old male center rear occupant. The infant was restrained within an Evenflo PortAbout Rear-Facing Child Safety Seat (RFCSS). The Ford was involved in an opposite direction angular impact with a 1998 Dodge Grand Caravan. The Dodge was driven by a 41 year old male and was the vehicle's sole occupant. The front left aspect of the Dodge impacted the Ford at the left front corner and then continued to engage the left side of the Taurus to its C-pillar. The force of the angular impact resulted in severe intrusion into the Ford driver's occupant space. The driver was trapped within the vehicle and had to be extricated. The driver suffered a c

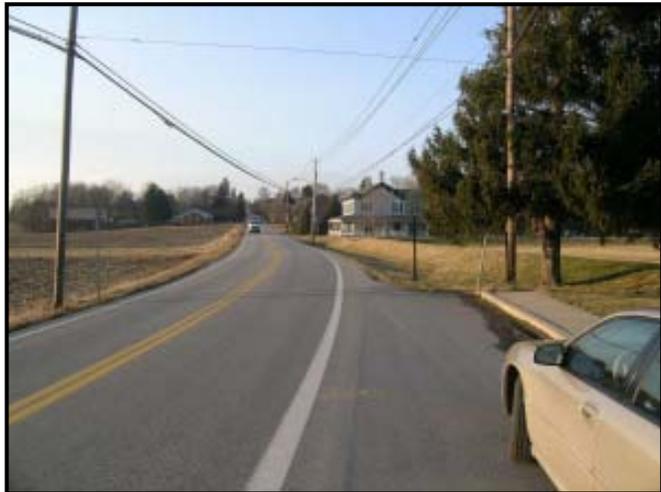
**Figure 2: Northbound trajectory view at the crash site.**

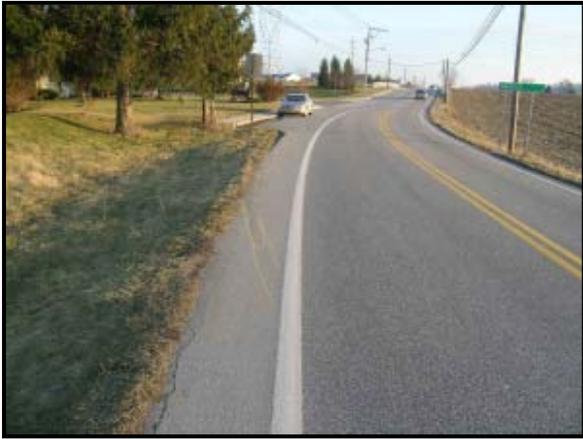
This two-vehicle crash occurred during the afternoon hours of February, 2005. At the time of the crash, it was daylight and raining. The asphalt road surface was wet. The crash occurred on a two-lane predominately north/south road in a rural residential setting. At the scene, the respective travel lanes measured 3.1 m (10.3 ft) in width and were separated by a double yellow center line. The outboard edges of the travel lanes were bordered by white fog lines and 0.9 m (3 ft) wide asphalt shoulders. The point of impact was identified by two arc shaped gouge marks located in the middle of the southbound lane. There was an open fallow field on the west side of the road. The elevation of the field was approximately 1.2 m (4 ft) below the grade of the road. The embankment outboard of the west road shoulder had a negative grade with an averaged measured slope of 33 percent. The road profile was straight and level in the area of the impact. However, south of the point of impact there was a left curve for northbound traffic that contributed to the crash. The curve ended 23.7 m (78 ft) south of the point of impact. The radius of the curve measured 259 m (850 ft). South of the point of impact, through the apex of the curve, there was a 3.9 m (12.7 ft) wide parking lane located outboard of the northbound lane. Refer to **Figure 2**. This parking lane ended 50 m (164 ft) south of the impact. Tire marks attributed to the right tires of the Dodge were observed in the grass beginning at the termination of the parking lane. The tire marks measured 16.8 m (55 ft) in length and curved back into the northbound lane leaving side scuff marks. **Figure 3** is a look back view along the tire marks. **Figure 4** is

**Figure 3: Southward look back view along the Dodge's trajectory.**

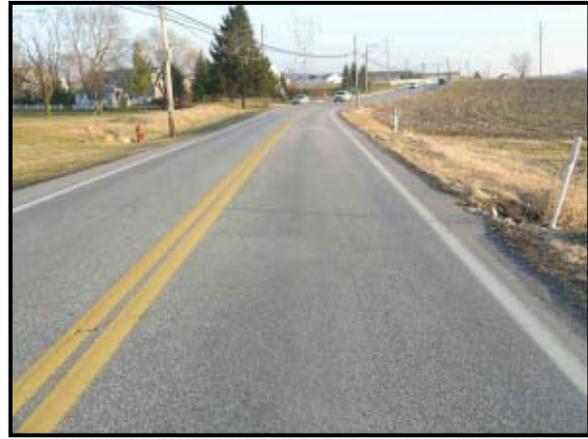
a northbound trajectory view of the Ford. The Ford came to rest on the open field on the right side of the figure. The speed limit in the area of the impact was 56 km/h (35 mph). A schematic of the crash is included at the end of this narrative report as **Figure 12**.

**Figure 4: Trajectory view of the Ford 60 m (200 ft) before impact.**
